M A G A Z I N E
F L I G H T
A I R W O R T H I N E S S
S U P P O R T
T E C H N I C A L
A I R B U S

A320 Family

A practical guide to reducing in-flight interruptions

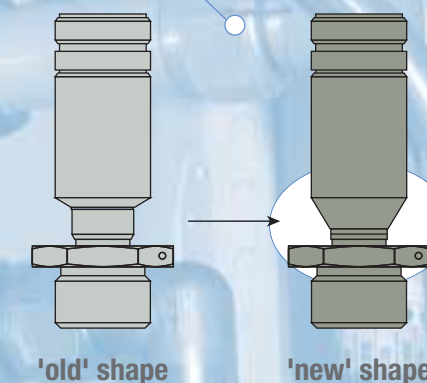
Pressure Switch shape change

As shown in the main leak drivers pie chart, the pressure switches currently installed can give some spurious low-pressure messages. In addition, hydraulic leakage from the switch itself was reported in past years. It is estimated that overall pressure switch failures have led to 8.4% (for ATA 29) of the in-flight interruptions since 2001.

- PN 450-1-3100-00 will replace PN 50-1-3100-00 on the EDP outlet ports
- PN 450-2-3100-00 will replace PN 50-2-3100-00 on the manifolds and EMP outlet ports.

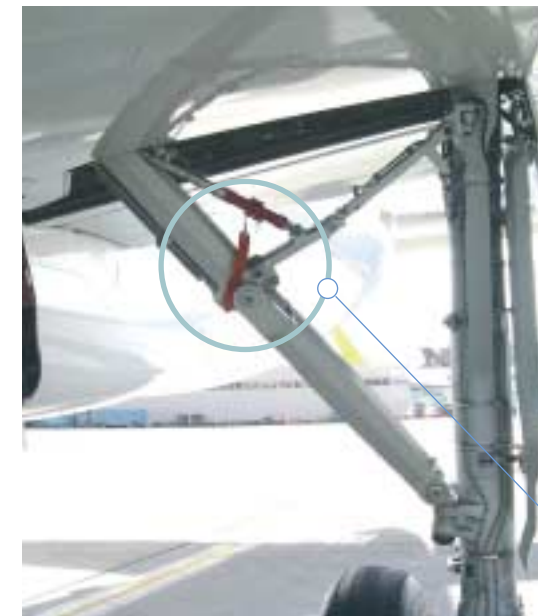
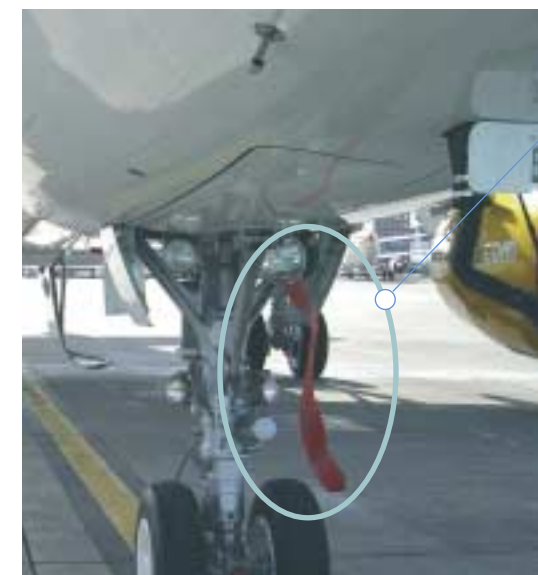
Landing gear safety devices: ground lock pins and collars

However, under towing operation for maintenance, when the hydraulic power supply is not available, one downlock means is removed. Under such circumstances, Airbus recommends usage of the ground lock pins and collars which are 100% reliable to ensure physical downlocking of the landing gear.

- Some airlines who fit ground lock pins and collars during turnaround have particular check-lists requesting their flight crew to ask ground crew to show, in their hands, removed pins and collars prior to final dispatch. This may be an effective way to avoid interruptions, if you wish to install those pins during short turn arounds.

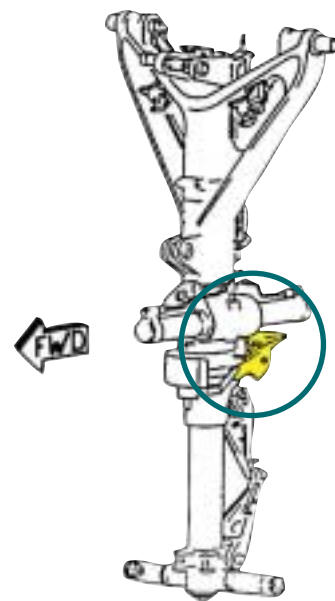
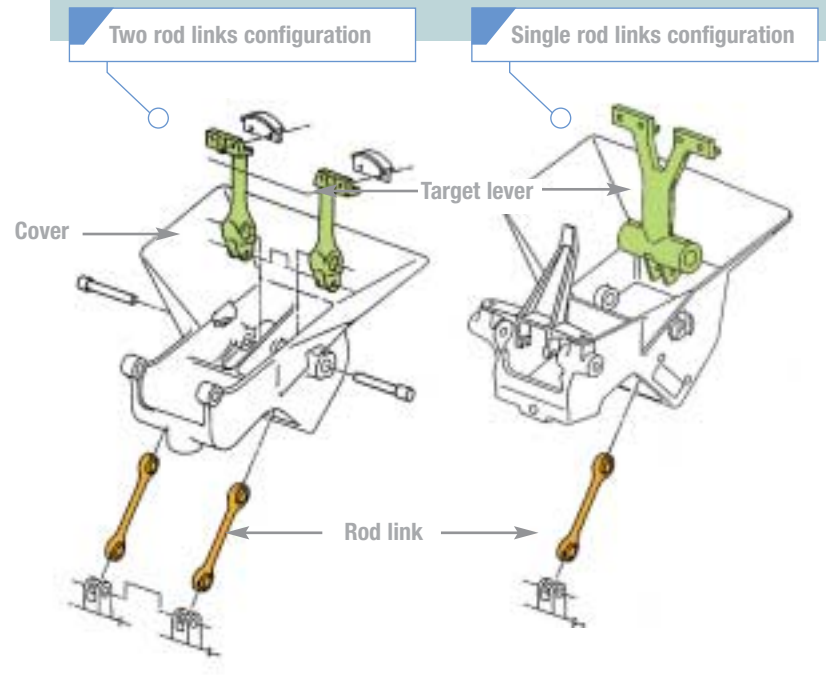
The NLG 'flight/ground' indicating system consists of a mechanical mechanism driving two sensors (FIN 24GA and 25GA) see figure above. It indicates whether the aircraft is 'in flight' and 'straight' (shock absorber extended and centred) or 'on ground' (shock absorber compressed or not 'straight').

Three failure modes have been identified that induce bending or fatigue break of the sensors 24/25GA rod links, which can lead to flight interruptions:

- Looseness of the NLG cover
- Seizure/jamming of the rod links
- Corrosion/seizure of the target lever eye end bearings.

Pending embodiment of these modifications, some maintenance may be applied to prevent the failure mode of the rod eye end and target lever axle (refer to TFU 32-21-11-012): 'Cleaning of the interface rod link axle as well as the target lever axle. If the target lever or the axles are removed, ensure the axle lever torque value is between 4 and 5nm (2.949 to 3.687lbf)'.

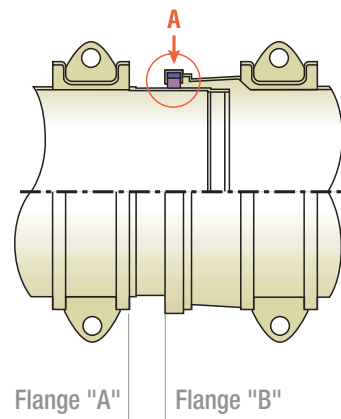
Typical installation

Investigation revealed that bleed air ducts leaks represent 17% of in-flight interruptions. For this type of failure mode there are two possible solutions.

"X" Flanges must be parallel (±2mm / 0.078in.)

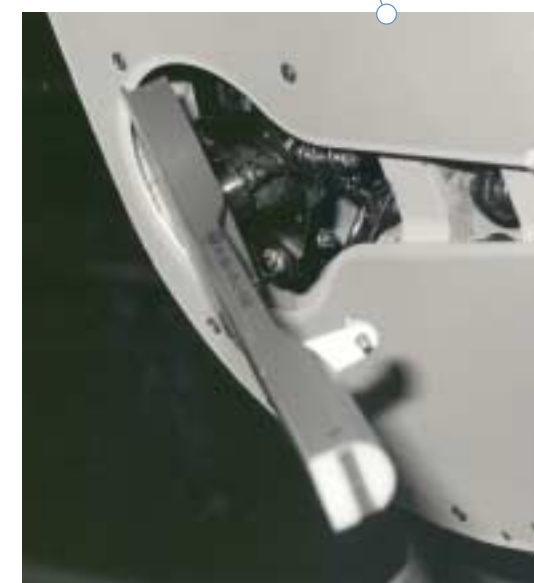
Old standard door handle from MSN001

On pre-mod 26213 (old design) aircraft, the cargo door handle can be deformed or cracked due to overloading or impact damage. In these cases, the proximity switch
