UNITED STATES COAST GUARD

REPORT OF THE INVESTIGATION INTO THE

FLOATING OCS FACILITY - TENSION LEG PLATFORM

LIFEBOAT FALL WITH LOSS OF LIFE ON JUNE 30, 2019

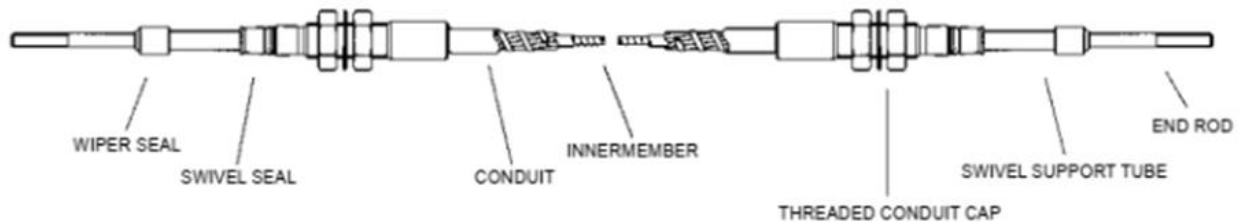
The hook control cables are heavy duty low friction cables with threaded end fittings and four inches of travel at the end rods (see Image 4). Each cable has an outer conduit and an inner member. The conduit is comprised of three layers: a green plastic cover; steel reinforcement; and a white polyethylene liner. The conduit provides a protected path for the steel inner member. With the ends of the conduit fixed at each terminal point (provided it is not fully compromised), the conduit also controls the travel length of the inner member. The inner member transmits linear motion from the hook release unit to the locking shafts located within the hooks via the end rods.

Image 4: Control cable components. Credit: Cablecraft, modified by the USCG.

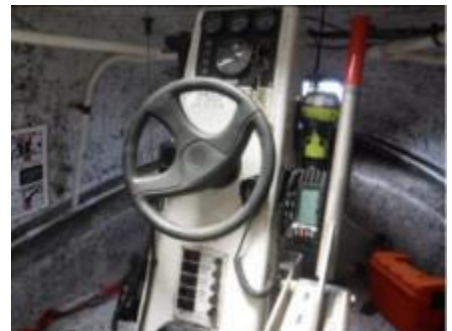
*Figure 3: Lifeboat No. 6 release unit.
Credit: Palfinger, dated 2016.*

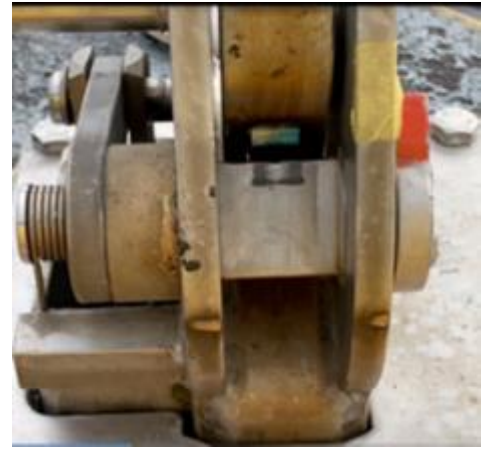
4.1.12. Boat Crew Person 1 had watched the hook locking shaft roll back into place. He looked for and saw the flat face of the locking shaft (see Figure 6). To him, this indicated that the locking shaft was in the correct position and the hooks were correctly reset. He also said he would generally look at the hook indicator on the side of the hook. He noted that if in the closed position, the arrow should be in the red; if in the open position, the arrow would indicate in the green.⁴

Figure 6: The “flat face” of the locking shaft on a LHR 3.5M2 hook (image does not depict Lifeboat No. 6’s hook). Credit: CG.

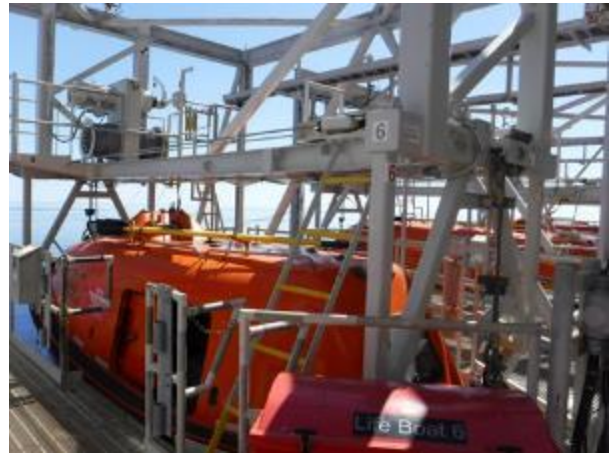
4.1.26. The winch is located on a raised landing above the forward end of the lifeboat (see Figure 7). The BCO reached the winch by climbing a ladder. At the winch, he inserted the handle and started to crank. The winch at Lifeboat Station No. 6 had recently been changed out. While the new winch was not “new,” it had been refurbished in or around 2018 and was in significantly “newer” condition than the previous winch at Lifeboat Station No. 6. Furthermore, it was a more powerful winch: the new winch was converted to a model 9300XL, rated for 9300 kg; while the old model, a 7800XL was rated for only 7800 kg. To the BCO, the winch model looked identical. However, he did note that it was easier to operate. Later, he recalled that it felt “smooth” and “like butter.” He observed, “Where the old one had like maybe two pounds of resistance . . . this one had like a half pound of resistance against it.”

Figure 7: Lifeboat Station No. 6 davit. Figure depicts raised landing where winch is located. Credit: Palfinger, dated May 2015.

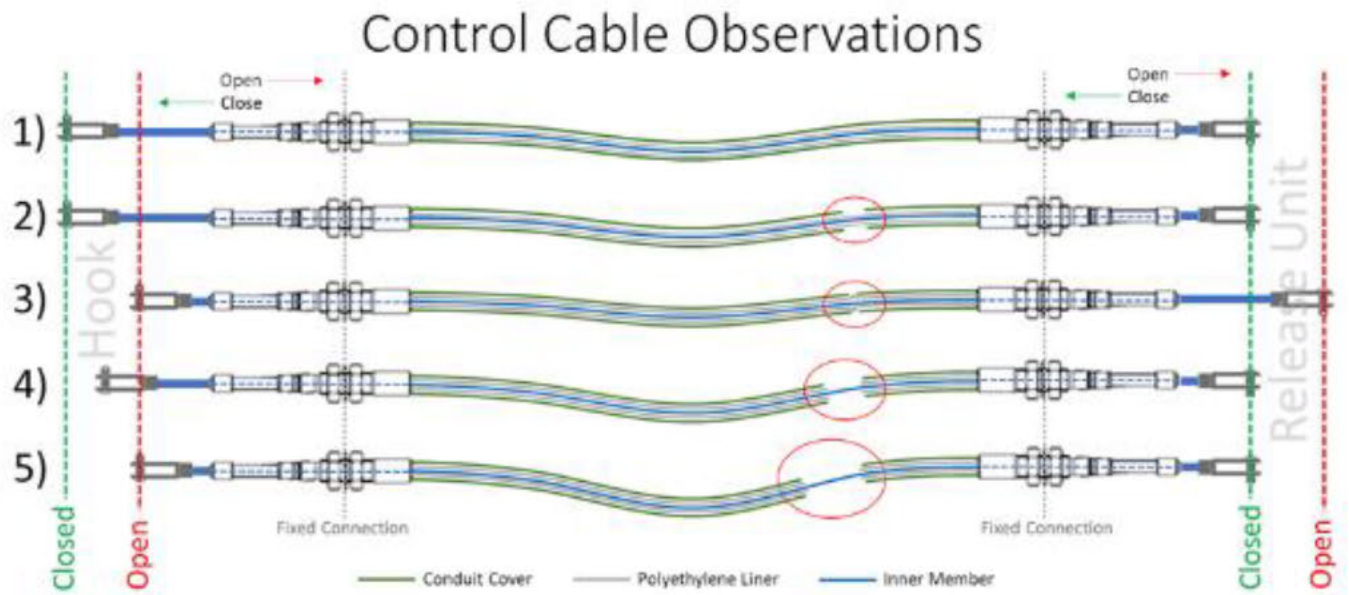
- 1) Hook closed with release handle locked in closed position (cable intact).
- 2) Hook closed with release handle closed. Conduit cover and steel layer removed (9 mm) with liner intact.
- 3) Hook open with release handle open (liner compression noted during testing).
- 4) Polyethylene liner failed during closing with 48 mm of conduit separation and locking shaft in partially-closed position (i.e., closed/locked, but almost open).
- 5) Subsequent release unit actuation after initial liner break extended conduit separation to 91 mm and would not rotate the locking shaft (i.e., hook remained open).

Figure 46: Control cable observations. Credit: CG.

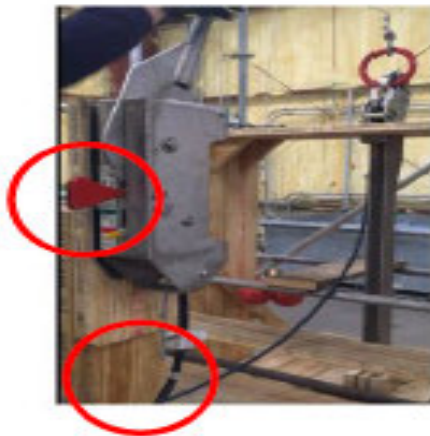
Image 50: The release handle is in the locked and closed position. However, the cable is damaged.

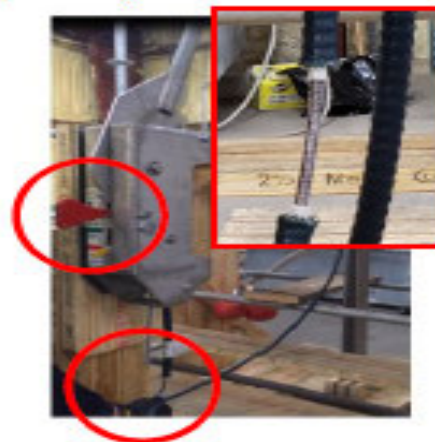
Image 51: Forces cause the outer layers of the cable to separate. The release handle stays closed.

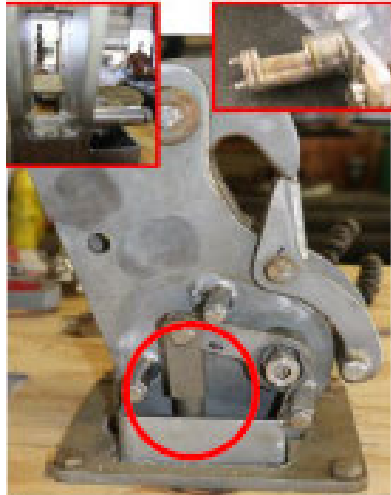
Image 52: At the hook end, the cable end rod moves. This causes the locking shaft to rotate.

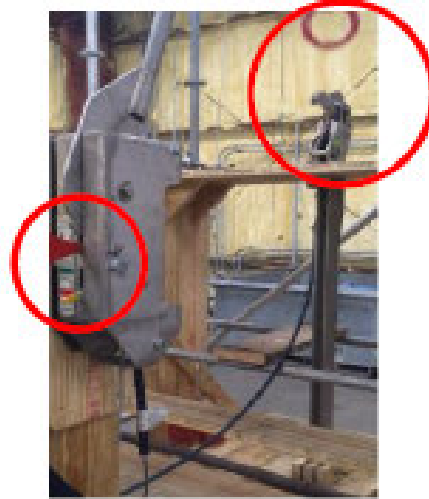
Image 53: If the locking shaft turns enough, the hook will release, even as the release handle stays locked.

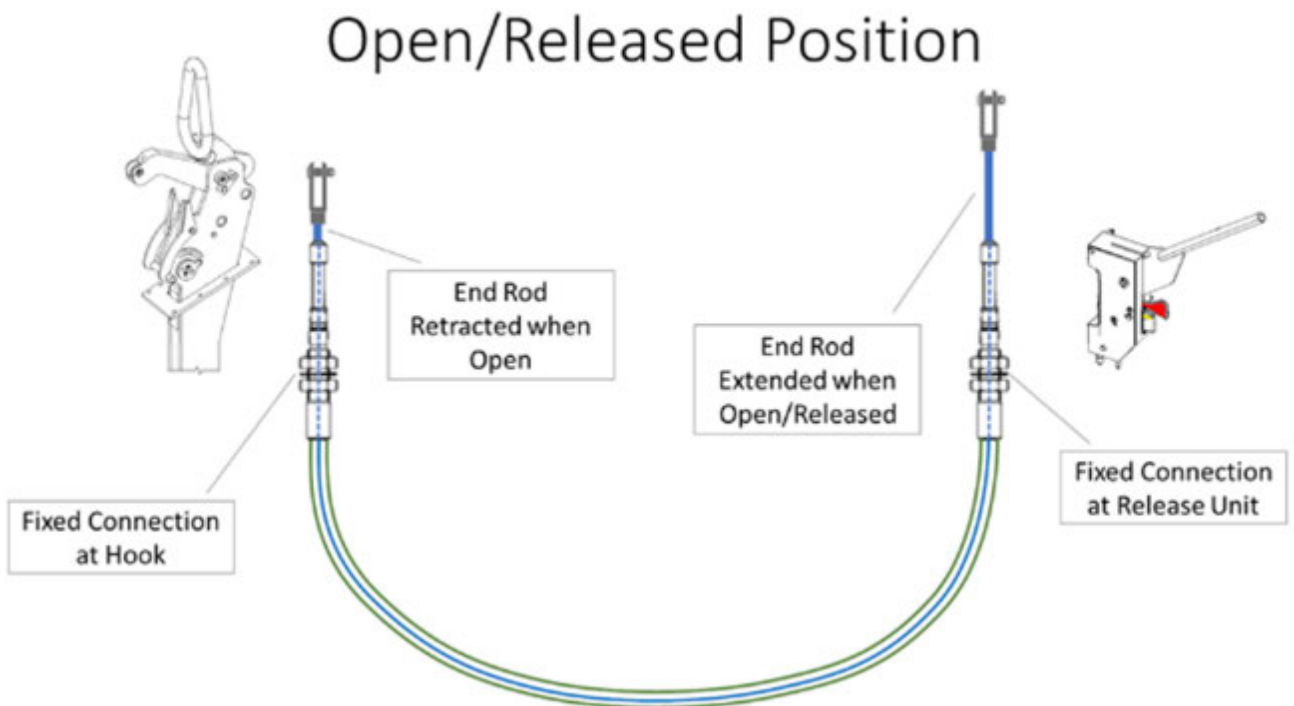
Figure 55: In this figure, the hook is open. There is no damage to the cable. Credit: CG.

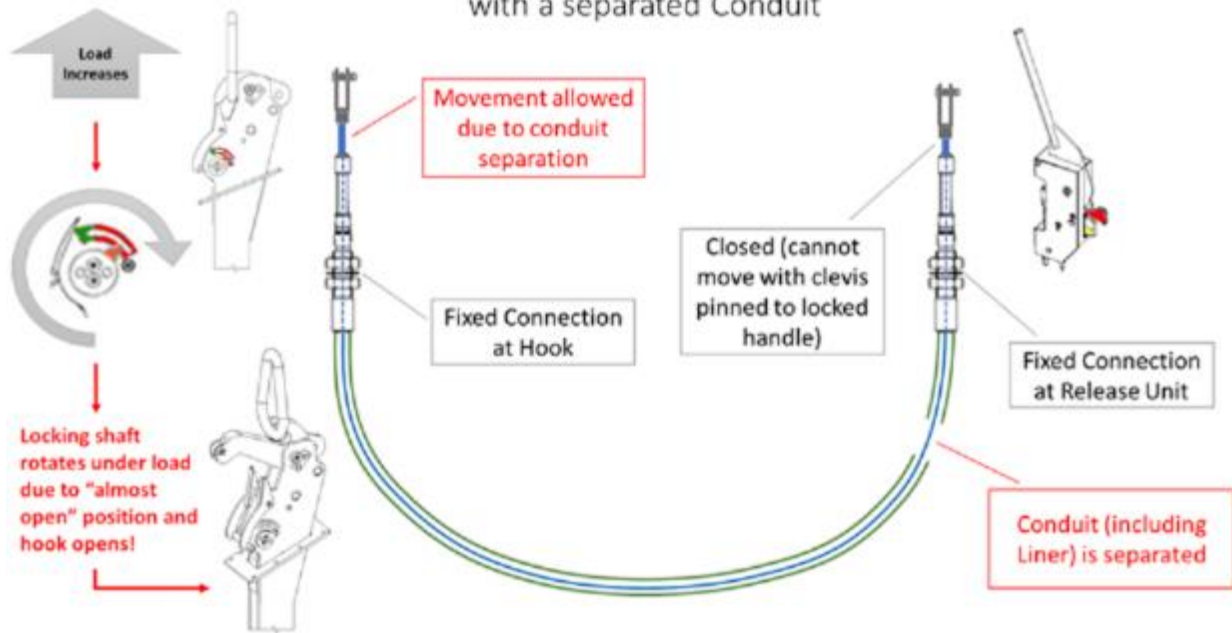
The Coast Guard attempted to validate the testing using worn cables (seeking to better replicate the condition of Lifeboat No. 6's 7-year-old cables) installed in an EL24 lifeboat with LHR 3.5M2 hooks and routed similar to those of Lifeboat 6. As discussed in the findings of fact above, the Coast Guard's experiments at MSTC showed that a separation in the conduit of a control cable, while cycling the release unit from open to closed (resetting), can result in the hook locking shaft stopping between the open and closed positions. With the locking shaft in an "almost open" position immediately following conduit separation, the hook can still support the weight of the lifeboat and the occupants. However, in that position an additional load can cause the locking shaft to rotate from the "almost open" to open position.

Figure 58: In this figure, the load is increased on the hook, as a result the locking shaft turns from “almost open” to open. Credit: CG
