# UNITED STATES COAST GUARD

Report of Investigation into the Circumstances Surrounding the  
Explosion, Fire, Sinking and Loss of Eleven Crew Members

## *DEEPWATER HORIZON*

April 20 – 22, 2010

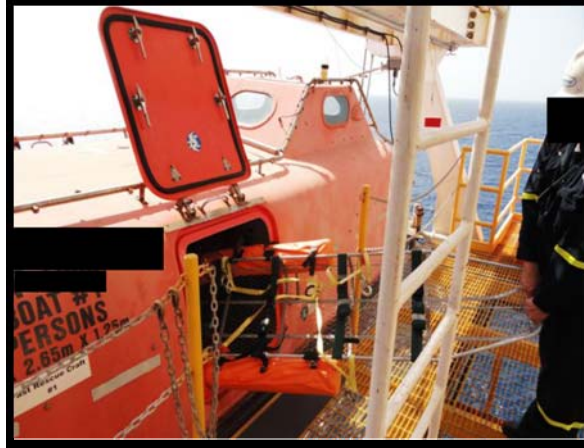
Figure 8 - Typical Stretcher Loading

The lifeboat design was not conducive to receiving an injured crew member on a stretcher. As illustrated in Figure 8, when loading a stretcher via a side loading door, crew members must maneuver it past the threshold. As shown in Figures 9 and 10, once loaded, the positioning of a stretcher in the lifeboat significantly impedes egress and reduces seating capacity by eight to ten occupants. Neither arrangement provides a means to secure a stretcher from shifting during operation of the lifeboat.

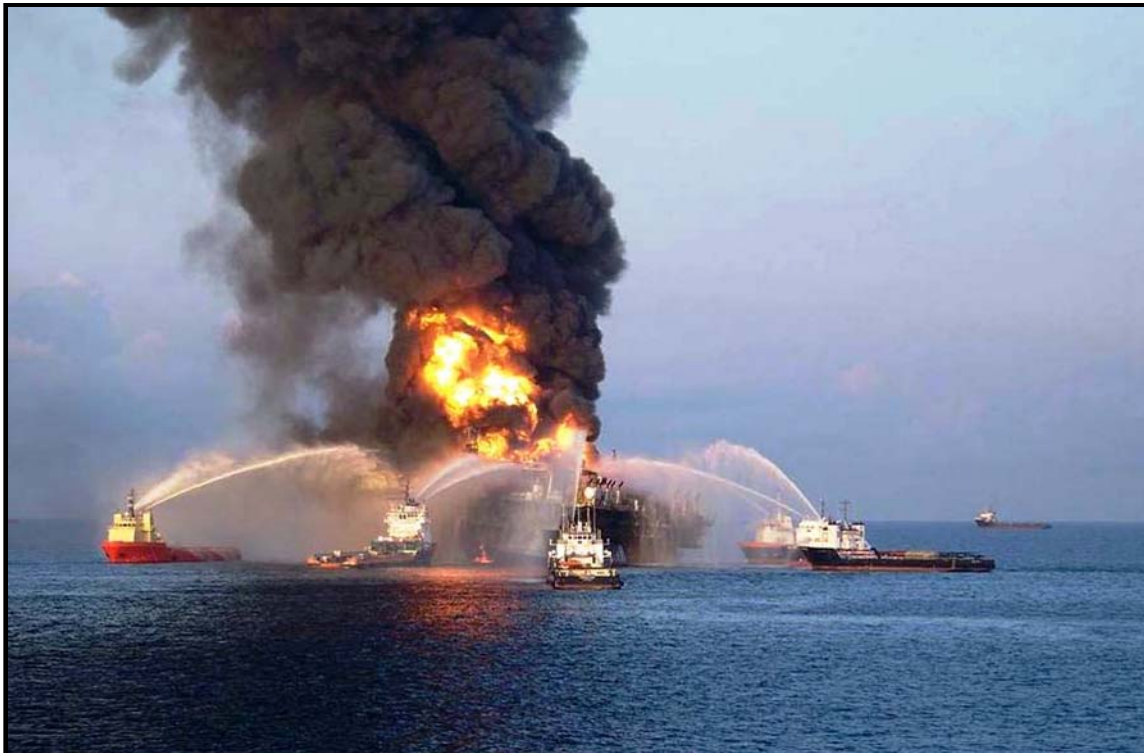
Figure 14 – Vessels directing water towards the fire

Transocean's salvor, SMIT Salvage Americas, initially did not take the lead either. When SMIT Salvage Americas arrived at the Transocean Emergency Response Center in Houston, Texas at approximately 0500 on April 21, it was not clear who was directing the fire-fighting effort on scene.<sup>309</sup> The first successful two-way communication between SMIT Salvage Americas at the Transocean emergency response center and the operations manager-performance onboard *MAX CHOUEST* was at 1300 on April 21.<sup>310</sup> At 1315, the Captain on watch aboard the *MAX CHOUEST*, logged "Informed C. G. Cutter *ZEPHYR* to have fire vessels redirect water flow to legs as per Transocean - [REDACTED]"<sup>311</sup> Figure 14 shows at least 6 vessels providing water to the fire.

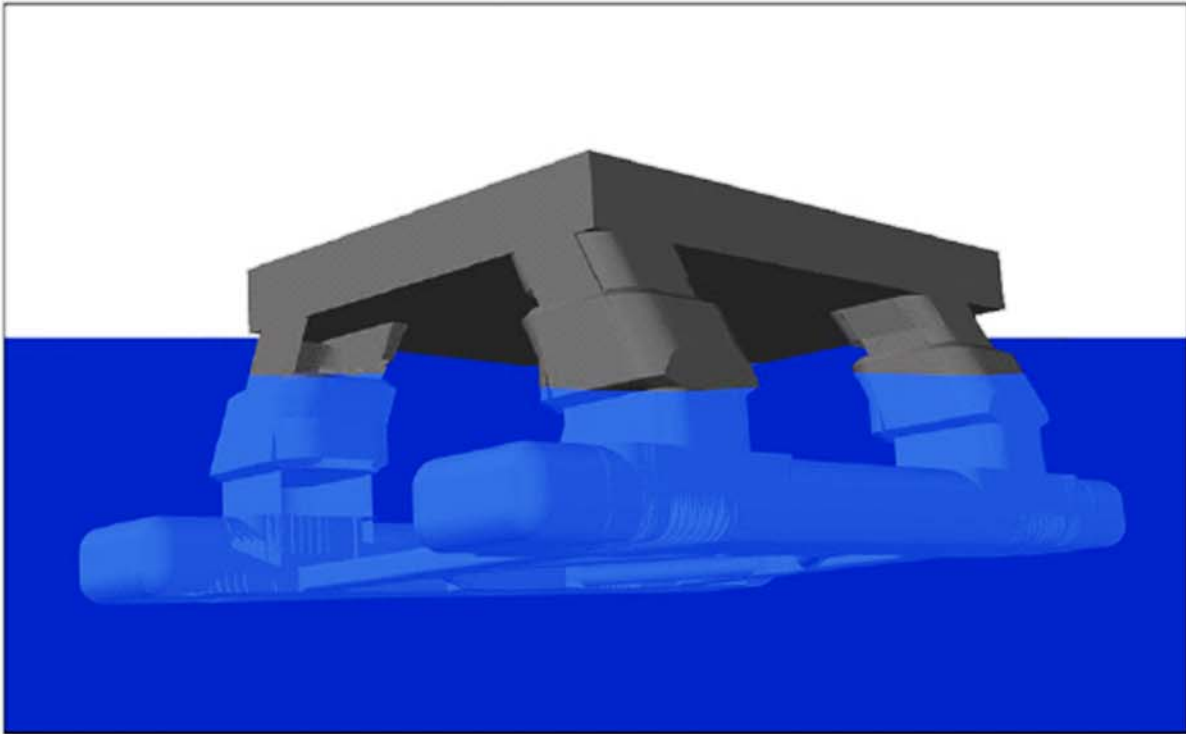
Figure 5: Computer Model Showing the Estimated Waterline, Port Bow Aspect (0612 on 22 April 2010)

Based on the waterplane estimates shown in Figures 5, 6, 9, and 10, we estimated the displacement, heel, and trim at two discrete times: 0612 and 1030 on 22 April 2010. The rig’s attitude and displacement for these conditions, as well as the presumed 23 meter draft pre-casualty condition are shown in Table 2. These results show that the rig’s displacement had increased by approximately 1500MT at 0612 and by 2300MT at 1030 on 22 April 2010. Changes in displacement describe the cumulative effect of added weight (or lost buoyancy) required for the rig to achieve its estimated waterline. The results shown in Table 2 indicate that the vessel must have experienced flooding, either as the result of damage to the watertight envelope, or as a result of downflooding caused by firefighting water and/or downflooding through preexisting openings, or some combination thereof. In other words, without any flooding, the shifting of on-board weights such as ballast, topside loads, and/or the toppling of the derrick, either alone or in combination, would not have been sufficient to place the vessel in the conditions shown in Table 2.
