# National Transportation Safety Board

## Marine Accident Brief

### Collision between Passenger Vessel *Diamond Edge* and Liftboat *B.W. Haley*

<b>Accident no.</b>	DCA15LM015
<b>Vessel names</b>	<i>Diamond Edge</i> and <i>B.W. Haley</i>
<b>Accident type</b>	Collision, with subsequent partial sinking of the <i>Diamond Edge</i>
<b>Location</b>	Freshwater Bayou Safety Fairway, Gulf of Mexico (29°27.84'N, 092°18.76'W)
<b>Date</b>	March 2, 2015
<b>Time</b>	1027 central standard time (coordinated universal time – 6 hours)
<b>Injuries</b>	None
<b>Damage</b>	Est. \$1.75 million
<b>Environmental damage</b>	None reported
<b>Weather</b>	Dense fog, visibility less than 0.1 mile; air temperature 65°F; winds easterly at 8 knots
<b>Waterway information</b>	Open waters of the Gulf of Mexico about 55 miles south-southwest of Lafayette, Louisiana

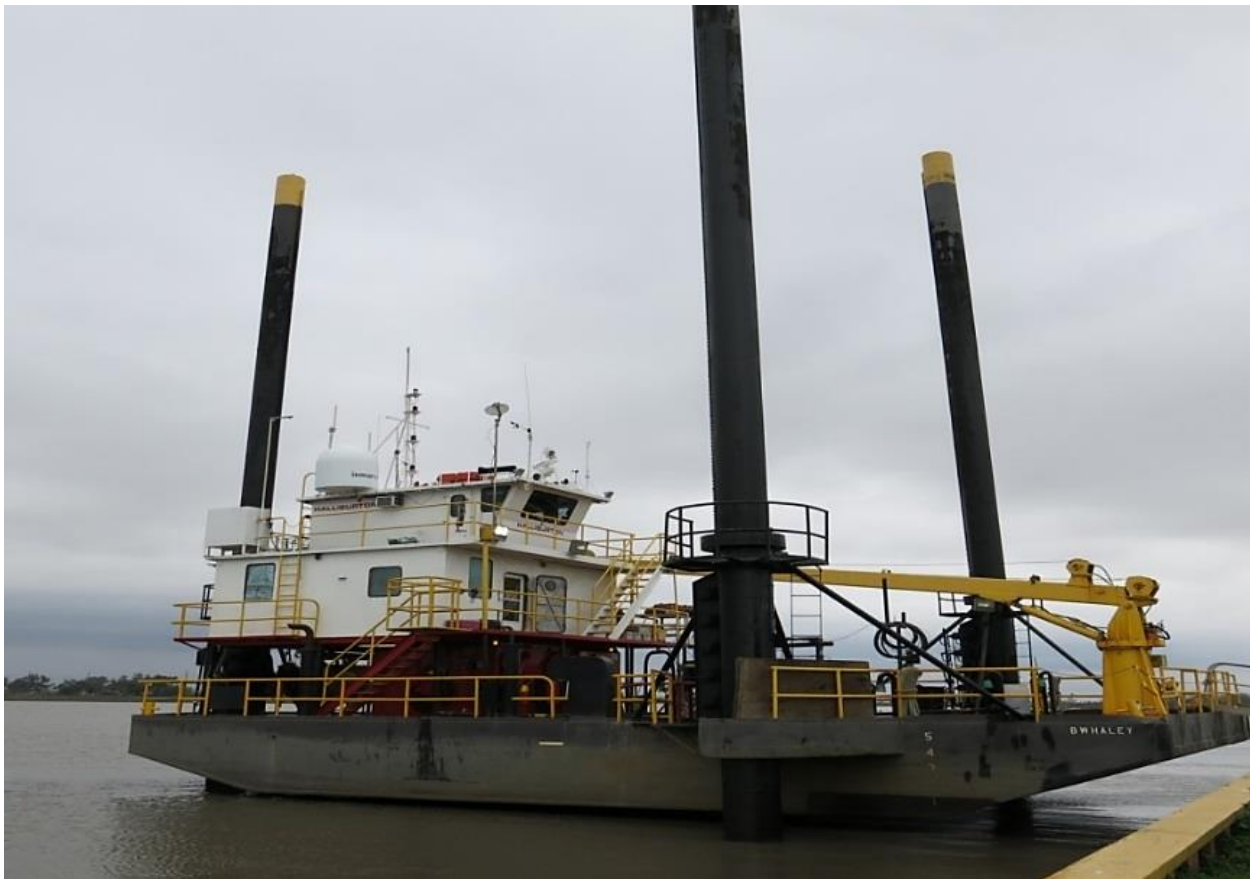
The *B.W. Haley* was a liftboat operated out of Grand Chenier, Louisiana, in the line services support sector of the oil exploration and support industry. A liftboat is an offshore supply vessel with moveable legs capable of raising its hull above the surface of the sea.<sup>5</sup> The 62-foot-long, 32-foot-wide steel vessel had a 15-ton steel crane and three large steel legs. The three steel legs were 4 feet in diameter, 90 feet in height, and had 12-foot-by-24-foot steel plates, known as mats, attached to the bottom of each leg. The mats provided stability when the legs were resting on the sea floor during lifting operations. While the vessel was under way, the steel legs were raised so that the mats were out of the water. In the raised position, the legs extended close to 90 feet above the water. The *B.W. Haley* had two 400-horsepower diesel engines capable of moving the vessel at a top speed of about 5.5 knots when fully loaded to its 170-ton displacement. It had one radar and was not required to carry nor fitted with AIS. Without this equipment, the *B.W. Haley* could not be detected by other vessels through AIS.

Liftboat *B.W. Haley* with legs in “elevated” position.
