NATIONAL TRANSPORTATION SAFETY BOARD

MARINE ACCIDENT REPORT

CAPSIZING AND SINKING OF THE
UNITED STATES DRILLSHIP
GLOMAR JAVA SEA
IN THE SOUTH CHINE SEA
65 NAUTICAL MILES SOUTH-SOUTHWEST
OF HAINAN ISLAND,
PEOPLE'S REPUBLIC OF CHINA
OCTOBER 25, 1983

NTSB/MAR-87/02
(SUPERSEDES: NTSB/MAR-84/08)

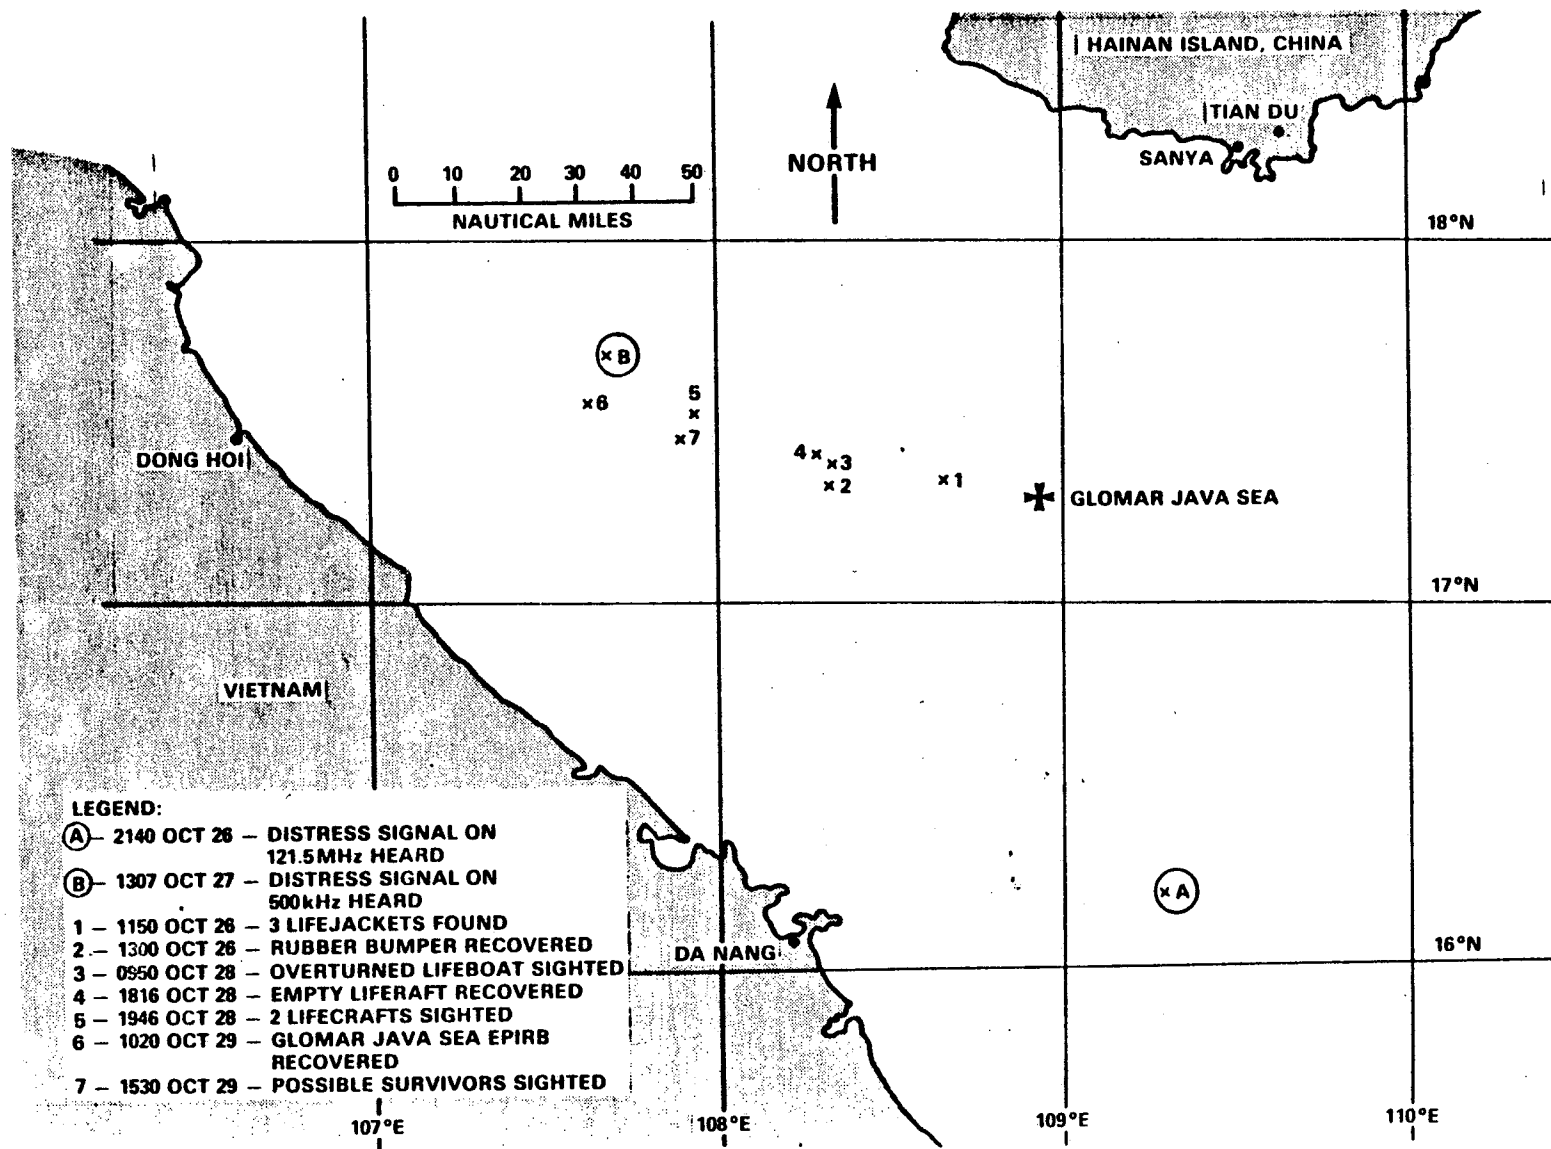
Figure 3.—Search and rescue effort from October 26 to October 29, 1983.

At 0430 on October 27, a commercial airplane reported to the Hong Kong Marine Department that an intermittent distress signal on 121.5 MHz was heard at 2140 on October 26 about 60 to 70 nmi east of Da Nang, Vietnam. This information was passed on to Kadena. It was later determined that a distress signal transmitted from that location could not have come from the GLOMAR JAVA SEA's emergency position indicating radio beacon (EPIRB). At 0643 on October 27, Kadena alerted its search and rescue airplanes and at 0747 launched a P-3 airplane with an estimated time en route of 3 hours. The P-3 spent 6 hours searching the drill site using a 25-nmi track spacing at an altitude of 300 to 400 feet. The area covered was bounded approximately by 14°30' N. latitude on the south, 30 nmi off the Vietnam coast on the east, 18° N. latitude on the north, and 110° E. longitude on the west. Due to the poor weather conditions, most of the unsuccessful search was conducted by radar. During the afternoon of October 27, a Singaporean ship about 200 nmi southeast of Saigon, Vietnam (see figure 2), en route from Dubai, United Arab Emirates, to Kobe, Japan, reported to the Marine Department of Hong Kong that it had received a distress signal on 500 kHz at 1307 on October 27. The distress signal included the GLOMAR JAVA SEA's call signal, WFDS, and a position of 17.41° N., 107.42° E. (about 70 nmi to the northwest of the well location). (See figure 3.) A vessel was sent to locate the source of the signal, but it was not found.

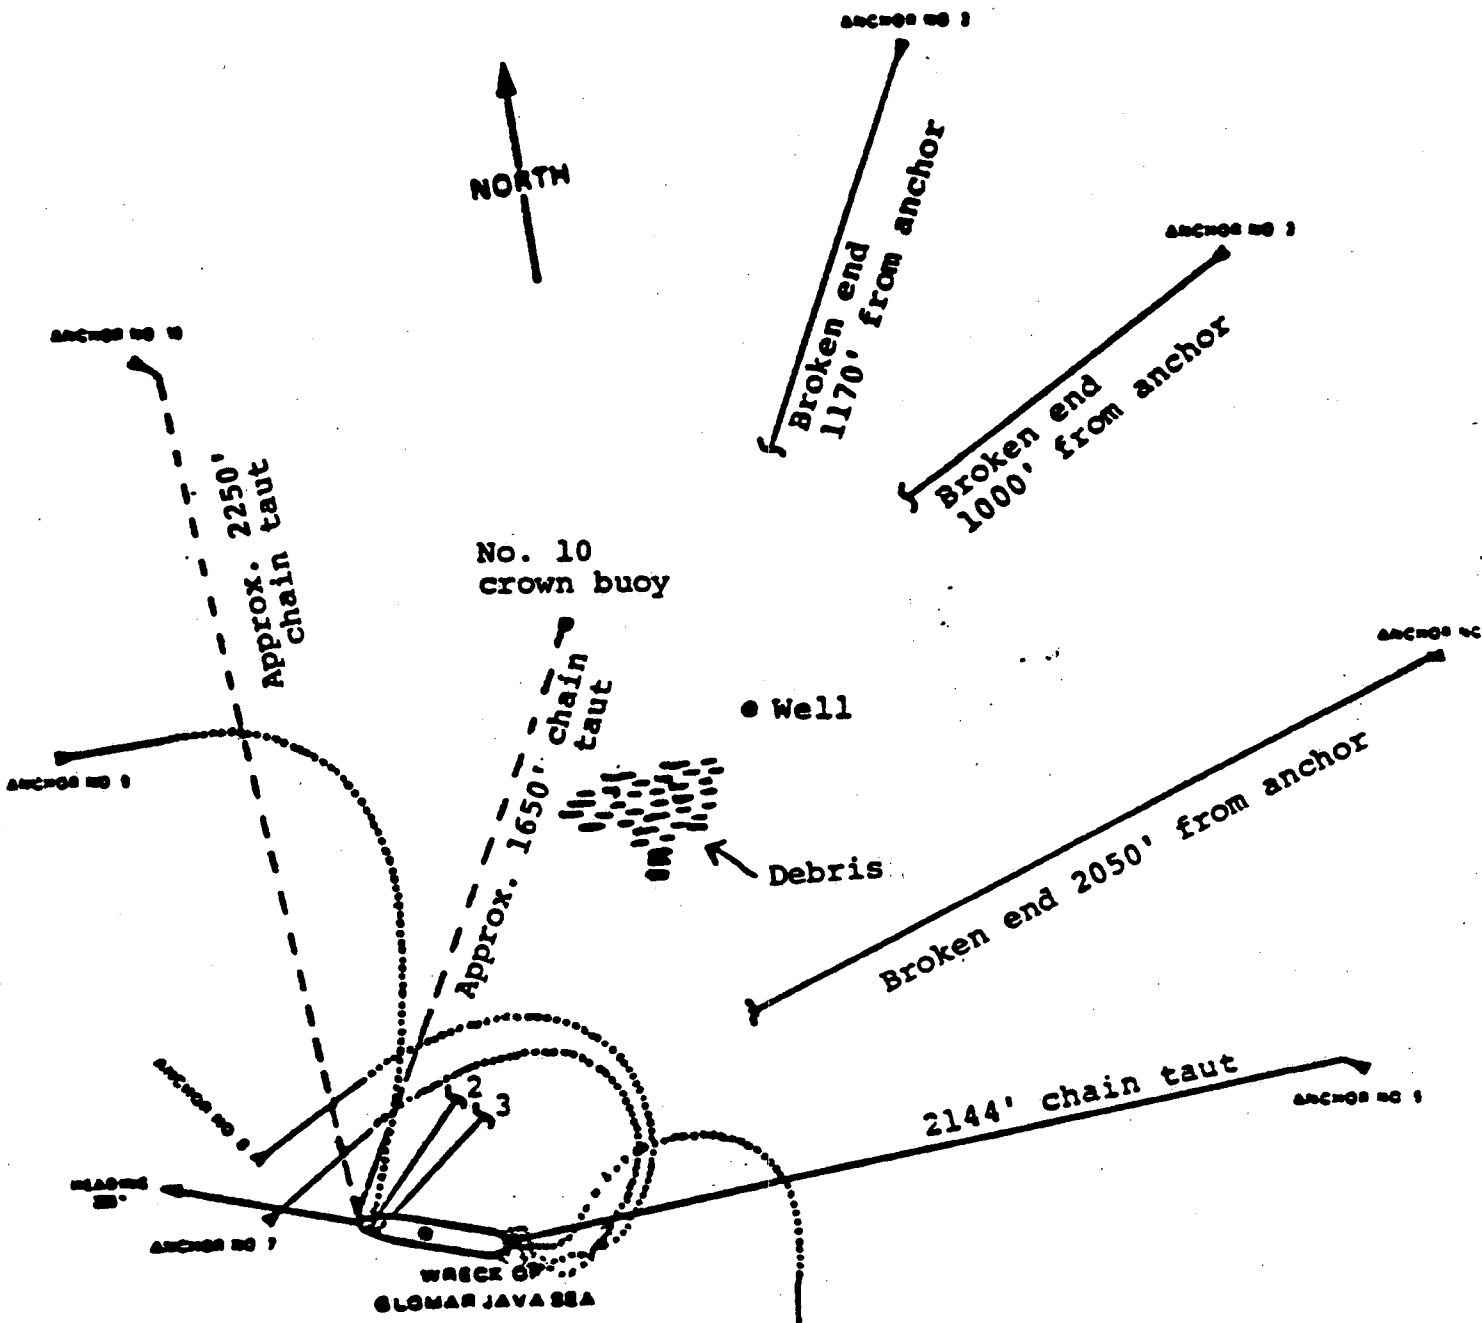
break, the condition in which it was found after the casualty. The sonar mosaic (MBI Ex. 79) shows a "return" from the position of anchor 4 leading to the southwest about 2000 feet ending south of the debris pattern. After chain 4 parts, the ship would now be restrained primarily by anchors 10 and 5, which would act as tethers as the capsized ship moved to the south-southwest under the influence of the prevailing seas and current and ultimately sinks to the bottom. The number 5 and 10 moorings were found to be taut in the November dives and chain retrieval operation. This scenario is illustrated by Figures 1 and 2 (based on MBI Exhibit 19 and Figure 4 in the Report) on the following pages.
