Issued May 9, 2023

MIR-23-08

Diesel Generator Engine Failure on board Offshore Supply Vessel *Ocean Guardian*

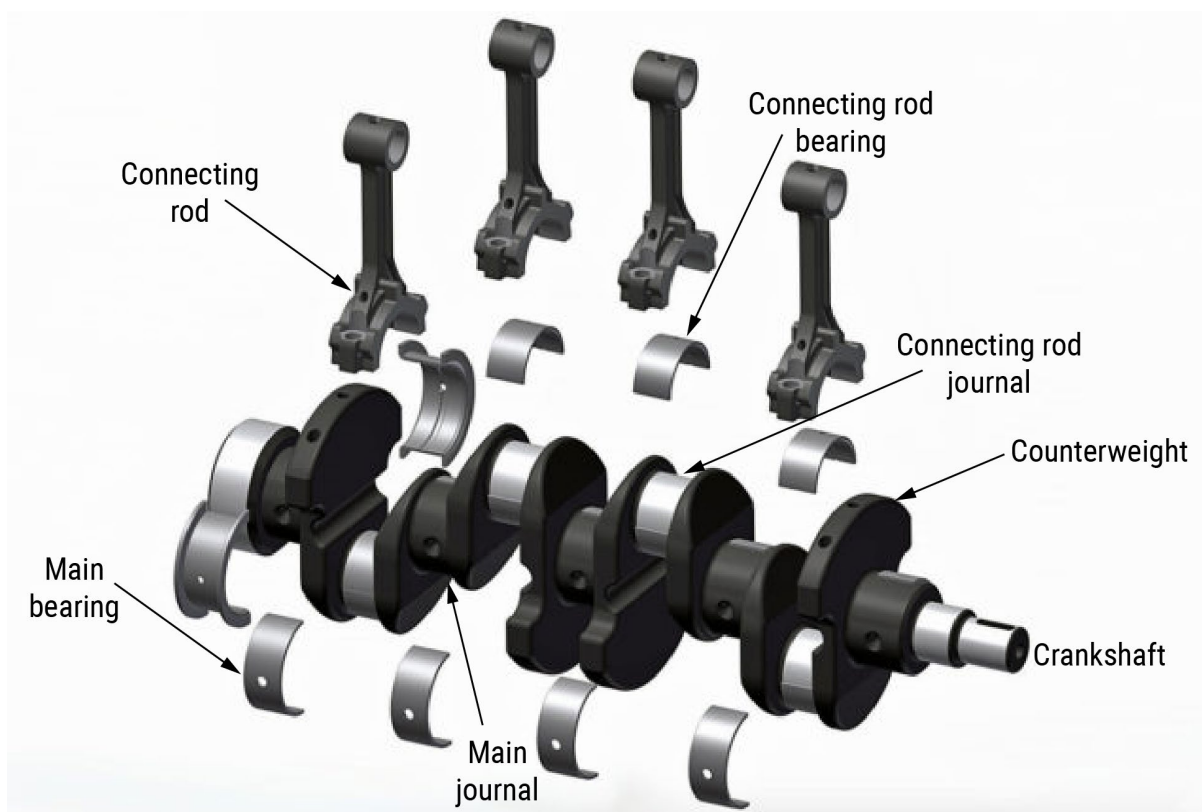
Figure 5. Typical components of a diesel engine crankshaft (not a Caterpillar 3516B). (Background source: enginelabs.com)
