UNITED STATES COAST GUARD

COMMERCIAL DIVING ACCIDENT

ONBOARD THE MOBILE OFFSHORE DRILLING UNIT
CLIFF'S DRILLING RIG NO. 12 ON MARCH 4, 1996
WITH THE LOSS OF LIFE

**COMMANDANT'S ACTION
ON THE FORMAL INVESTIGATION INTO THE
CIRCUMSTANCES SURROUNDING THE**

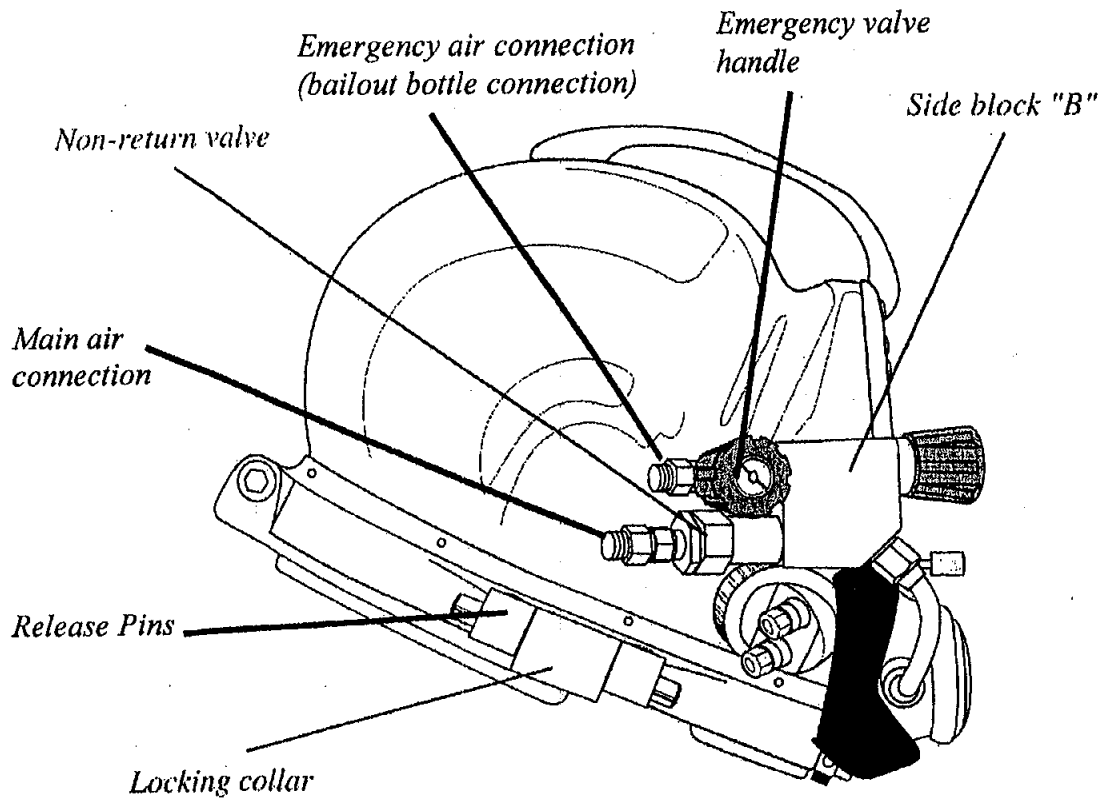
Figure 7: Side view of SuperLite-27 helmet

42. At about 1645 hours, Austin was watching the ultrasonic gauging monitor while Wiitala operated the air rack and directed Pilkington.¹⁰⁶ Wiitala checked the pressure gauge and saw that the pressure had again dropped to 90 psi. Wiitala told Pilkington once again to close his free flow valve, but Pilkington said that the valve was already closed. At this point, Wiitala realize there was a larger problem. Over the next several minutes Wiitala had a garbled conversation with Pilkington, during which Pilkington's manner became increasingly frantic and his breathing rapidly increased to the point it was apparent he was hyperventilating. "He [Pilkington] just kinda went into a whirl. He wouldn't really talk to me on an even keel, and he wouldn't respond to me. I mean, it just got away from him."¹⁰⁷ During the conversation, Pilkington complained of not being able to breathe and said that he heard a hissing noise. Pilkington speculated that he might have forgotten to tighten the airline to his helmet before

- have continued to gasp for air and violent attempts to breathe may have sucked water between the neck dam and the seal into his helmet.¹⁶³
4. Finally, water may have entered Pilkington's helmet through the emergency air connection. In a last ditch attempt to trouble-shoot his emergency, Pilkington may have reached for the emergency valve handle directly adjacent to the main air connection. This connection is typically used to couple the bailout bottle to the helmet. When not used, the only barrier preventing water from entering the helmet is the emergency supply valve (See figure 7). When Pilkington's regulator bottomed out, he may have instinctively opened his emergency supply valve, the standard procedure taught in commercial dive schools, and allowed water to enter his helmet. If the emergency valve was opened, water would only have entered the helmet if the air pressure inside the helmet was extremely low (indicating an almost total interruption in air supply and pressure). Even the smallest pressure above ambient would have forced air out of the emergency valve which would have prevented water from entering.¹⁶⁴

31. Wiitala's testimony raised the questions of whether Pilkington's main airline was secured to his helmet when he began his dive and whether Pilkington may have loosened the connection when he was underwater. Wiitala testified that before Pilkington quit talking, Pilkington said that he might have forgotten to tighten his airline.²¹² The reasoning is that Pilkington may have reached up to his main air connection (See figure 7) and, while trying to tighten the fitting, loosened it instead. Master Chief Bradford opined that it was "plausible" that Pilkington had loosened his main airline connection near the end of his dive.²¹³ I disagree. The eyewitness testimony on this issue is contradictory, but some facts are undisputed. Townsend says that when he tried to pull Pilkington into the personnel basket, Pilkington's safety harness came free and the umbilical detached from Pilkington's helmet. Champagne, on the other hand, clearly remembers the hoses being connected to Pilkington's helmet when Champagne reached to remove the helmet on the deck of Rig 12.²¹⁴ Wiitala saw Pilkington's helmet underwater during the rescue and distinctly remembers seeing the line attached to the helmet and bubbles coming from the "whiskers" of Pilkington's helmet -- indicating that air was going through the helmet fitting to Pilkington's respirator.²¹⁵

Recommendation #2: Commandant should require all unused auxiliary gas ports on diver worn life support equipment to be capped or blanked during all commercial diving operations. This will remove the possibility of water entering a diver's helmet if he inadvertently opens an emergency valve.
