Learning from Earthquakes

The M_L 6.7 (M_W 7.1) Taiwan Earthquake of December 26, 2006

National Center for Research on Earthquake Engineering (NCREE)

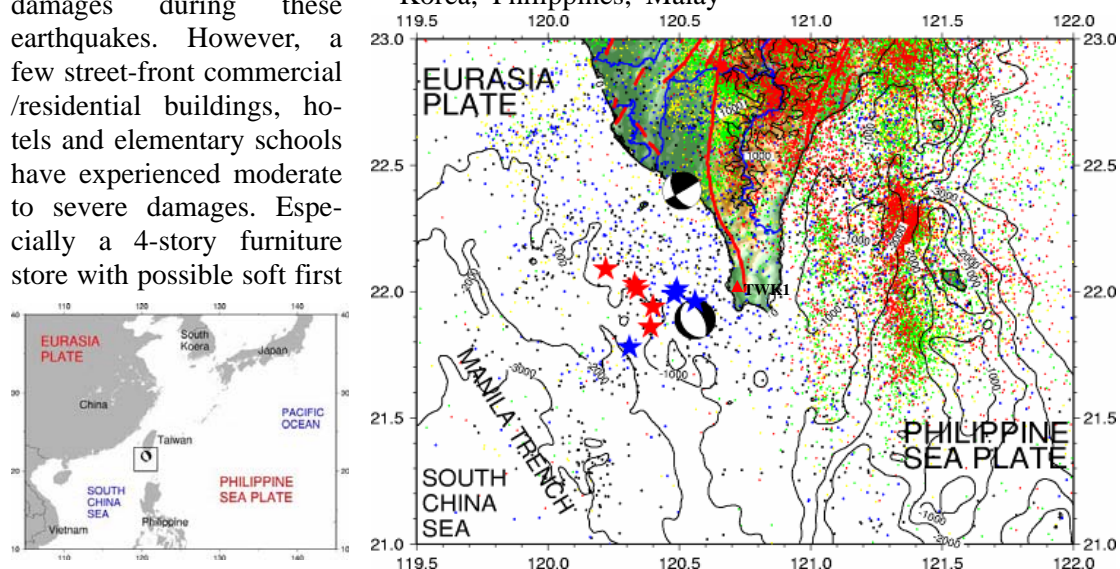
Fig. 1 The earthquake focal mechanisms of the main shock and its biggest aftershock are shown. The other aftershocks are shown as stars. The red stars are shallower than 30 km, the blue stars are those deeper than 30 km. The small dots indicate the seismicity for the past 16 years. The red, green, yellow dots are shallower than 10, 20, 30 km respectively. The blue and black dots are deeper than 30 and 50 km.

utes later represent two major type focal mechanisms (Fig.1). The main shock is a normal faulting event which means the upper part of subducting Eurasia plate is undergoing the tensional force caused by its overburden of thickening accretion wedges. Therefore the strike of the rupture plane is parallel to the Manila Trench. The biggest aftershock is a strike-slip faulting event which means the accretion wedges undergo the north-western compression force being pushed by

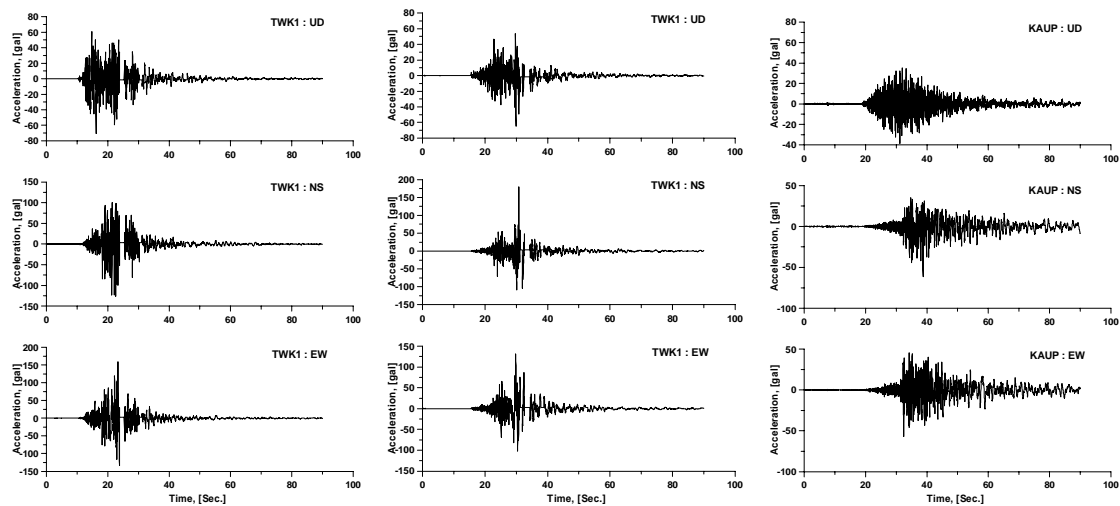
Fig. 2 The ground accelerograms recorded at RTD stations TWK1, KAU and KAUP in M_L 6.7 main shock

The strong ground motion were well recorded by Central Weather Bureau (CWB) TSMIP array and are shown in Figures 2 & 3 as well as Tables 1 & 2 (Further information can be found on

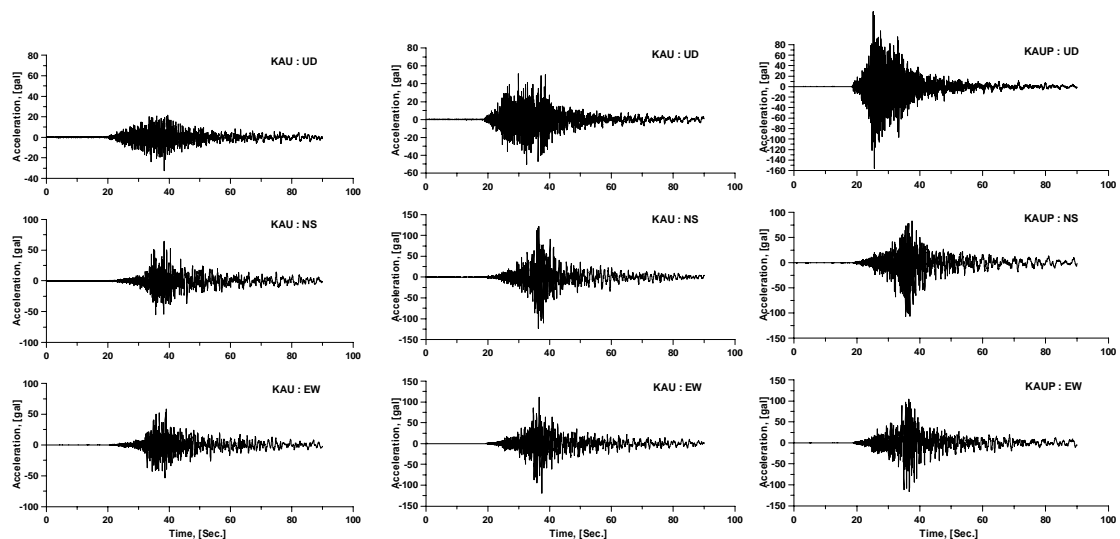
Fig. 3 The ground accelerograms recorded at RTD stations TWK1, KAU and KAUP in M_L 6.4 aftershock

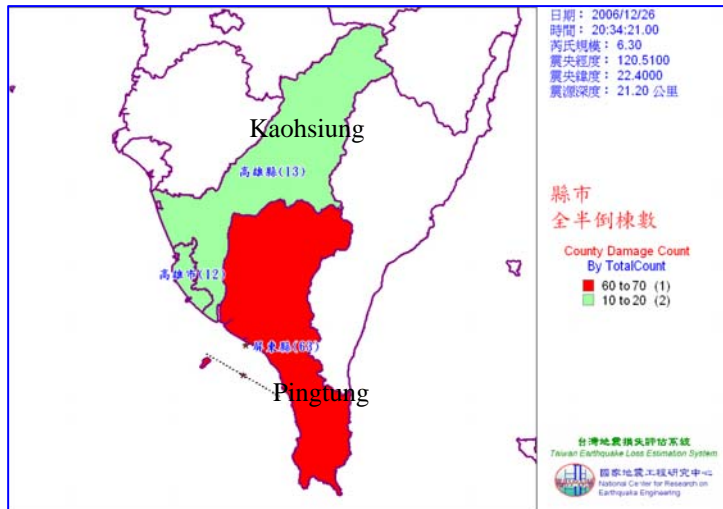
Fig.6 The map for estimated damaged house from TELES

of TELES for this Dec. 26 Hungchun earthquake shows that there will be casualty in Pingtung County and damaged buildings in both Kaohsiung and Pingtung Counties (Figures 6-7). The actual damages are quite similar to the estimation of TELES in this earthquake.

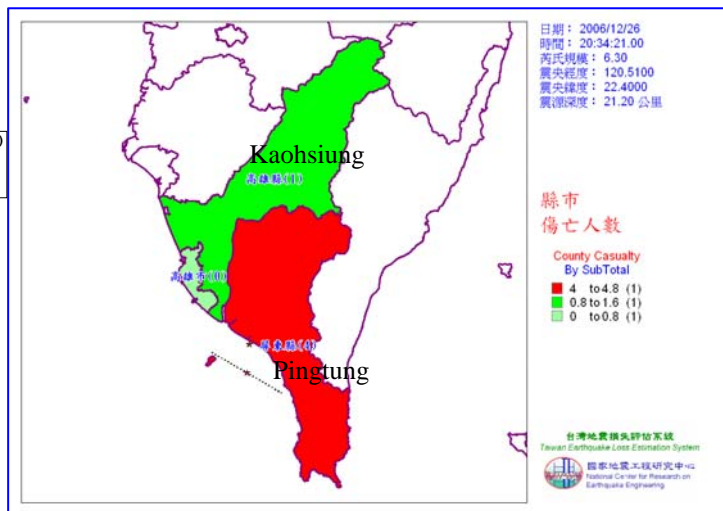
Fig. 7 The map for estimated casualty from TELES

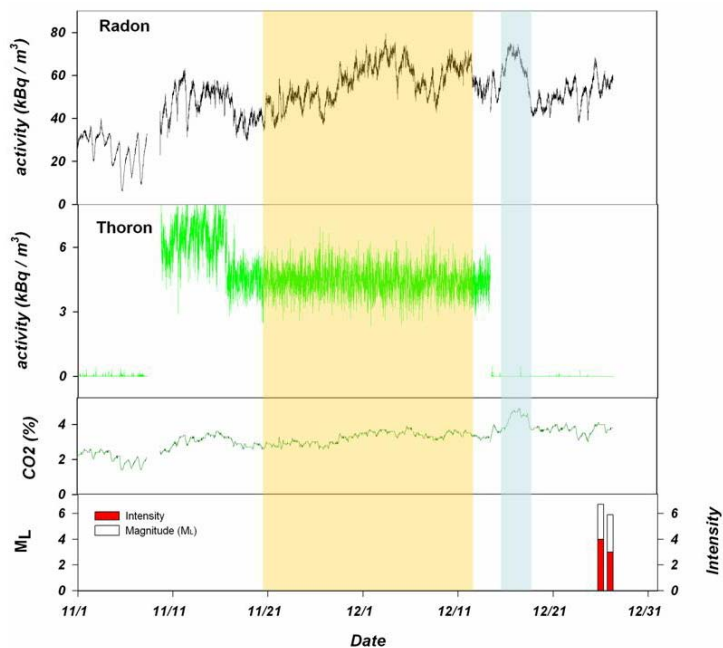
detector. Preliminary results of the monitoring station shows that the site is good for earthquake monitoring and soil-gas variations have shown good correlation with impending earthquakes of 26th December, 2006 having local intensity of 4 (as shown in Fig. 26). The radon concentration shows variation around 40 kBq/m³ with diurnal variation of 15-20 kBq/m³ in the normal conditions. Radon concentration shows steady increase from 21st of November, 2006 and reaches to its maxima of about 80 kBq/m³ on 3rd December, 2006, followed by decrease to its normal values of about 50 kBq/m³. These trends of increase and reaching to normal values continue till final anomaly on 16-17 Dec., about 10 days before the earthquake. The CO₂ carries gas for the radon in the region also shows anomalous values on

16-17 Dec. Whereas thoron (Rn²²⁰), another isotope of radon having very short life of 54.55 sec. as compare to radon (Rn²²²), has also shown very high values from Middle November to Middle December. These high values of radon, thoron and CO₂ before the earthquake at monitoring station are the precursory signals of 26th December, 2006 earthquakes and it may be due to the stress building in the region before the main events.

The anomalous fluctuation of radon, thoron and carbon-dioxide emanating from the soil-gas may have resulted from stress-induced pore collapse and stress-induced micro fracturing. The observed effect could be attributed to a possible combination of the both. The occurrence of soil-gas anomalies are random and they precede main

Fig 26: Variation of Radon, Thoron and Carbon-dioxide concentrations (Shaded areas represent the precursory signals in gases before the earthquakes) at earthquake monitoring station along Hsinhua fault in Tainan area.
