Chevron Pembroke Amine regeneration unit explosion 2 June 2011

An overview of the incident
and underlying causes

The explosion was caused by the unintended ignition of a flammable atmosphere within the tank (17T302), during what should have been a routine cleaning operation conducted in preparation for maintenance.

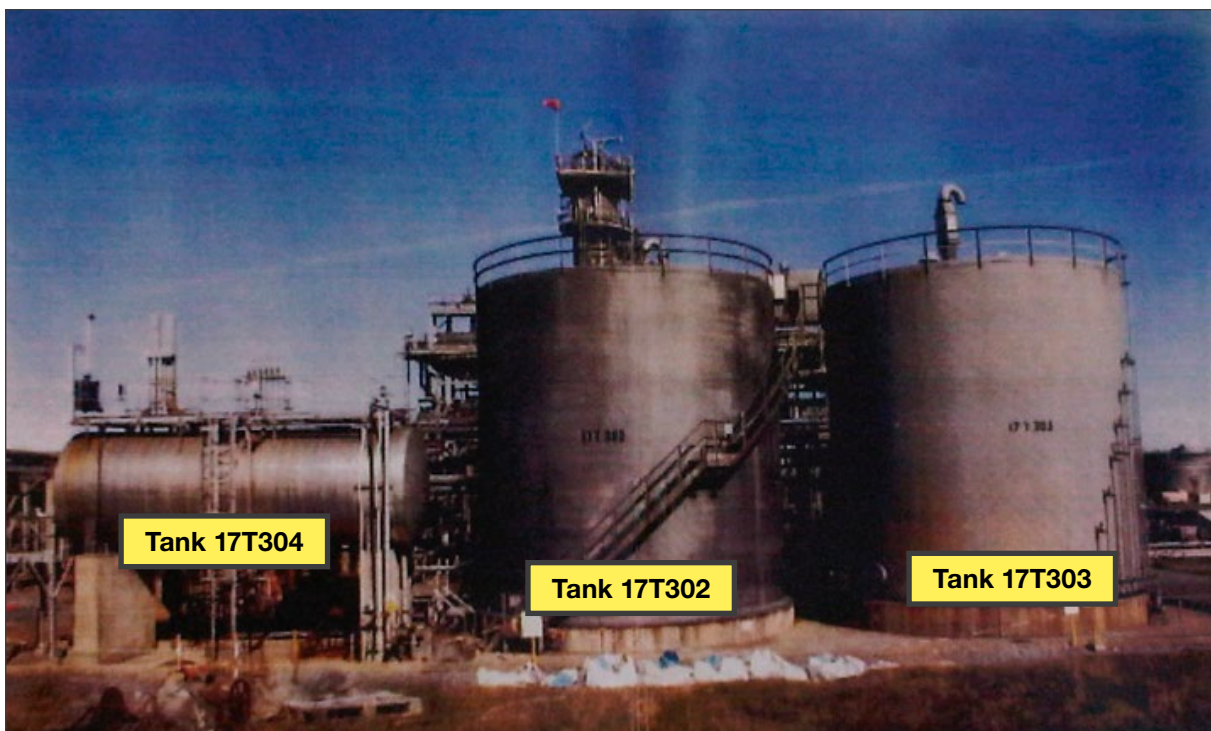
Figure 2 Pre-incident photograph of ARU tanks

The ARU had two vertical process tanks, identified as 17T302 and 17T303 (see Figure 2). Both were 9.7m in diameter and height, described as 'breathable' in terms of their ventilation arrangements. The vapour space above the liquid in each tank was connected to the atmosphere through an automatic pressure-vacuum valve. As the tank liquid level rose it allowed the tank atmosphere inside to be forced out of the vessel (breathe-out). Equally, when the level fell, to prevent the formation of a vacuum, air from the surroundings would enter the tank vapour space (breathe-in).

The tanks had been designed for two different purposes. Tank 17T303 was optimised for the separation of waste streams and tank 17T302 was designed to operate as the lean amine process reservoir. Contrary to the intention of the original design, the tanks were used interchangeably over the years. One tank was the designated 'running tank', kept at 40 °C and used for the storage and recirculation of amine to the refinery scrubbers, while the other was used for the separation of 'slop' material into its component

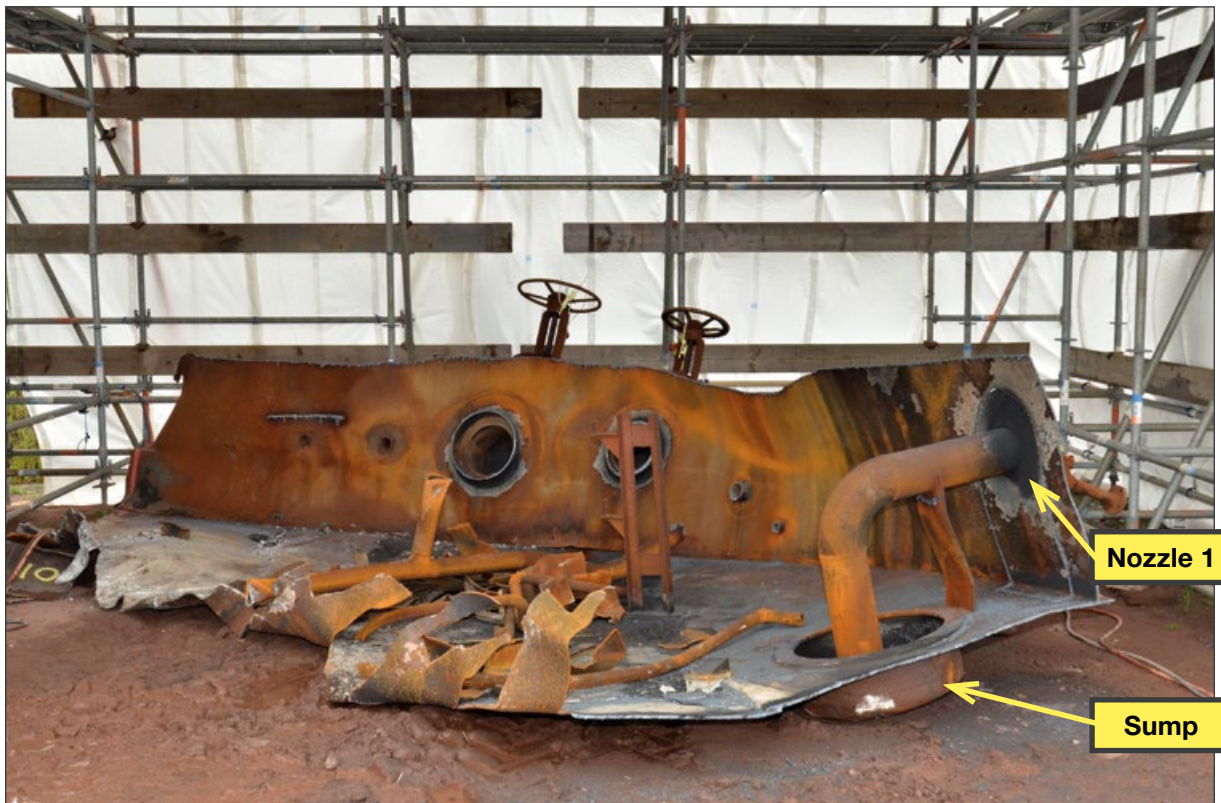
Figure 5 Post-incident section of tank 17T302 showing drain equipment

The final stages of draining tank 17T302 was carried out by a Plant Operator. On 18 May 2011, in the early hours of the morning, he attempted to empty the tank by opening the main drain valve manifold (valve 1), with which he was unfamiliar. He was not aware of the presence or the purpose of the internal sump and siphon drain equipment, which was designed to empty the tank completely. A cross-section of the internal tank siphon is shown in Figures 4 and 5.

The Plant Operator opened the drain valve (valve 1 as shown in Figure 4) and observed a flow of material into the ARU sump. When flow from the drain valve ceased, he closed the valve, incorrectly believing that all the liquid had been drained and that the tank was empty. The float and tape level gauge was not used to confirm that the tank was empty. The Plant Operator was not aware that the cessation of flow had resulted from loss of the siphon, or that further draining of liquid may have been possible if the siphon had been re-established. In the shift log for the following day, the status of tank 17T302 was recorded as '*empty*' and this was repeated in subsequent shift reports, even though a substantial volume of liquid remained.

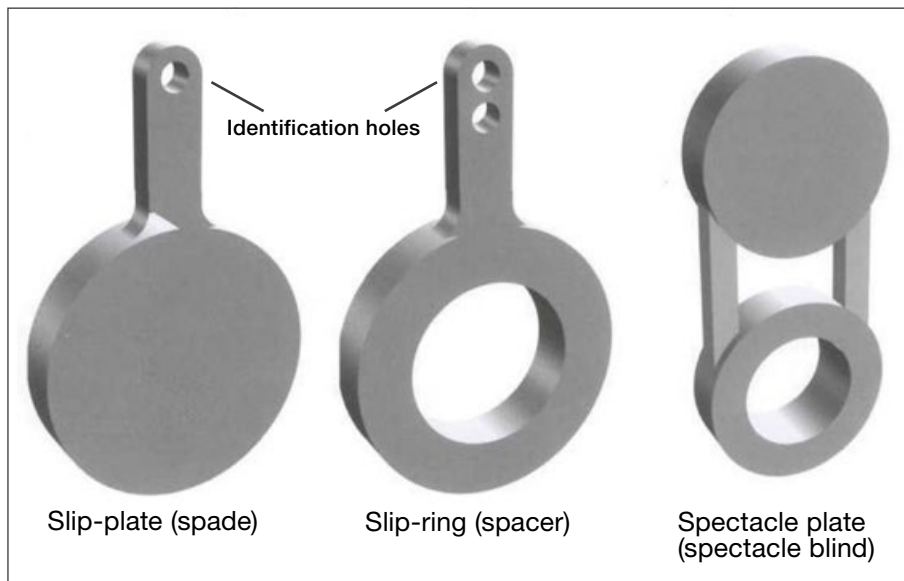
Figure 6 Tank isolation equipment

Before the initiation of cleaning and maintenance activities, between 26–28 May 2011, work was carried out on tank 17T302 to physically isolate it from the rest of the ARU process. To achieve this, flow from each pipe connected to the tank was blocked by the insertion of a thick steel disc in front of the valves closest to the vessel. The discs are referred to as either spades or spectacle blinds, illustrated in Figures 6, 7 and 9. This permit controlled work was undertaken by a team of engineering contractors, who were informed by Chevron that material inside the vessel was '*corrosive*'.

Background permit information for this task was assembled by a Chevron employee who had never previously prepared tank permit documents. He was able to identify amine and hydrogen sulphide as anticipated hazards within the vessel, but was unaware of the presence of diesel, light hydrocarbon or potentially pyrophoric material.

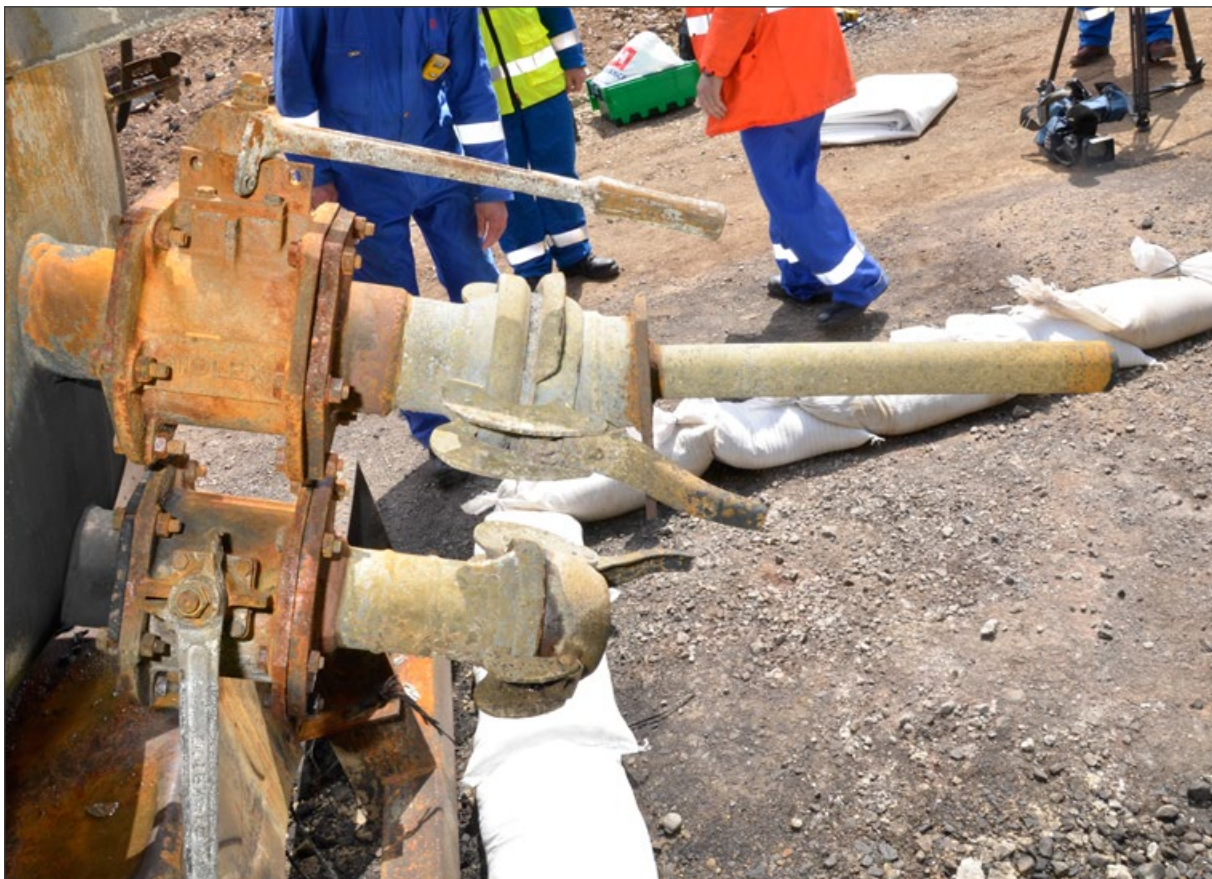
Figure 10 Two-inch inlet adapter on rear of vacuum tanker

The inlet connection at the rear of the vacuum tanker was a four-inch diameter fitting, designed for a hose of the same size. A non-standard adapter (see Figure 10) was used by B&A to attach the smaller green hose, which subsequently halved the inlet diameter. A reduction in hose diameter would have significantly increased the linear velocity of liquid being drawn into the vacuum tanker and increased the extent of static charging within the non-conductive hose.
