Defence
Safety Authority

Service inquiry

Loss of F-35B Lightning
ZM152 (BK-18) of 617
Squadron RAF, embarked on
HMS QUEEN ELIZABETH

SERVICE INQUIRY INVESTIGATION INTO THE LOSS OF F-35B LIGHTNING ZM152 (BK-18) FROM 617 SQUADRON, EMBARKED ON HMS QUEEN ELIZABETH, ON 17 NOV 2021

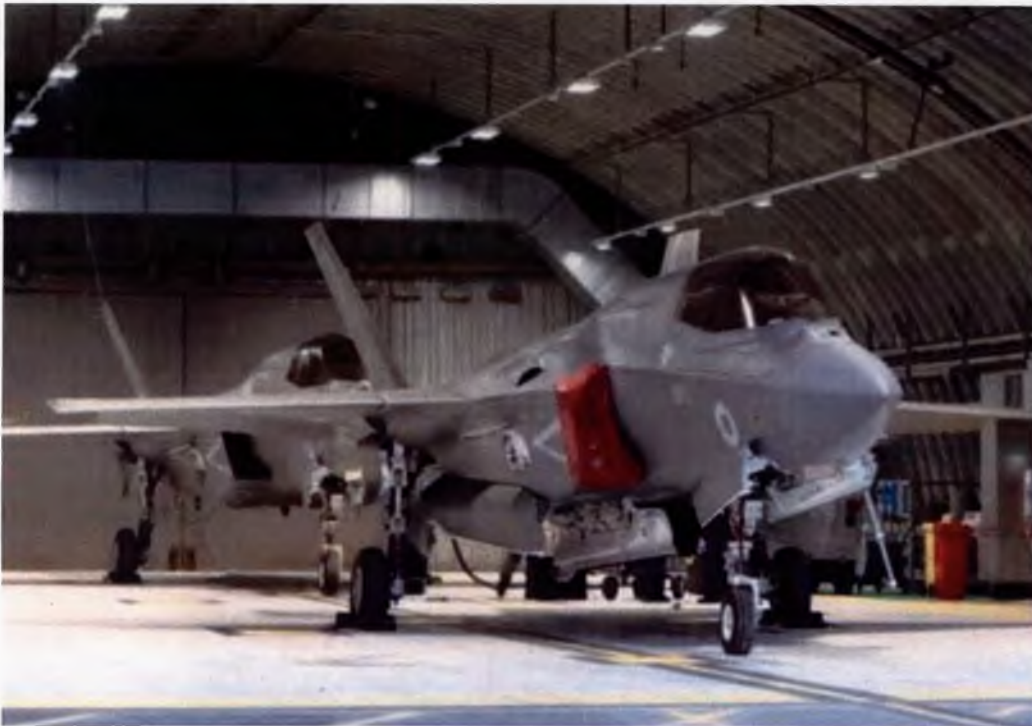
1.3.27. At the time of the accident, three different designs of intake blank had been used. The first design was a wrap-around cover (Figure 1.3.7) allocated Lockheed Martin design numbers A00016 (left) and A00017 (right). Lockheed Martin observed that these were difficult to fit and caused damage to the external skin of the aircraft, as well as materially breaking down and presenting a FOD risk.

Figure 1.3.7 – Wrap around intake cover fitted to 617 Sqn aircraft at RAF Marham.

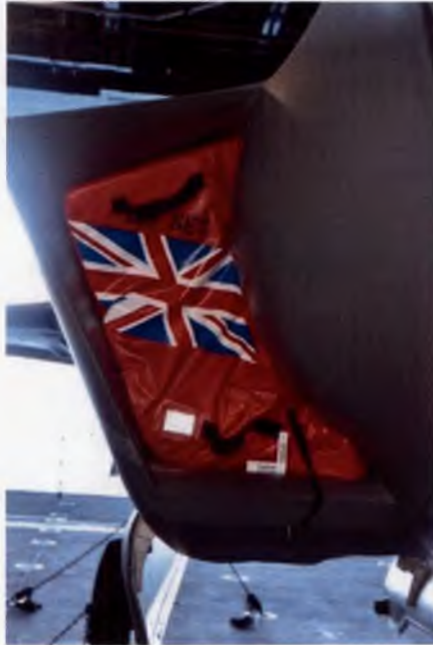
1.3.30. The text 'REMOVE BEFORE FLIGHT' was printed on the intake blanks by the manufacturer but the characters were found to peel off and present a FOD hazard. Early on Op FORTIS, 617 Sqn engineers removed the lettering from the intake blanks and raised awareness of the FOD issue by raising a Defence Air Safety Occurrence Report (DASOR).⁹

Figure 1.3.9 – Plug-type intake blank of the approved design, as used on Op FORTIS.

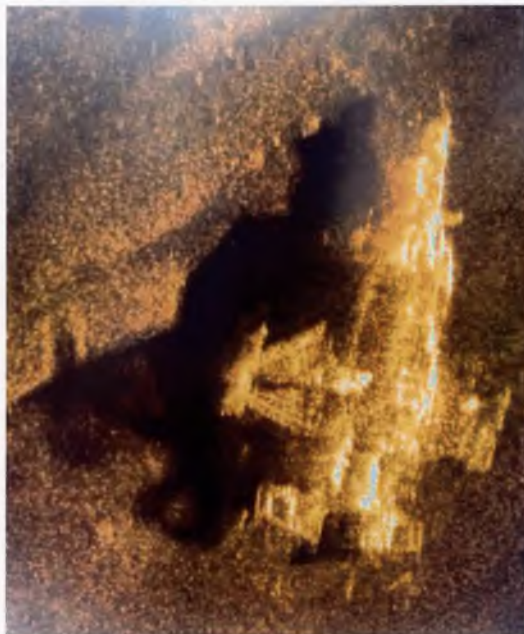
Figure 1.3.16 – BK-18 on the seabed prior to recovery.

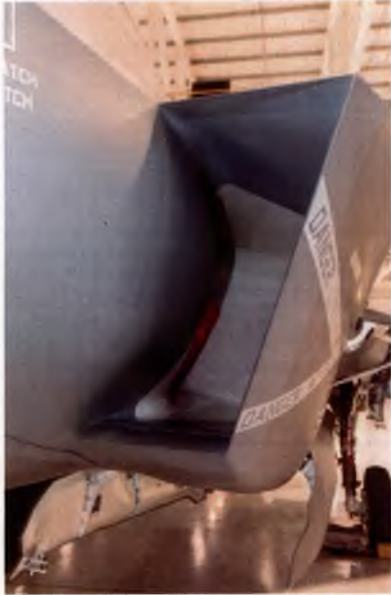
Figure 1.4.8 – Intake blank positioned in the intake.

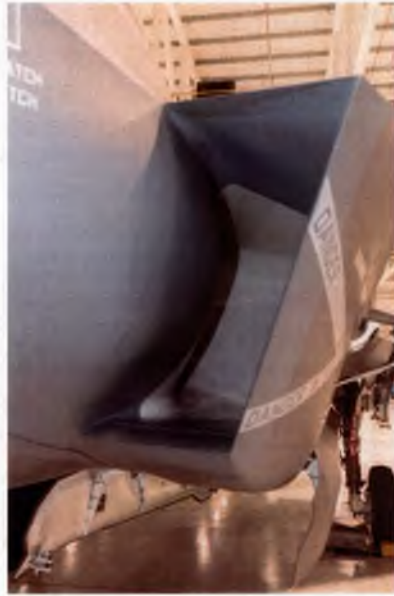
Figure 1.4.9 – Intake blank positioned in the intake, but not externally visible.

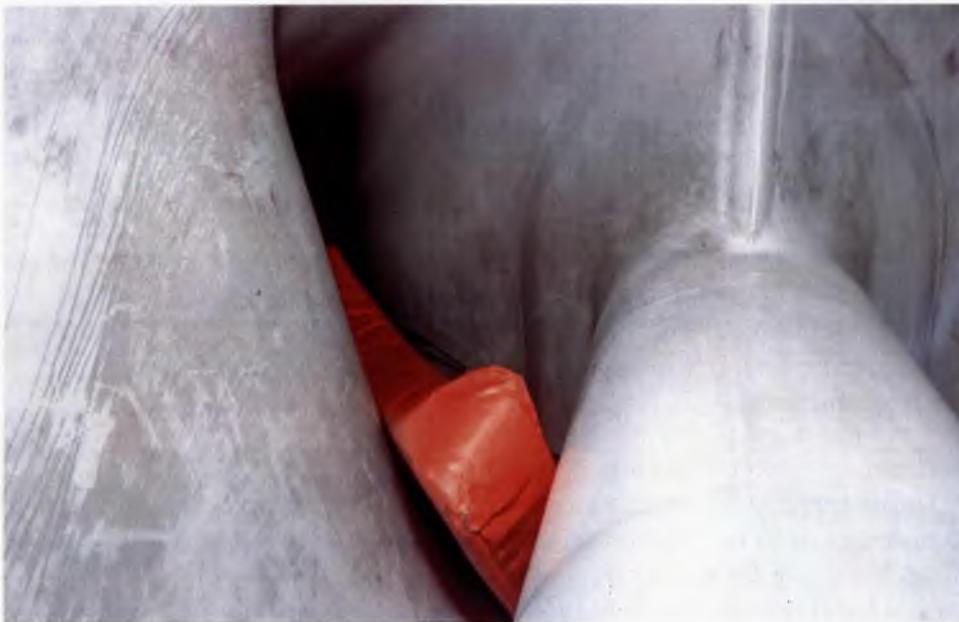
Figure 1.4.10 – Blank located in common duct, but no longer visible to external view.

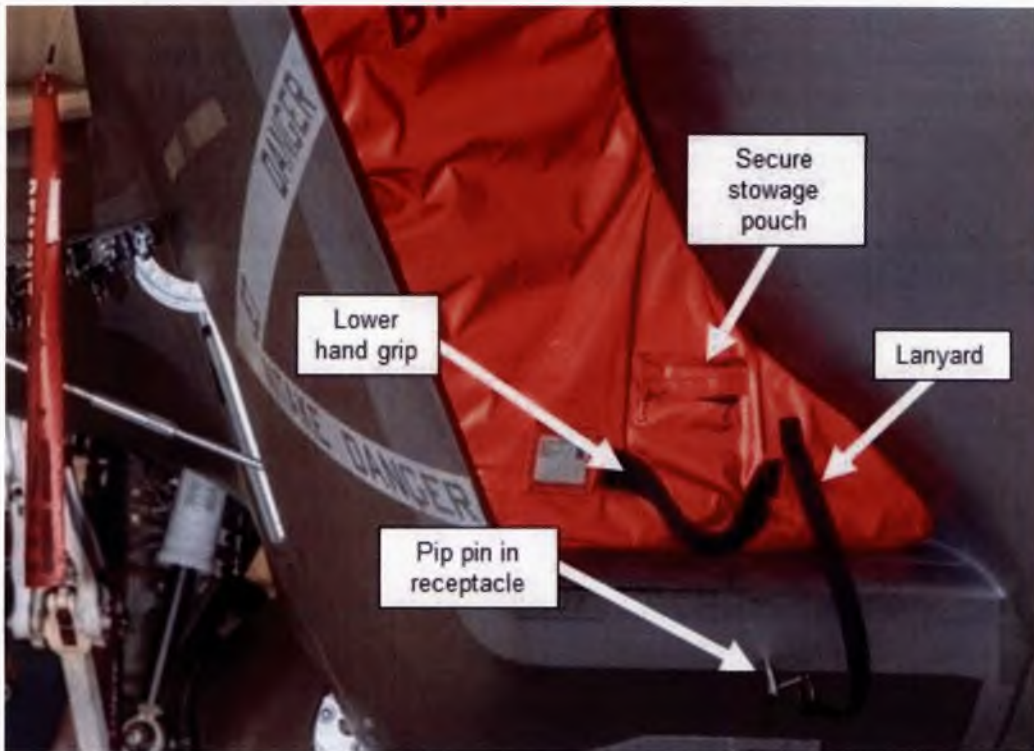
Figure 1.4.11 – Installed intake blank showing lanyard and pip pin.

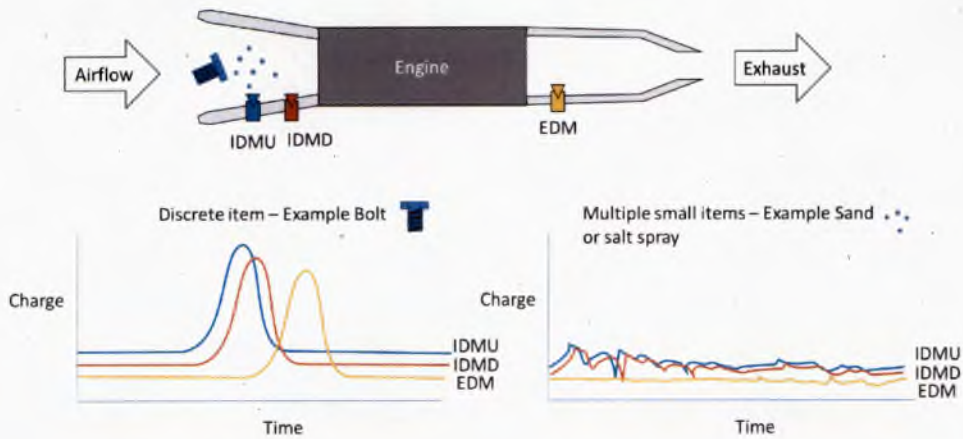
Figure 1.4.15 – Idealised IDMS response to ingestions.

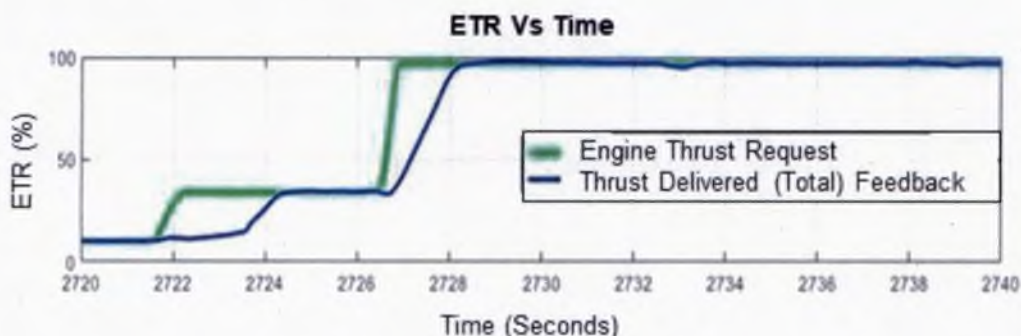
1.4.121. The data from the sortie prior to the accident sortie (flown on 13 Nov 21) was also still available on BK-18's CSMU, so 'normal' data could be compared to that recorded during the accident (Figure 1.4.18). During that launch the throttle to power response curves showed that engine output matched ETR within approximately two seconds.

Figure 1.4.18 – Correct ETR and response curves.⁵⁰

1.4.122. On the day of the accident, the initial engine demand to 34% ETR was satisfied, but the engine was unable to respond correctly to any higher throttle setting subsequently demanded by the pilot. The engine initially followed the demand but then never achieved the desired thrust, plateauing no higher than 80% (Figure 1.4.19). Fuel flow was initially set to reach 97% ETR but then modulated by the FADEC to match the decreased airflow experienced by the engine. Air flow was recorded as being 6% less than a normal STOVL take-off, and the engine compressor exit pressure was 30% less than nominal, so the FADEC tolerances were exceeded, and the core fuel flow was reduced by 32% accordingly. The CSMU data showed that the engine performed within the control laws that governed it, and therefore did not raise any cautions or warnings. The lack of air flow through the engine and commensurate reduction in fuel flow resulted in a lack of thrust.

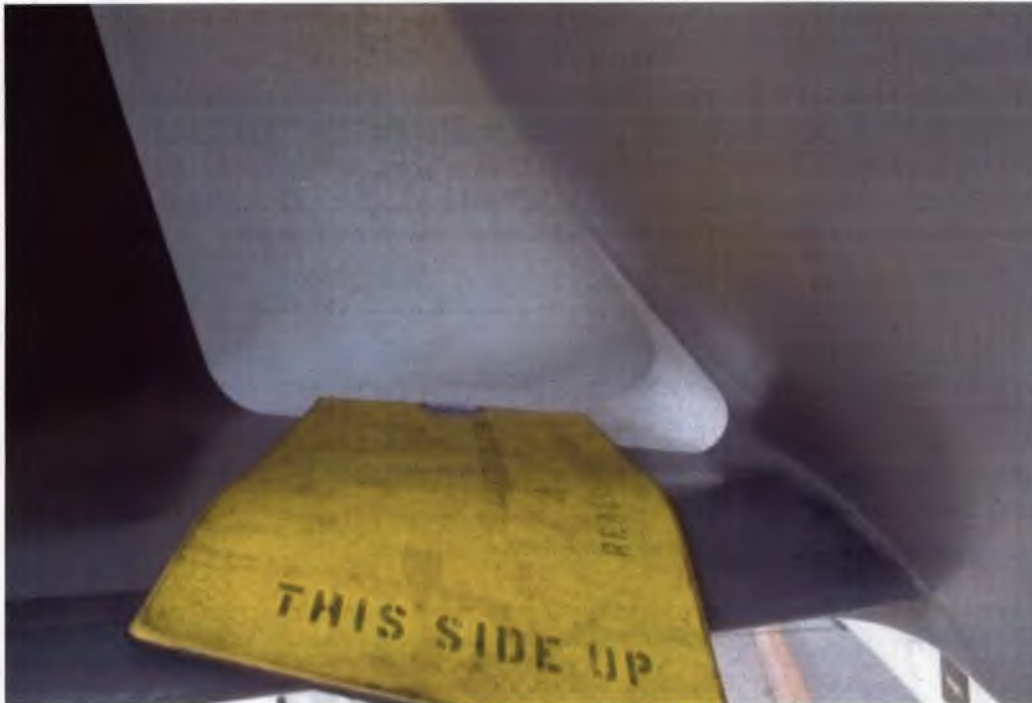
yellow maintenance mat when conducting work in the intakes and there were incidents of these being left in the aircraft (Figure 1.4.25). These mats were not in use on the UK Lightning Force.

Figure 1.4.25 – Yellow maintenance mat used by US forces.

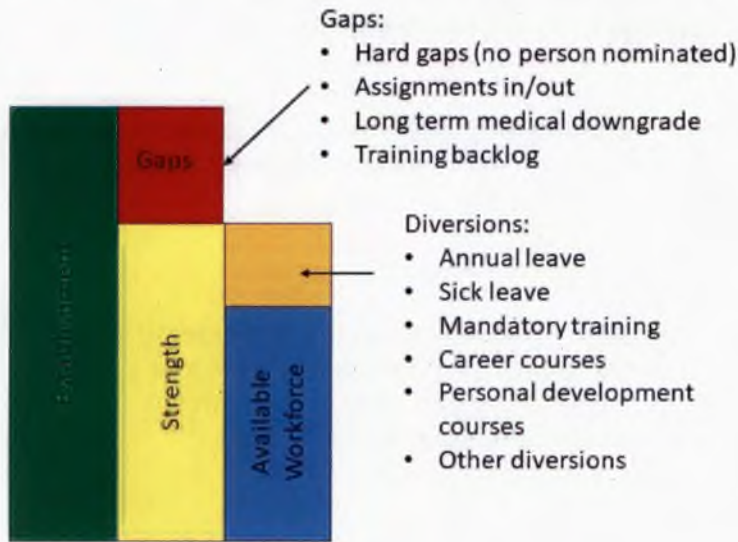
Figure 1.4.31 – Generic workforce limiters.

1.4.151. Since its inception the UK F-35 workforce was under resourced. This resulted in an inability to generate sufficient aircraft to deliver the required operational capability. The establishment was below that required, resulting in insufficient availability of workforce. To put this in perspective, on Op FORTIS 617 Sqn deployed 113 personnel for their [REDACTED] aircraft, [REDACTED] deployed 255 personnel to support [REDACTED] aircraft. Whilst some of these were support staff, they still had around 50-60 more engineers than 617 Sqn for only [REDACTED] more aircraft. Even to deploy 113 personnel on Op FORTIS, 617 Sqn had to borrow personnel from 207 Sqn.

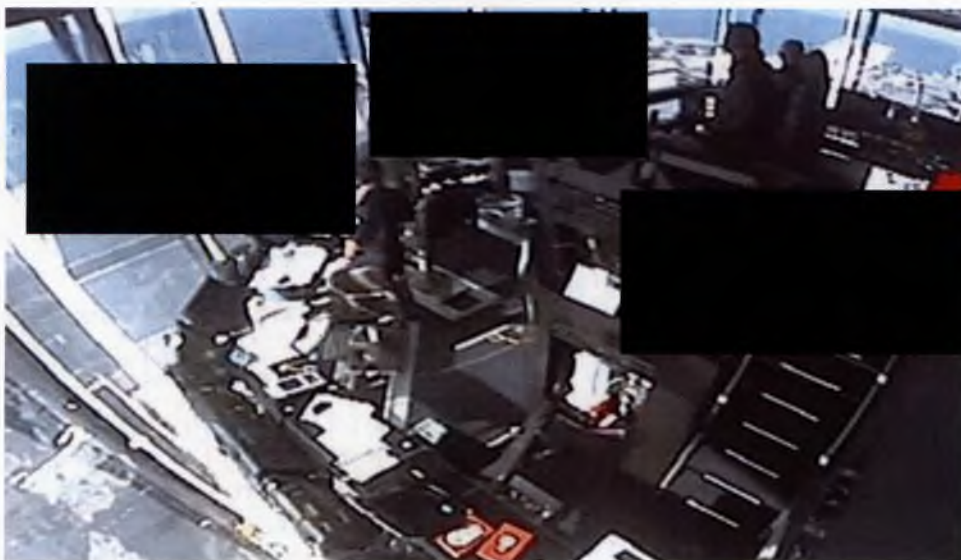
Figure 1.4.32 – FLYCO communications equipment positions.

1.4.198. **Recommendation. Director Force Generation should ensure that key personnel in Queen Elizabeth Class Flying Control are equipped to respond rapidly to emergencies with appropriate communication and alarms in order to allow a timely response to accidents.**
