November 7, 2023

RE: Existing Building Structural Assessment – 1962 Market Street

EXISTING BUILDING ASSESSMENT
 1962 MARKET STREET
 DENVER, CO

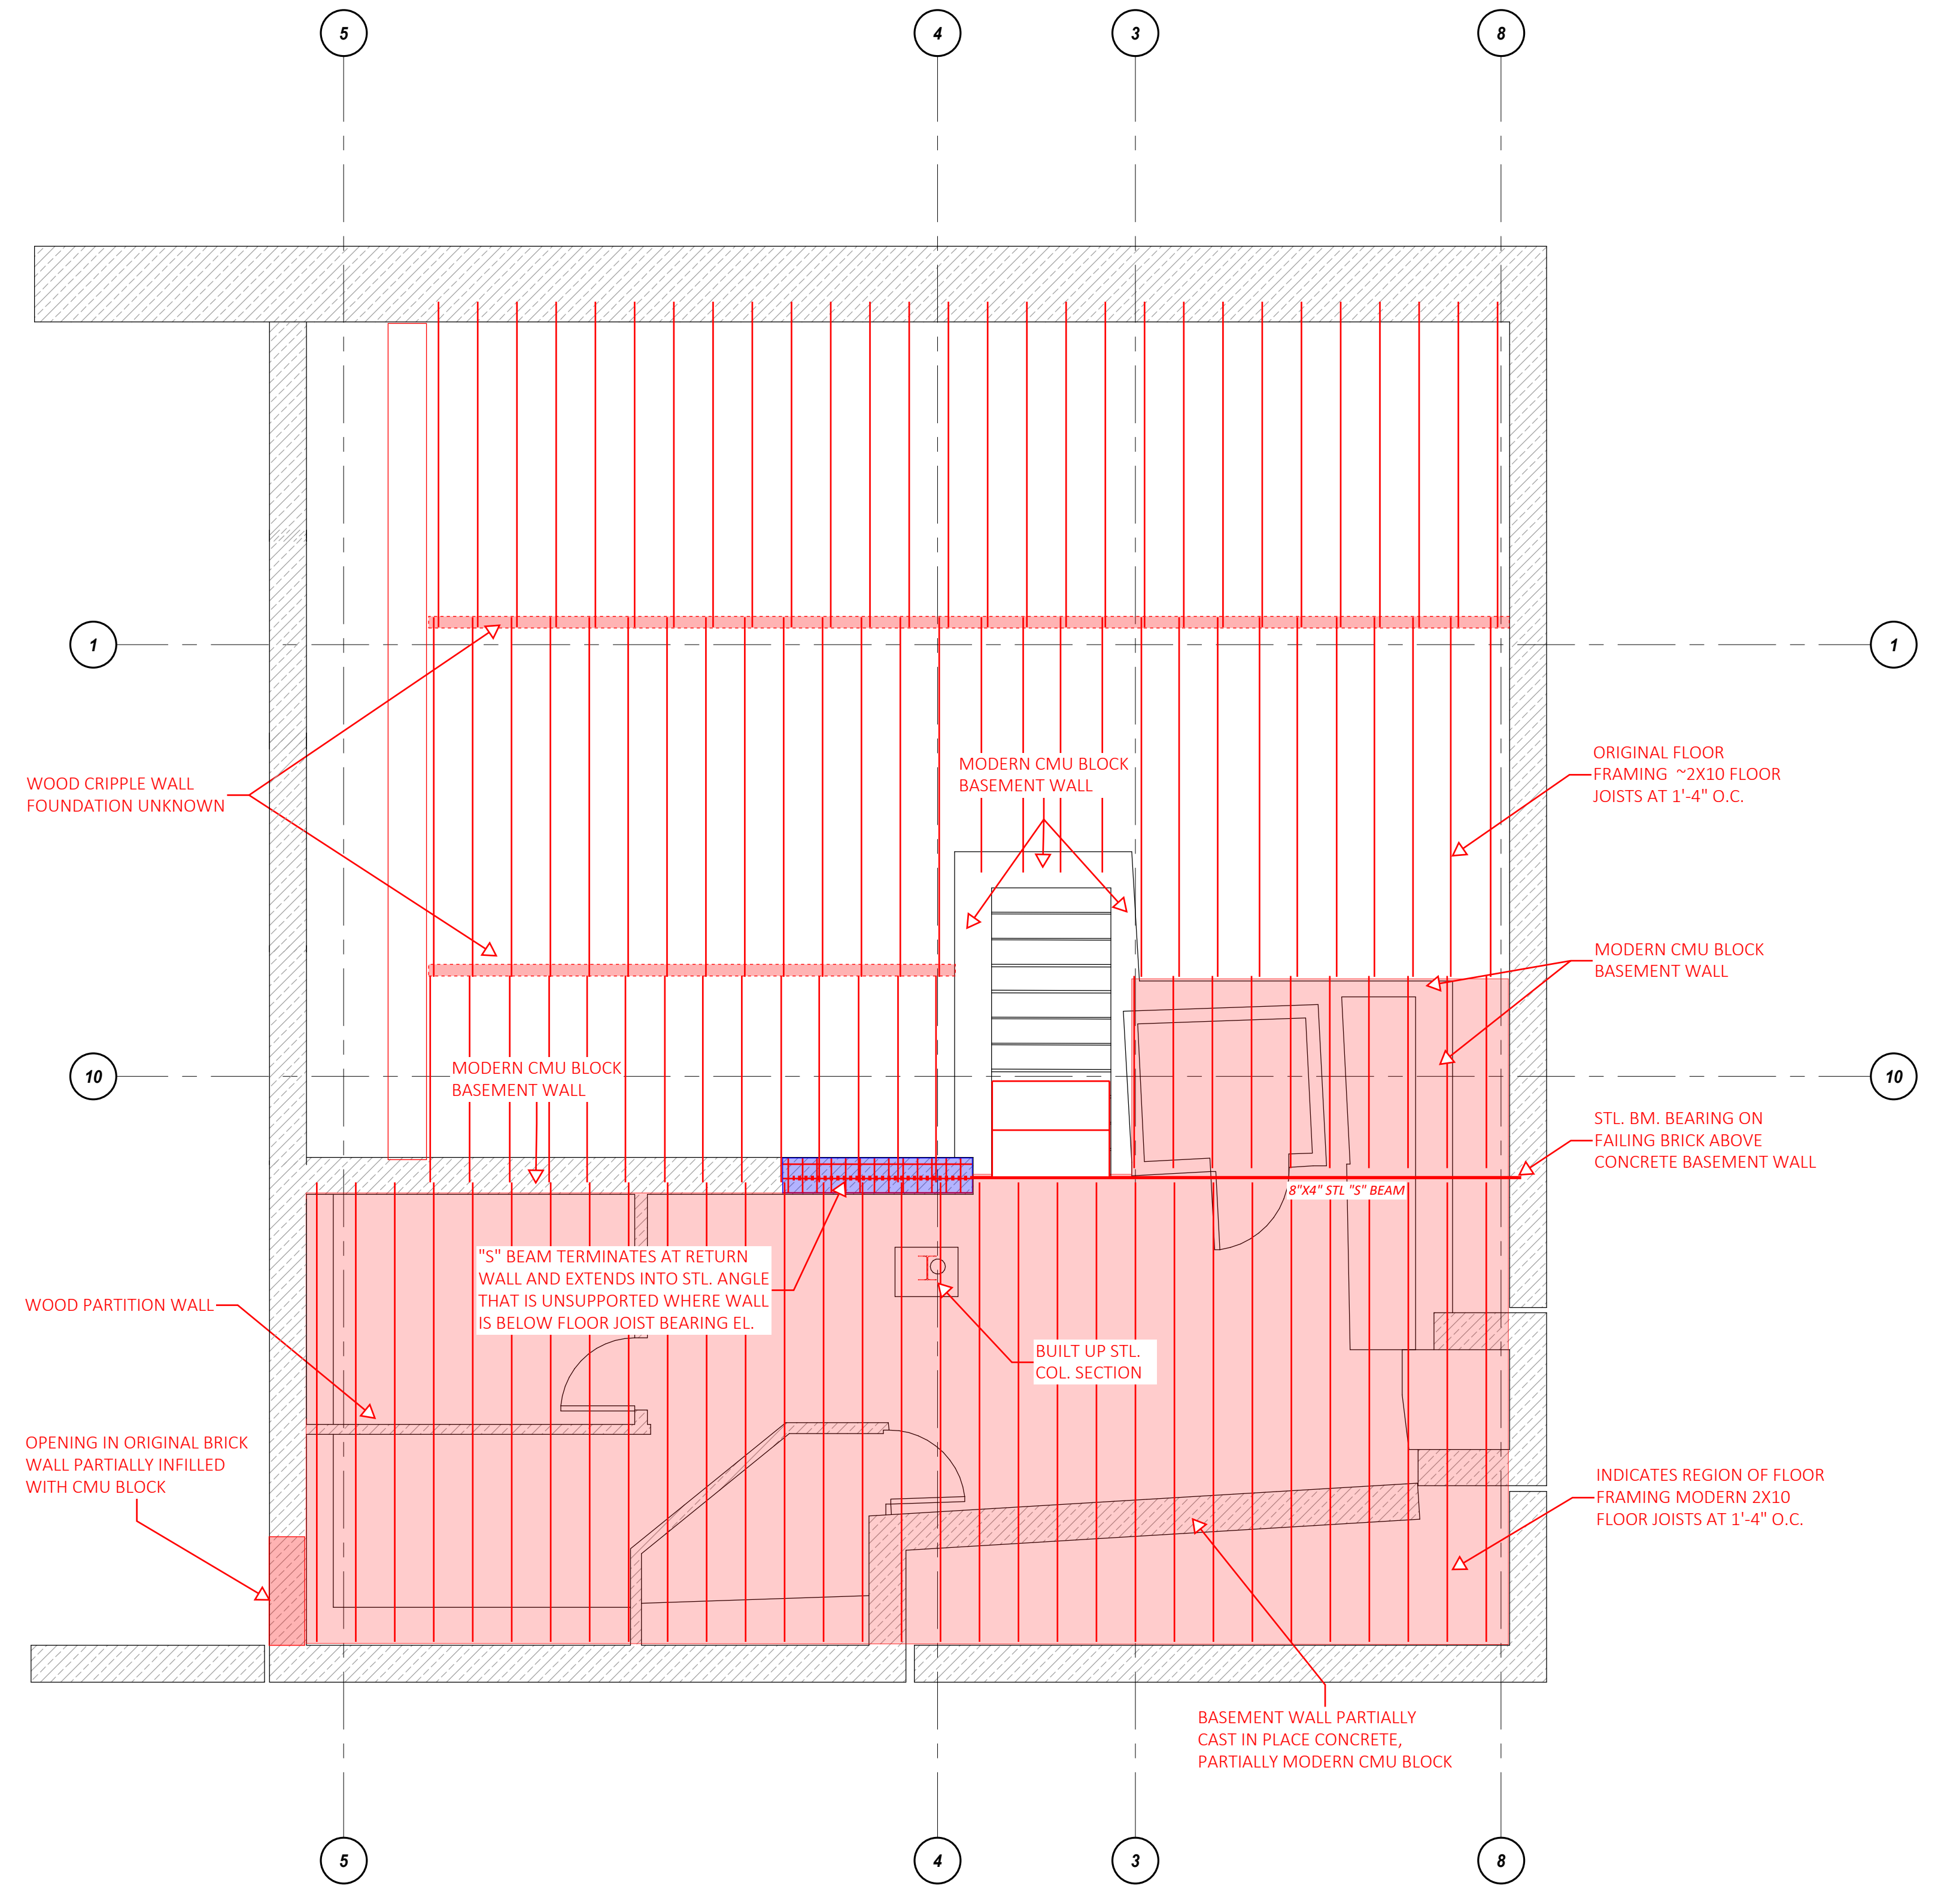
SHEET # **S1.02**

The existing main level framing mostly consists of 1x tongue and groove wood decking supported by 2x10 wood joists at 16” on center, spanning south to north in bays assumed to be approximately 12’. It is unclear what supports the joists in the crawl space, as the soil level in the crawl space appears to be directly below the joists. The support condition of the temporary steel columns and points loads from the roof and second floor framing are questionable, and the main level framing will need to be removed to provide adequate foundation elements, as many foundation elements will require complete reconstruction. It is assumed the close proximity of the wood framing to the soil has caused decay and compromised many of the original floor joists.

The northern section of the crawl space appears to have been reconfigured and deepened many years ago, but well after the original construction date. In this area, original brick masonry walls are exposed at the exterior walls, along with cast in place concrete and concrete masonry unit stem walls. It is assumed the concrete walls were added to undermine and underpin the original brick masonry foundation walls. Numerous questionable bearing conditions were observed in the deeper section of the crawl space. It is assumed the entire main level will require complete reconstruction. Images of the existing second floor framing are shown and described below.

- The brick walls fixed per the descriptions above, significant portions of the exterior walls will require complete reconstruction.
- The entire roof framing area will require complete reconstruction.
- The majority of the second floor framing will require complete reconstruction.
- To properly access and repair the main level, the entire existing floor structure will require complete reconstruction.

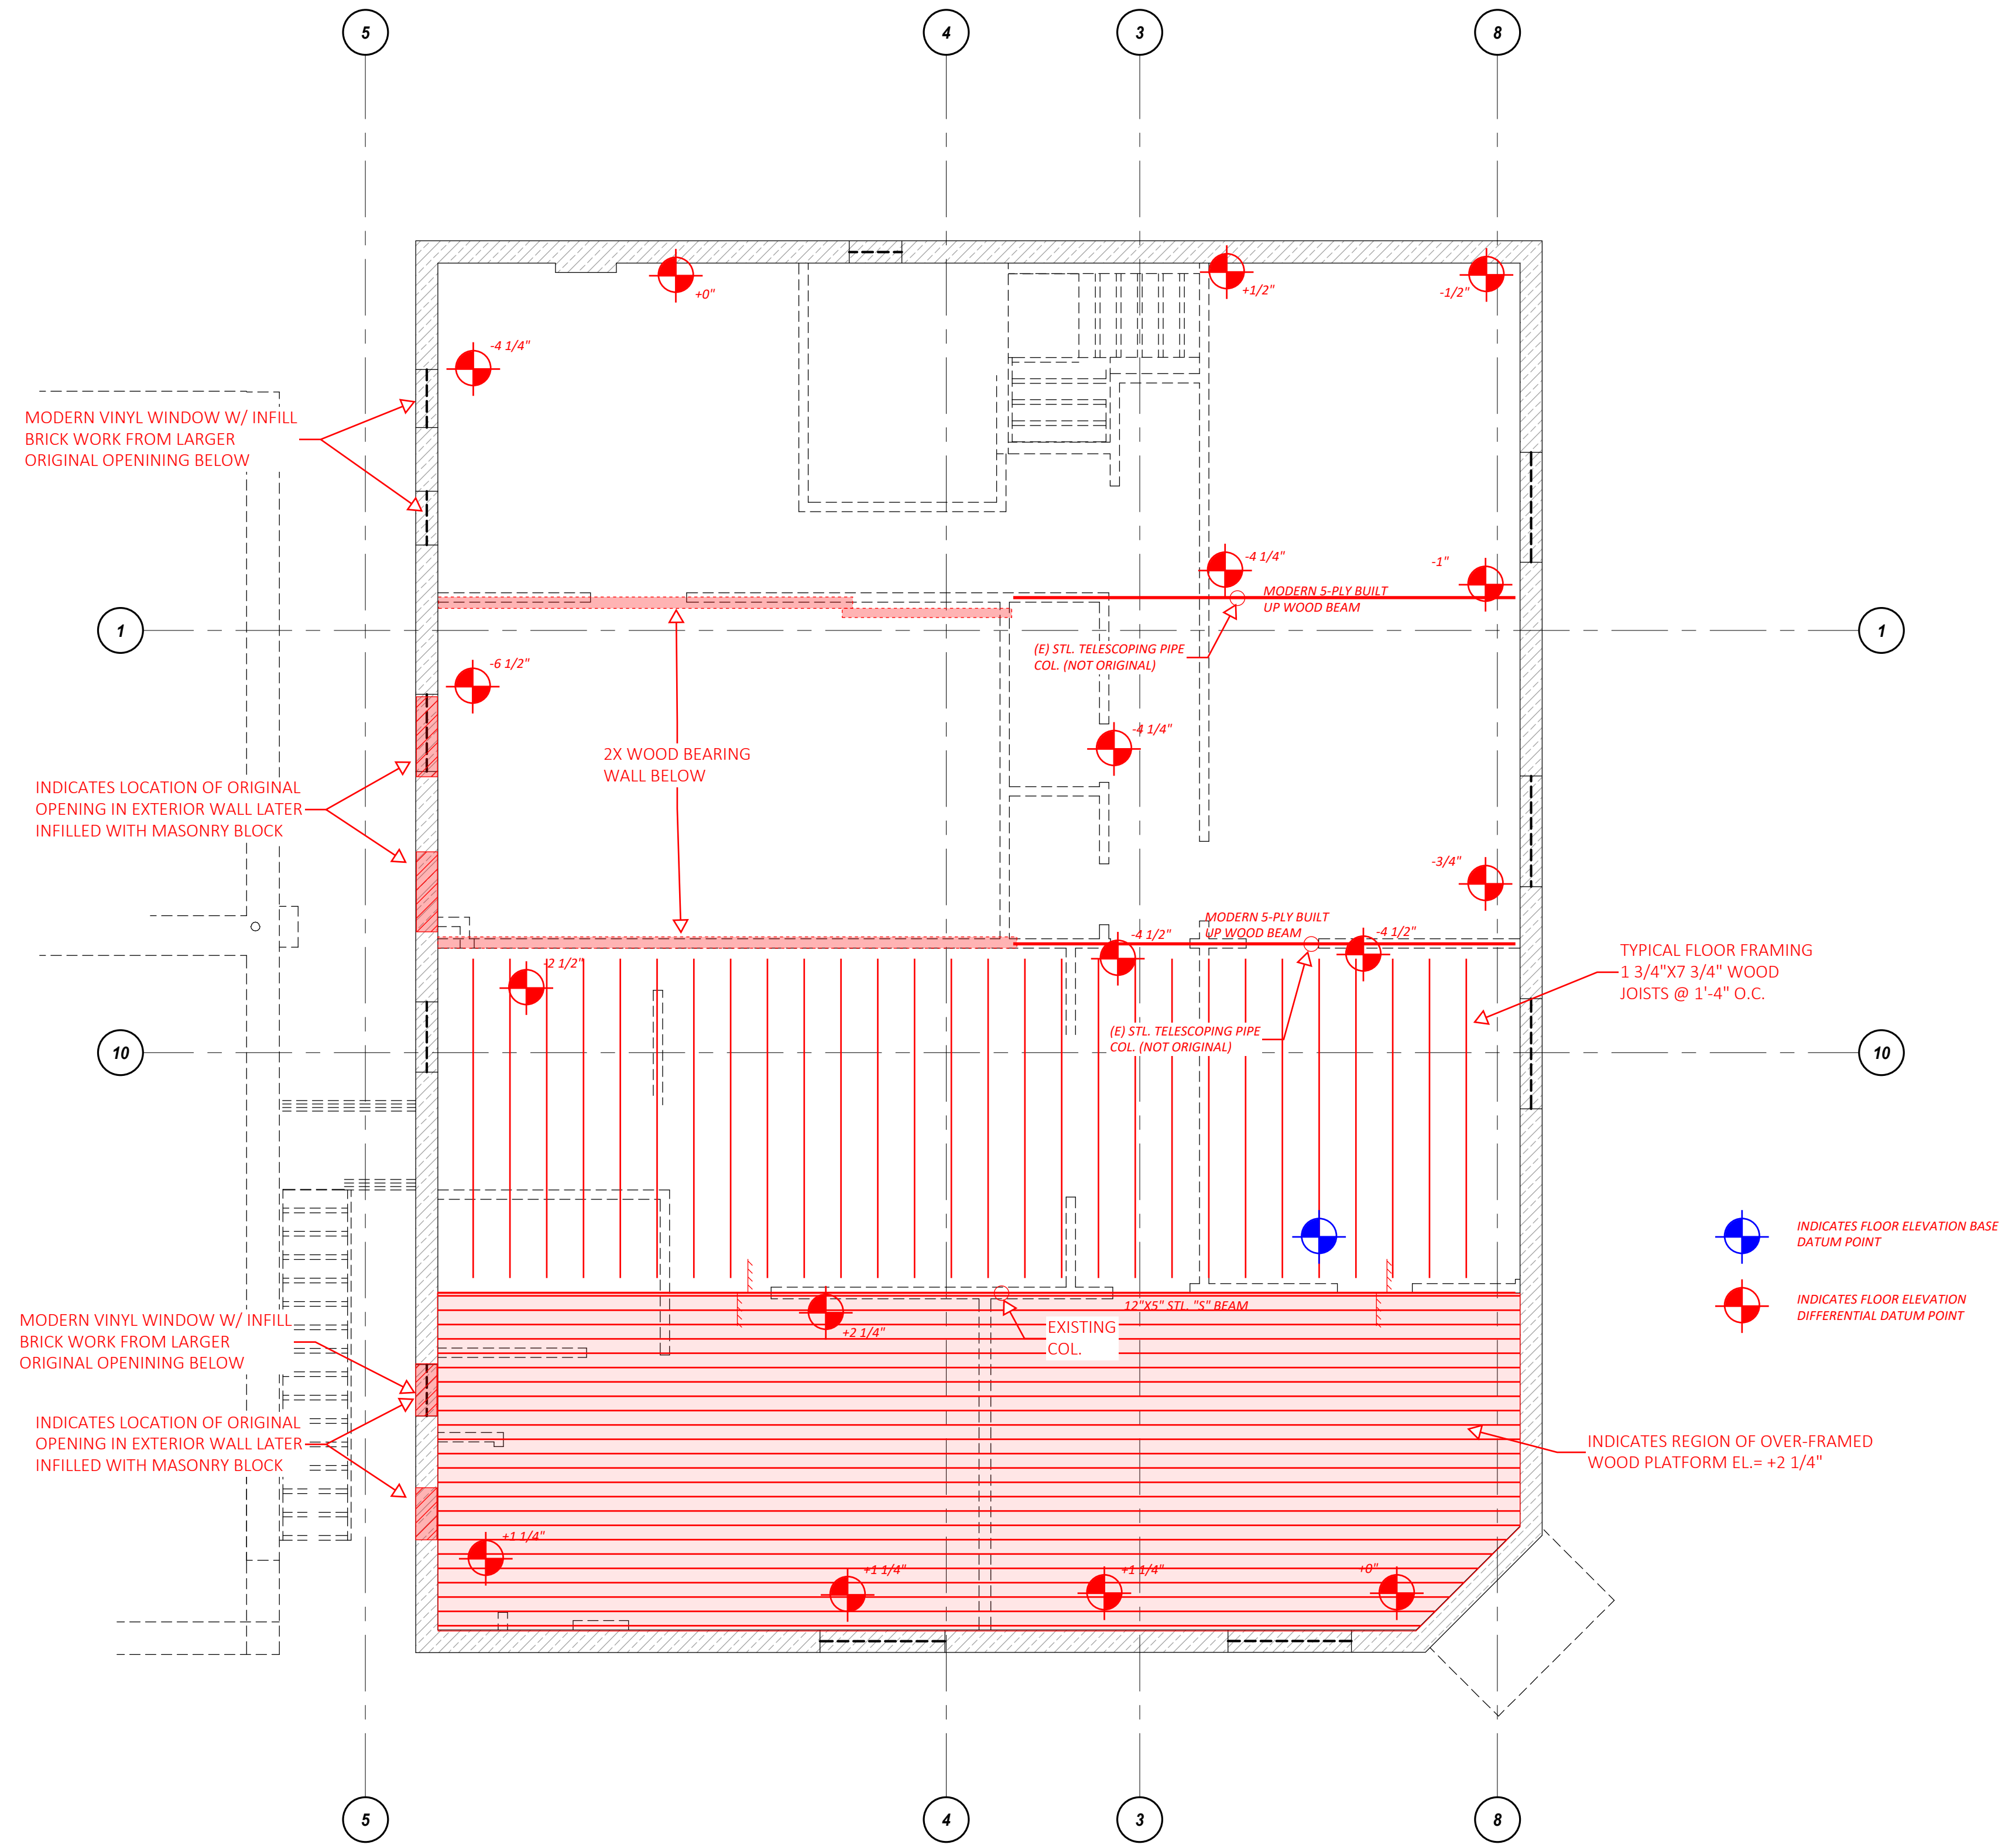
SHEET # **S1.04**

Due to the extent of distress, we anticipate the floor to require complete reconstruction, or nearly complete reconstruction, extending from the existing steel beam support to the south exterior wall. The updated support conditions will need to be properly tracked and supported at the foundation level. In its current condition, the second level can not be occupied. Images of the existing second floor framing are shown and described below.

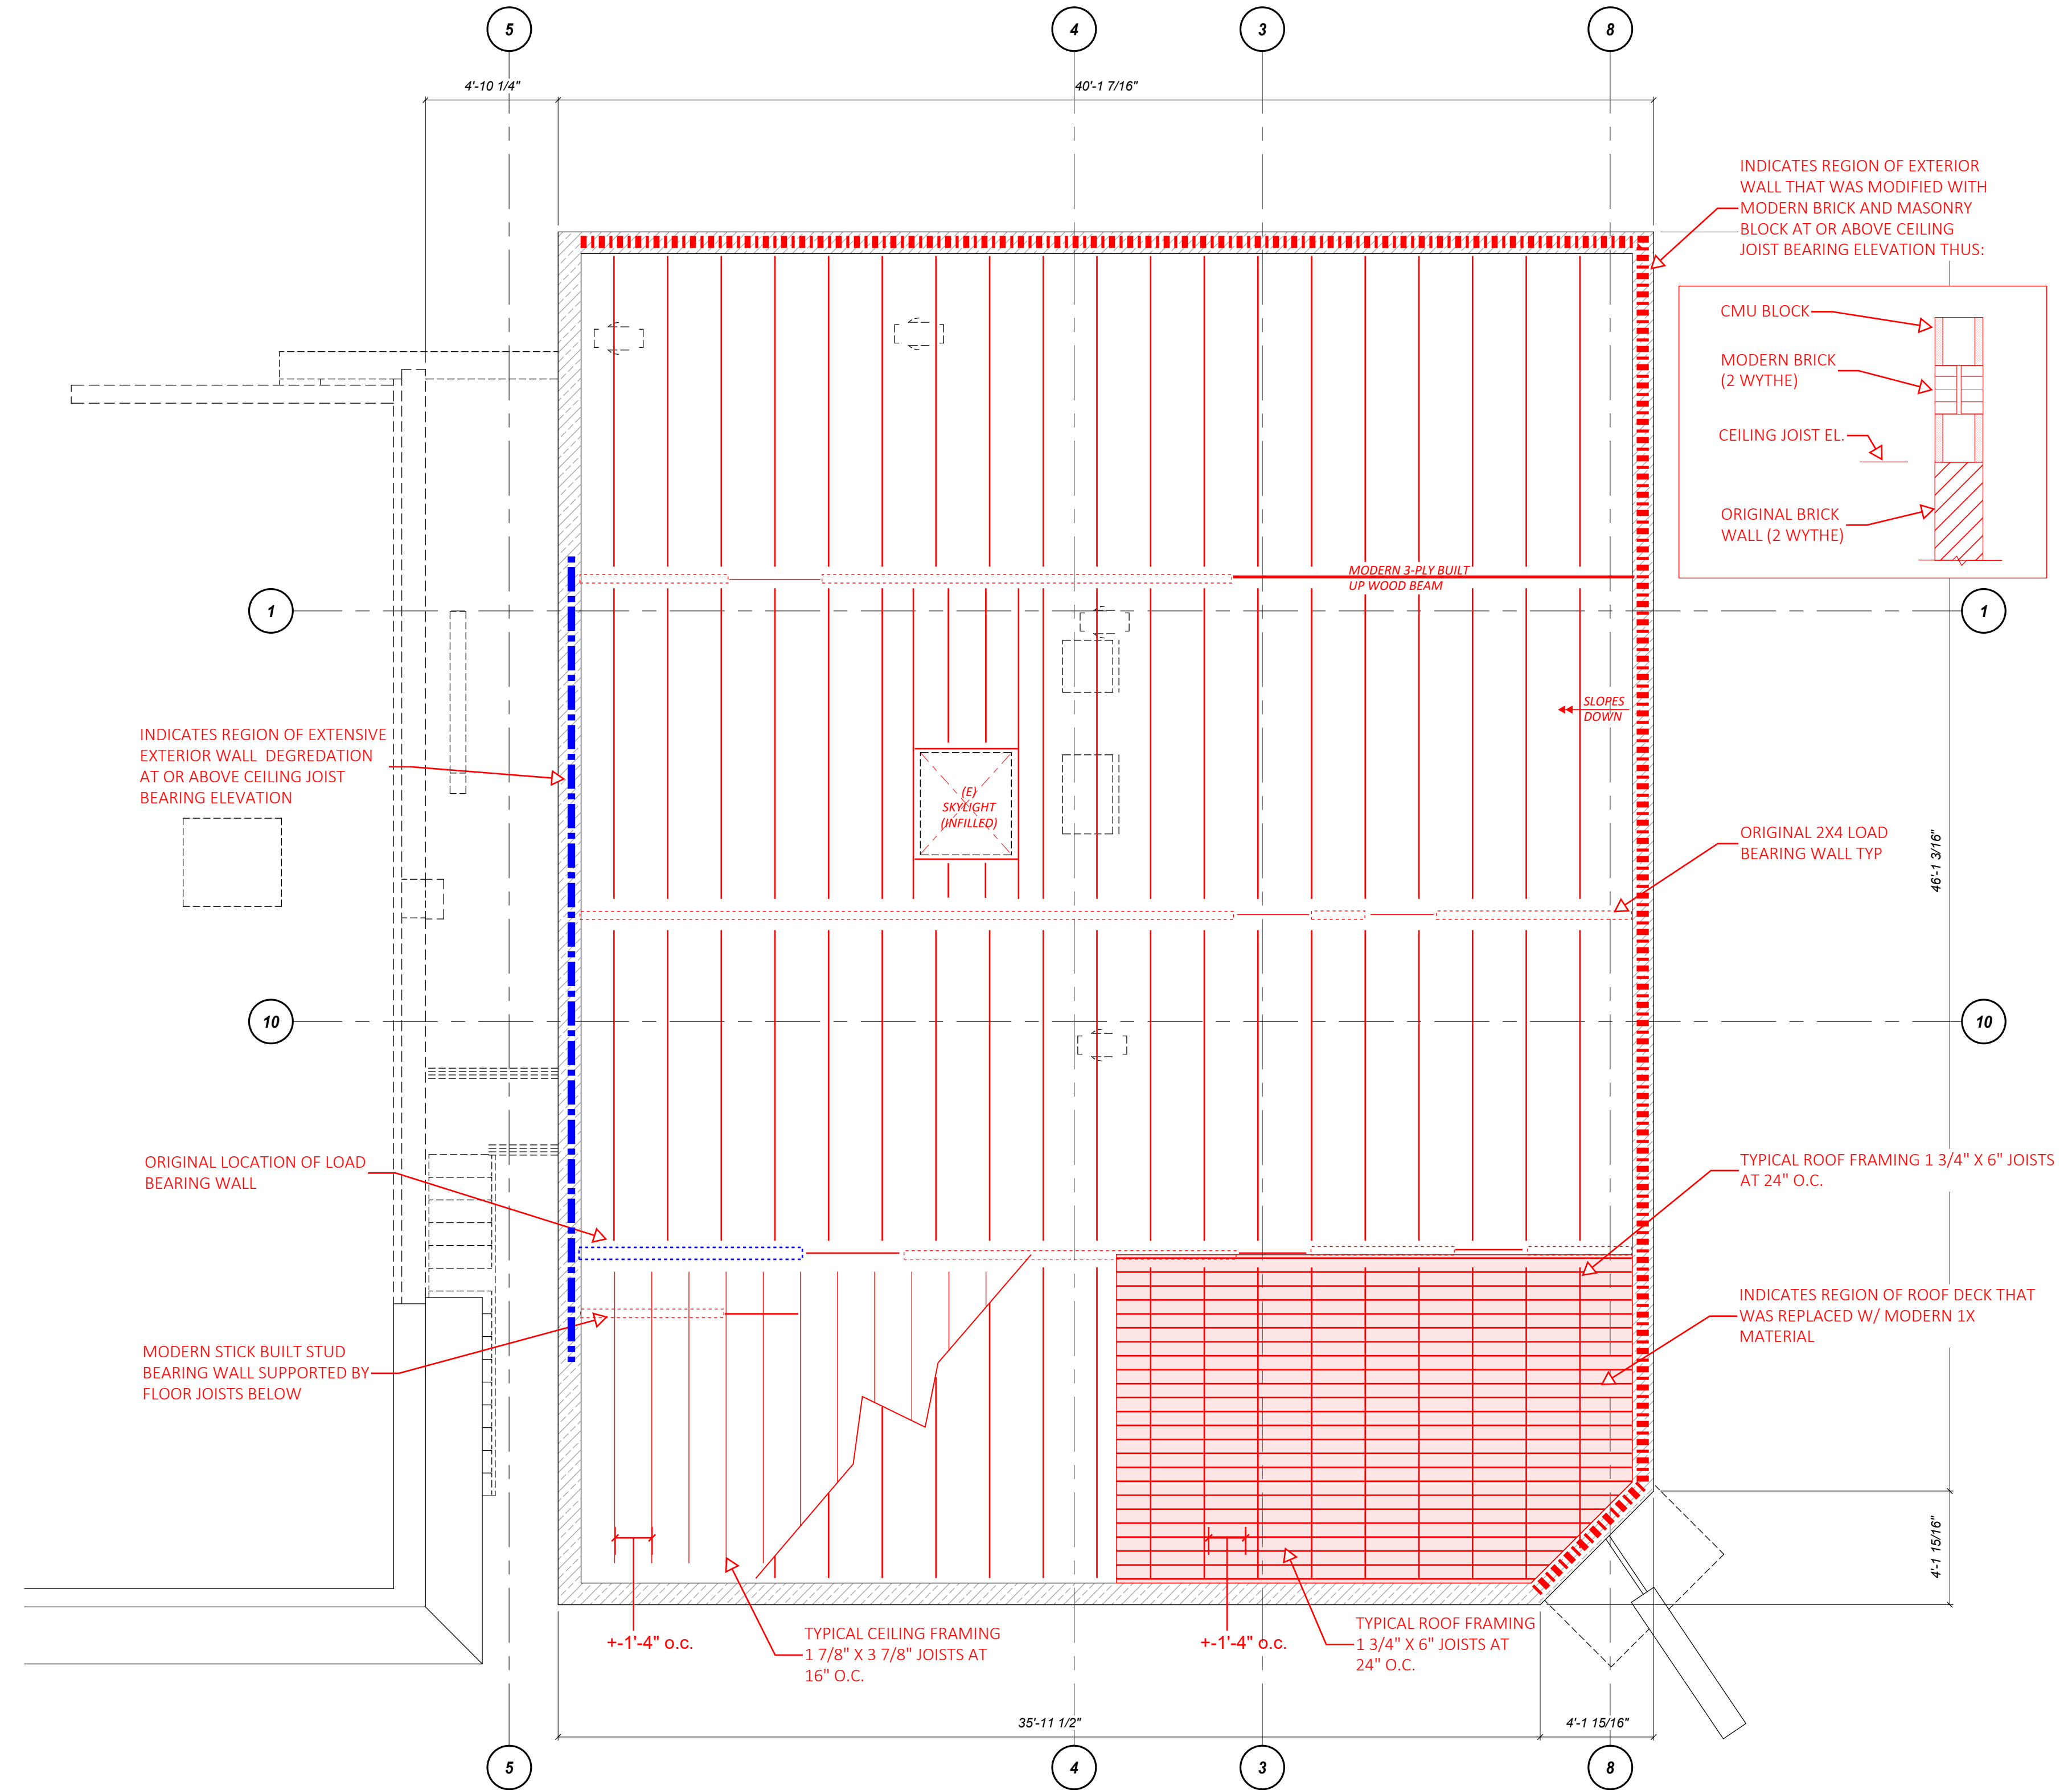
SHEET # **S1.05**

The existing roof framing consists of 1x wood decking of various widths supported by 2x6 wood joists at 24" on center, spanning south to north in bays of approximately 12'. The mild roof slope is perpendicular to the joists, sloping down to the east. A portion of the original decking appears to have been removed and replaced at the northwest corner of the building. Due to the large amount of splits and knots in the members, the 2x6 joists do not appear to be high grade framing members. The joists bear in brick pockets at the north and south exterior walls, with some pockets being oversized and not providing adequate bearing conditions. Some of the roof joists have supplemental supports to the 2x4 ceiling joist framing, which are spanning south to north and are spaced at 16" on center. Load carrying analysis of the existing roof joists show the members are overstressed in bending by 15% to 40%, depending on the allowable stress of the existing wood members. Excessive deflection of approximately 1" was observed in the framing system, and several severe splits near midspan in the ceiling and roof joists were observed, as a result of the members being overstressed. The damaged members are structurally unsound and are not capable of supporting future snow loads or activity on the roof.

The interior supports of the roof and ceiling joists appear to have originally consisted of 2x4 wood stud bearing walls, but some locations have had modern 2x wood beams installed where sections of the original bearing walls were removed. There are some new wood bearing walls installed, moving the original bearing wall location and load path. The modern built up wood beams are inadequately supported by wood posts at the beam ends, contributing to excessive deflection at the base of the posts and deflection of the roof and ceiling framing. The load path of the relocated wood bearing walls and point loads from the posts is severely compromised down to the foundation elevation. Due to the current condition and supports of the roof framing members, we believe the roof cannot be repaired and will require complete reconstruction. Images of the existing roof framing are shown and described below.
