# Electron backscatter diffraction characterization of fatigue crack growth in laser metal wire deposited Ti-6Al-4V

Pia Åkerfeldt<sup>a</sup>  
Magnus Hörnqvist Colliander<sup>b</sup>  
Robert Pederson<sup>a,c</sup>  
Marta-Lena Antti<sup>c</sup>

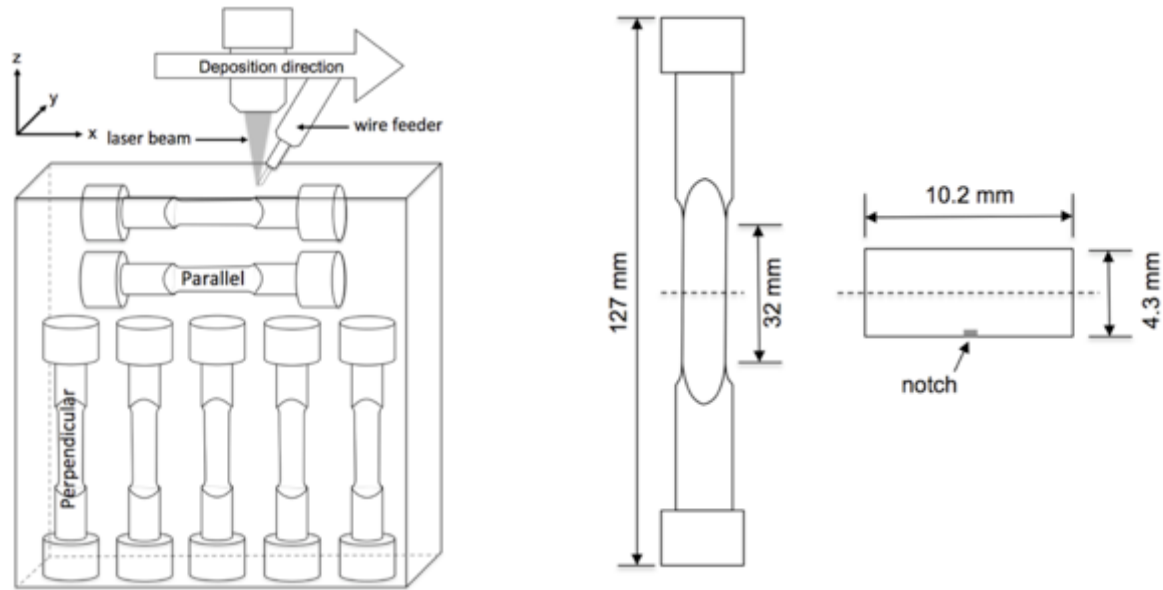
**Figure 1.** Schematic illustration showing the laser metal wire deposition process of a wall and the specimen orientations (left). The dimensions of the fatigue crack growth specimen and its cross section of the gauge section (right).

Fatigue crack growth testing was performed using the surface flawed Kb specimen geometry [19]. Cylindrical blanks with a diameter of 14 mm were machined from the walls with the longitudinal axis in the deposition direction ( $x$ , denoted “parallel”) or in the wall height direction ( $z$ , denoted “perpendicular”). See schematic representation of the specimen orientation in the walls in Figure 1, left. The blanks were inertia welded to larger cylinders of forged Ti-6Al-4V at both ends to allow machining of the button-head grips. The final gauge section had a rectangular cross-section ( $W \times T$ , where  $W$  is the specimen width and  $T$  is the thickness) of 10.2x4.3 mm<sup>2</sup>, and a gauge length of 32 mm (Figure 1, right). The orientations of the  $y$  and  $z$  directions were tracked during the machining operations, ensuring that the wide face of the gauge sections lay in the  $x$ - $z$  plane. A notch was created in the middle of the gauge section, centered on the wide face, using EDM machining.

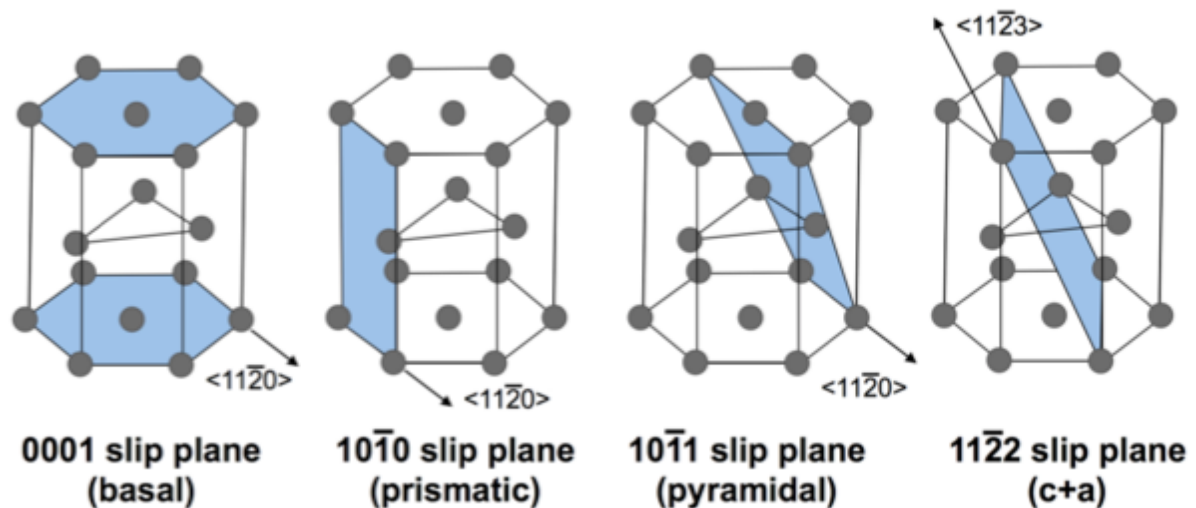
*Figure 2. The primary slip systems of alpha titanium.*

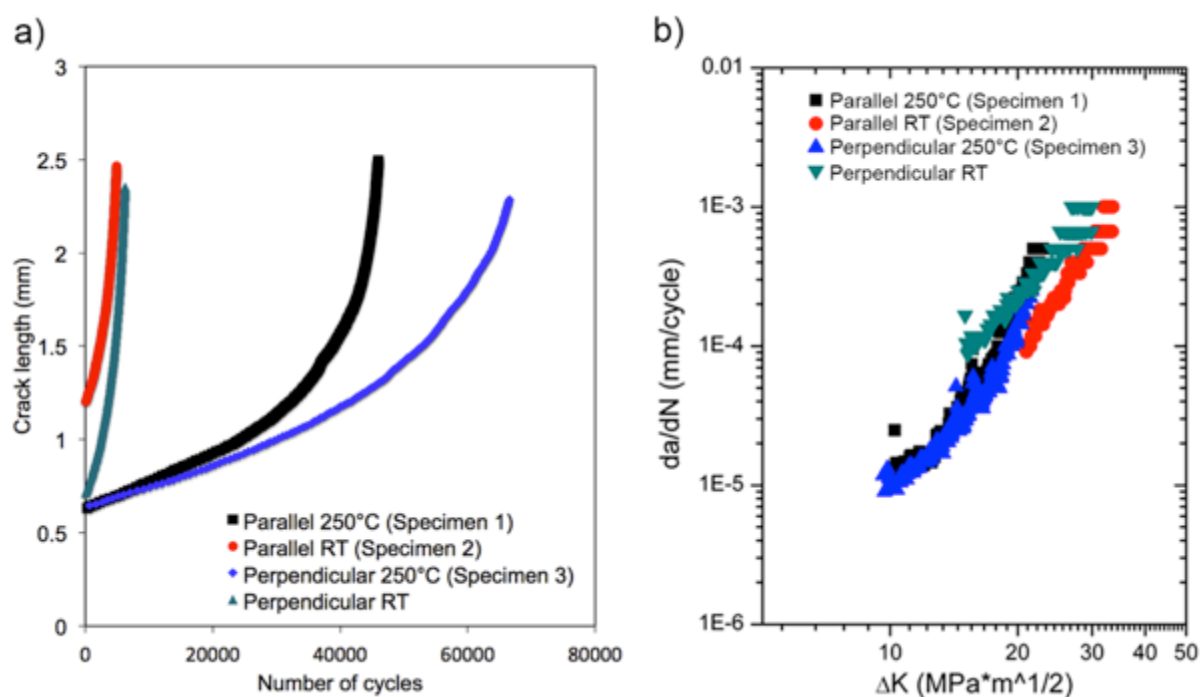
**Figure 3.** The crack length versus the number of cycles (left) and fatigue crack growth rate (right) for LMwD:ed Ti-6Al-4V parallel and perpendicular to deposition direction at room temperature and at 250°C.

Figure 3 a) shows the development of the crack length with number of cycles. The higher rates observed at room temperature are caused by the higher maximum load. Note also the difference in starter crack size between the two room temperature specimens. Differences in

load levels and starter crack size make it difficult to compare the different specimens. Therefore, the crack growth rate versus the stress intensity factor range is shown for all specimens in Figure 3 b). The resulting crack growth rate curves are close to linear on a log-log scale, indicating that the crack follows the expected power law behavior (Paris' law). At room temperature there is an observable difference between the two orientations, with the perpendicular specimen being approximately a factor 3 faster than the parallel, see Figure 3 b). However, this difference is within the level of scatter that can be expected from testing of coarse-grained material, and thus no firm conclusions can be drawn due to the low number of specimens tested here. For 250 °C the crack growth rates for the two orientations are virtually identical on a log-log scale (Figure 3 b)), and the difference in crack length with cycle number between specimens 1 and 3 in Figure 3 a) is only due to the accumulation of the small difference in propagation rates. Again, this is within the expected scatter between nominally identical specimens from a coarse grained material, no conclusions regarding the effect of specimen orientation on the crack growth behavior at 250 °C can be drawn. Furthermore, there is no significant difference between the crack growth rates at room temperature and 250°C, as seen in Figure 3 b).

Based on the observations it can thus be noted that the combination of fine alpha colony size and crystallographic orientation of specimen 2 are conditions promoting a less serrated crack path and that the crack propagation will continue easily and undisturbed until the conditions change (such as crystallographic orientation and alpha colony size). In other words, this shows that the crack propagation characteristics vary between individual prior beta grains and moreover it can be assumed that the size and orientation of the alpha colonies within the prior beta grains will influence the crack growth characteristics on a local scale. However, the influence of individual prior beta grains on the crack front is not as prominent. During fatigue crack propagation the crack front will strive to remain continuous, which prevents large differences in crack growth rate along the crack front as well as arbitrary crack directions in individual prior beta grains. The characterization of the crack path in the current study is limited to the selected cross sections, in which the crack growth is also affected by the local geometric conditions imposed by the adjacent segments of the crack front. The measured crack growth rate, on the other hand, is the average over the entire crack front, and it is therefore difficult to correlate the local observations of the crack to the crack growth rates in Figure 3.

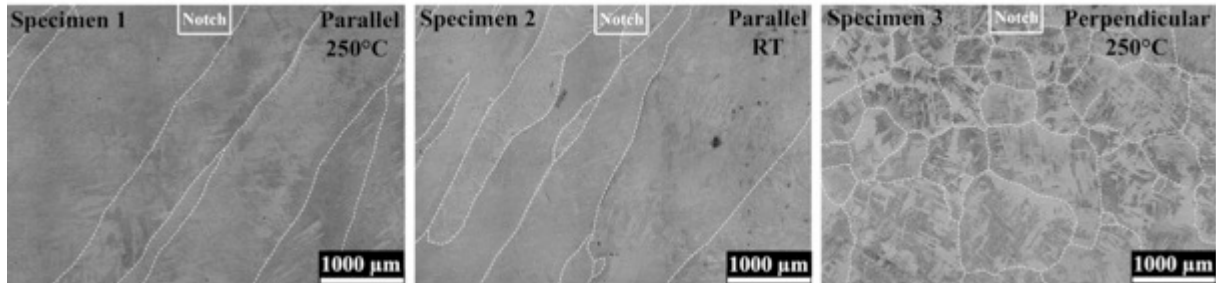
**Figure 4.** Micrographs of cross-sections in FCG specimen 1, 2, and 3 parallel to the fracture surface showing the orientation of columnar prior beta grains. White dashed lines highlight the prior beta grain boundaries.

The microstructure of the as-deposited material consists of large columnar prior beta grains growing through several deposited layers aligned with the thermal gradient in the material. Thus, the alignment of the prior beta grains will be varying with specimen orientation within the deposited wall. In Figure 4 cross sections parallel to the fracture surface are shown for three characterized specimens, with the notch located at the top edge of the cross section. For the two parallel test specimens it is clearly seen that the orientation of prior beta grains is similar, i.e. elongated along the cross section. It should be mentioned that the alignment of the prior beta grains at an angle of approximately 45°, see Figure 4, in the current study is a result of the specimen machining and placement of the notch rather than the thermal gradient in the

built material. In contrast and as expected, the cross sections of each individual prior beta grain are shown when characterizing the cross section of the perpendicular specimen, see Figure 4, right. Noteworthy is the large variation in size of the prior beta grains, from approximate 100  $\mu\text{m}$  to 2000 $\mu\text{m}$  in thickness (see Figure 4 specimen 1 and 2). This size variation is also seen on the perpendicular cross section (Figure 4 specimen 3).

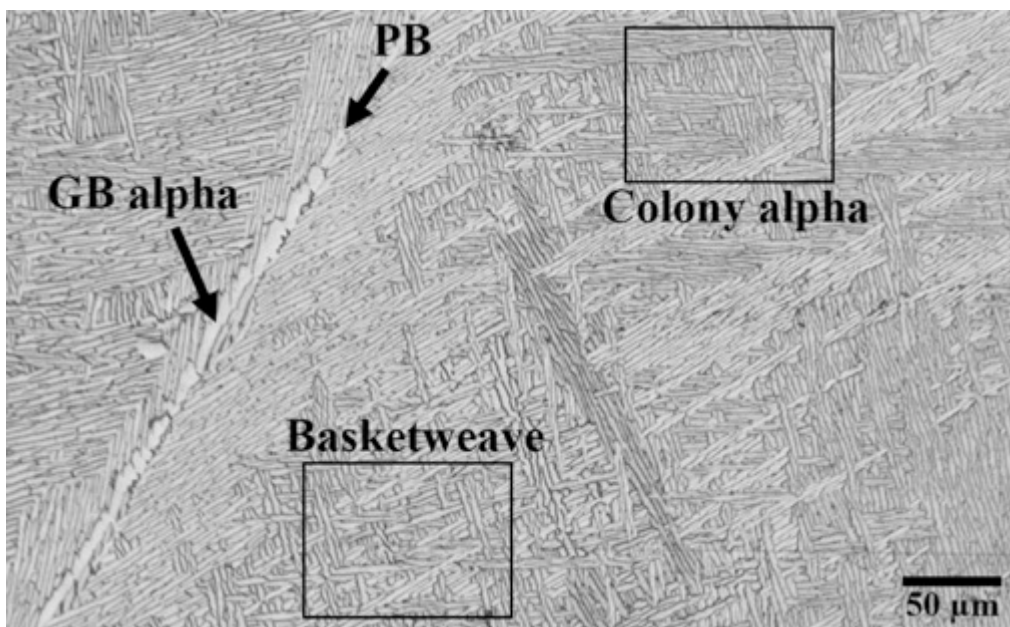
**Figure 5.** The microstructure within the prior beta grains consists of fine alpha laths forming alpha colonies and basketweave alpha microstructure. The prior beta grain boundary (PB) is decorated with grain boundary alpha (GB alpha) and closest to the grain boundary some areas of wide colony alpha are frequently observed.

At higher magnification, within the prior beta grains, the microstructure consists of fine alpha laths separated by retained beta. In Figure 5 the typical appearance of the different alpha structures is shown; the alpha laths are either observed as alpha colonies in which bundles of laths in the same orientation form a colony, or as basketweave alpha structure when there is arbitrary orientation of the alpha laths. Moreover, grain boundary alpha (GB alpha) is observed along the prior beta grain boundary (PB). In addition, areas with wide colony alpha are frequently observed next to the prior beta grain boundary. Regarding possible influence of specimen location (in the built wall) on microstructure for AM:ed material, no variation has been observed in this and previous studies on the same walls [9,10].

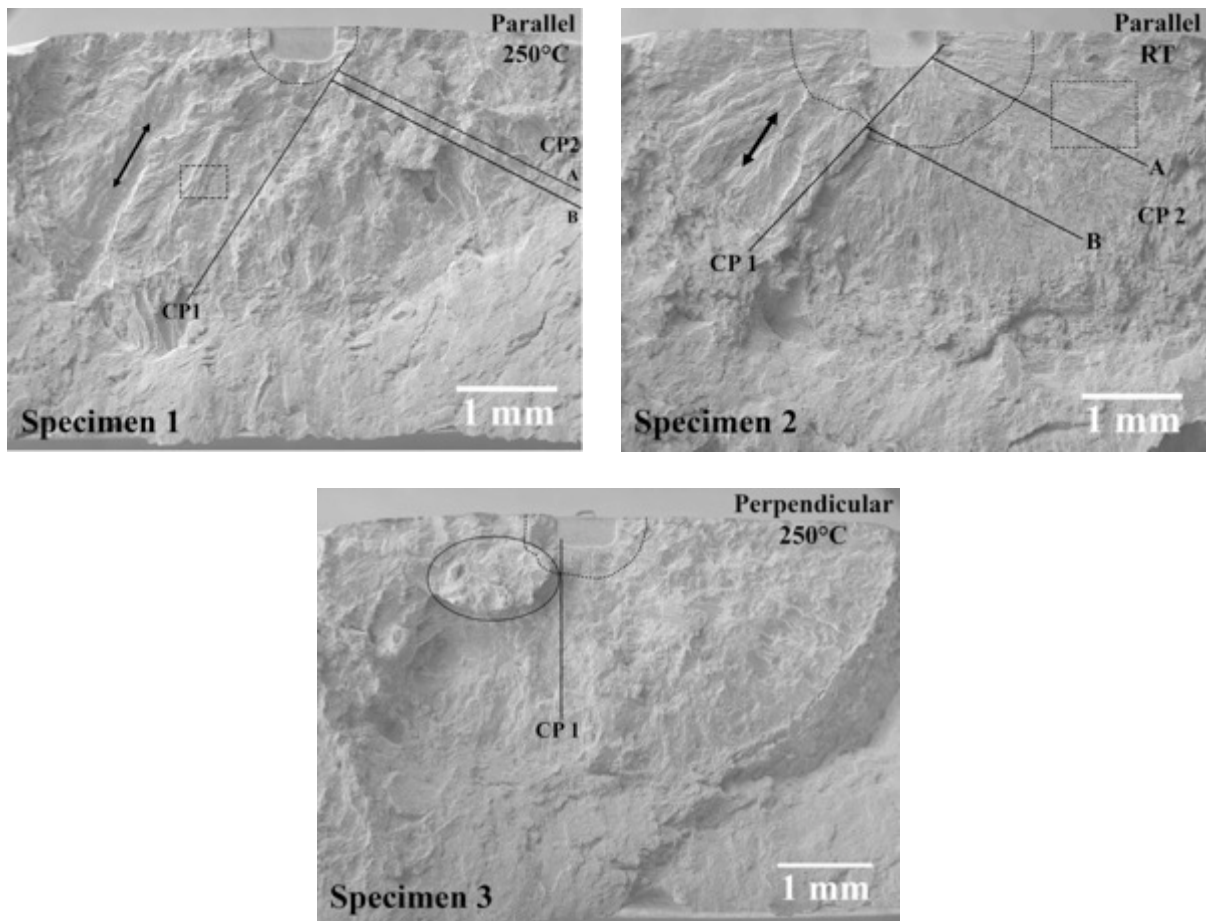
**Figure 6.** The fracture surfaces of specimen 1, 2, and 3. The positions of the characterized crack profiles (CP) are indicated in the fracture surface as well as the length of the pre-crack (black dotted lines). The arrows to the left in the fracture surfaces of specimen 1 and 2 indicate the orientation of the columnar prior beta grains determined after the fractographic study. The dashed squares on the fracture surface of specimen 1 and 2 indicate the location of Figure 7 b) and a) respectively.

In Figure 6 the fatigue crack propagation areas of the three evaluated specimens are shown. Common for all specimens is that certain regions of the fracture surface indicate a more serrated crack path. For instance, the left side of specimen 1 is rather flat compared to the right side; similarly the right side of specimen 2 is more flat than the left side. Moreover, features indicating the orientation of the columnar prior beta grains are observed on specimen 1 and 2, see features parallel to the arrows on the fracture surfaces. Also less distinct features are observed, for instance as shown by the hollow arrows in Figure 7 a), which is the flat area to the right of specimen 2 at higher magnification. In between these features believed to be prior beta grains there are ridges with higher tortuosity. Since the features and the indicated orientation of the columnar prior beta agree well with the microstructural characterization presented in Figure 4, the features are believed to be a reflection of the prior beta grains. Also on the fracture surface of specimen 3, features indicating the location of prior beta grains are observed. The most pronounced area is seen next to the notch, indicated by an ellipse. Here a large plateau is seen with a similar size as the prior beta grains shown in Figure 4.

Specimen 1 and 2 were further evaluated by characterizing the crack profiles CP2A and CP2B, see Figure 6. Again, the orientation of the prior beta grains is confirmed by the crack profiles for both specimens. Additionally for specimen 1, interesting features along the crack path are observed, see Figure 11. According to the IPF color scheme (in Figure 8), it can be noted that the crack growth direction changes dramatically as the crystal orientation changes to  $[\bar{1}2\bar{1}0]$  (green area) in crack profile CP2A. The  $[\bar{1}2\bar{1}0]$ -oriented area appears to be a very unfavourable crystallographic orientation for crack propagation, as the crack deflects almost  $90^\circ$  from the crack path. Interesting to note is that the Schmid factor for basal slip in the  $[\bar{1}2\bar{1}0]$ -orientation is close to zero, whereas it is close to maximum in the region just prior to the crack deflection, where the crack propagated perpendicular to the applied load. The Schmid factors for the other systems show the opposite behavior (low in the adjacent region and high in the region that is circumvented by the crack). The fact that the presence of a region where basal slip is hindered poses such an effective obstacle, although slip on all other systems is rather favorable, could indicate that slip on the basal planes is an important part of the crack propagation mechanism. Moreover, a large crack and a lack of fusion (LoF) defect were observed in crack profile CP2A and CP2B, respectively; see squares just below the surfaces in Figure 11. LoF defects could be detrimental to the mechanical properties [9, 23-26] and stems from the manufacturing process itself and is related to incomplete melting. The

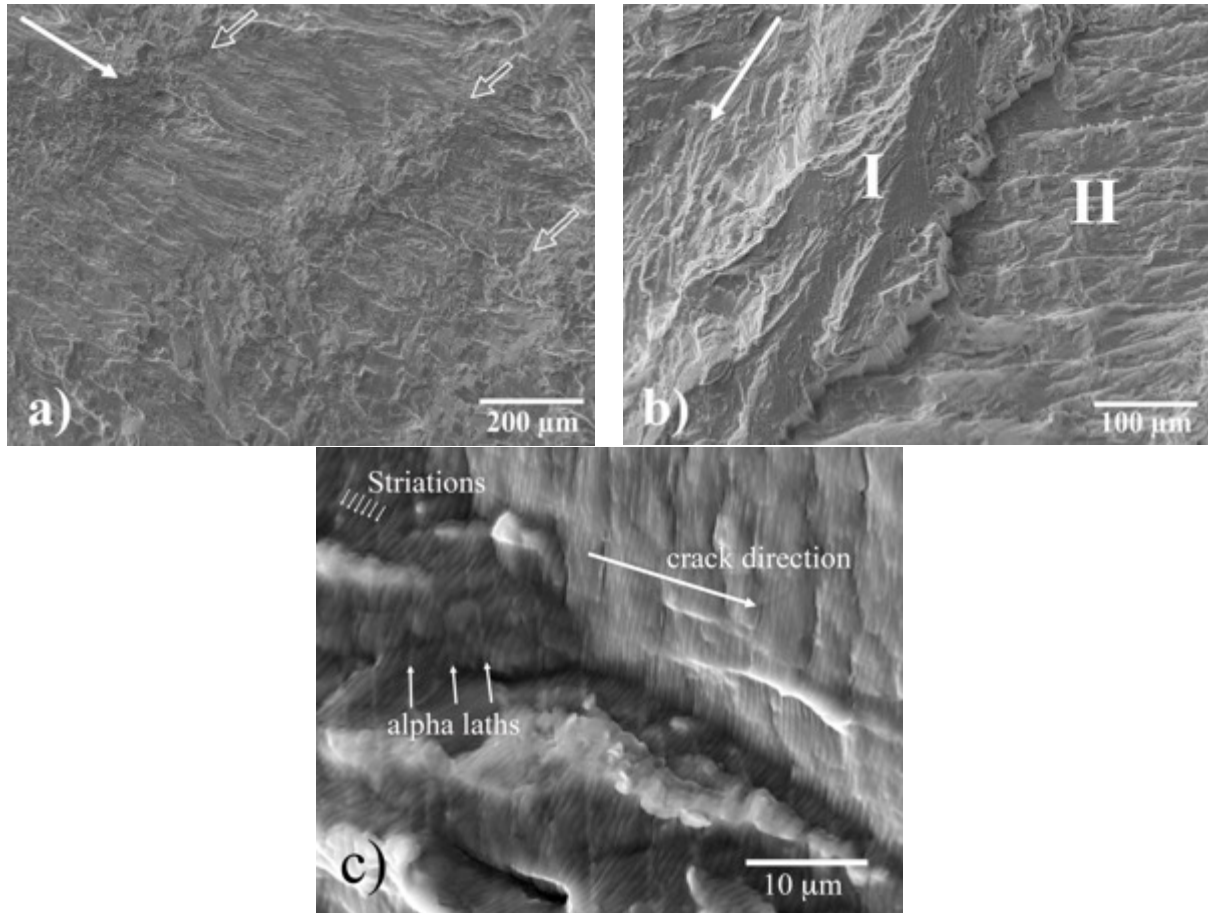
**Figure 7.** Features on the fracture surfaces indicating the orientation of the prior beta grains, here indicated by hollow arrows in a). The different crack path appearance in areas I and II could be attributed to different slip characteristics in specific prior beta grains. The solid white arrows indicate the crack growth direction in a) and b). The locations of a) and b) is indicated by dashed squares in Figure 6 in specimen 2 and 1, respectively. In c), striations normal to the crack direction, crossing the alpha laths, are shown (from the fracture surface of specimen 2).

Furthermore, the crack path appearance varies for certain regions on the fracture surface, for instance the crack path through region I is different to that of region II in Figure 7 b). From the crack path perspective, region I is smoother than II, which exhibits more staircase-like features along the crack path. The different appearance could be attributed to different slip characteristics in the different regions, which in this case as well as for the features on the fracture surface discussed above may be connected to the orientation of the prior beta grains since the features agree well with the orientation presented in Figure 4. Concerning the influence of test temperature, a smoother fracture surface is observed for the specimen tested at room temperature compared with the specimen of the same orientation tested at 250°C, i.e. compare specimen 1 with specimen 2. However, because of the limited number of specimens evaluated in the present study no further conclusions can be made regarding influence of test temperature. The pre-crack was generated at room temperature for all specimens, but in general no difference is observed between the pre-crack area and the area of the succeeding crack growth at 250°C. More secondary cracks are observed for the perpendicular specimen compared to the two parallel specimens, regardless of temperature. A detailed observation of the striations were not possible to perform in the current study since  $R=0$  during testing and hence the striations are demolished and poorly shown on the fracture surface. However, in

some areas the striations were observable, see Figure 7 c), indicating a ductile fatigue crack propagation.

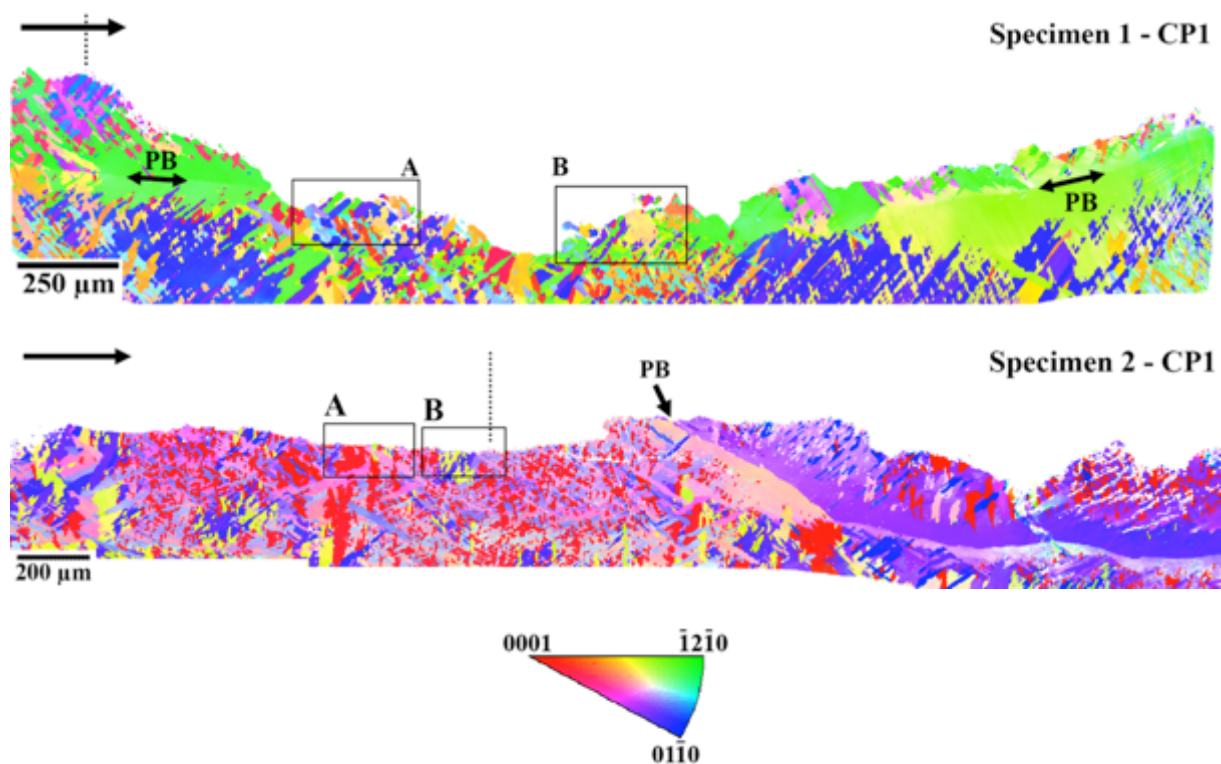
**Figure 8.** Inverse pole figure maps of the crack profiles CP1 in specimen 1 (250 °C) and 2 (RT), aligned with the assumed orientation of the columnar prior beta grains based on the findings of the microstructural and fractographic characterization. The length of the pre-crack is indicated by dotted lines at the crack profile. Crack direction is indicated with black arrows.

To further verify the orientation of the columnar prior beta grains, crack profiles along the prior beta grain orientations were evaluated in detail. In Figure 8 inverse pole figure (IPF) maps of crack profile 1 (CP1) of specimen 1 and 2 in Figure 6 are shown, together with the IPF color scheme used for the orientation maps in the present study. The prior beta grain boundary is marked PB in the crack profile and based on the IPF maps, the orientation of the columnar prior beta grains is verified and agrees well with the highlighted orientation in Figure 4. Interesting to note is that large areas exhibiting similar crystallographic orientation can be observed along the prior beta grain boundary, which is attributed to the wide columnar alpha present along the grain boundary, as seen in Figure 5.

When comparing the two crack profiles it can be further observed that the crack profile of specimen 1 is more serrated than that of specimen 2. Also the alpha colony size, which is represented by the different colors in the IPF maps, is different for the two crack profiles; specimen 2 exhibits a finer alpha colony size than specimen 1. It is well known that the alpha colony size is one of the most important microstructural features having impact on the mechanical properties, since its size corresponds to the effective slip length [20], which in this case could explain the more serrated appearance of specimen 1. In Figure 9 the Schmid factors for the primary slip systems are mapped for the two crack profiles, with the loading direction in the vertical direction. A high Schmid factor corresponds to a high resolved shear

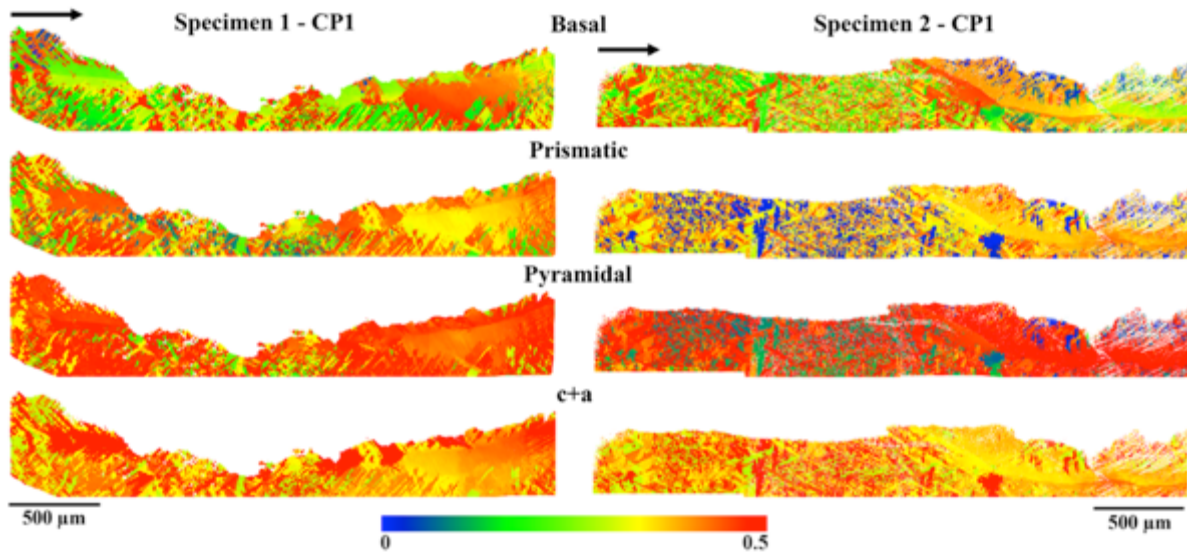
**Figure 9.** The Schmid factor intensity maps for crack profile 1 of specimen 1 and 2. The black arrows indicate the crack direction.

stress, and thus a high probability of slip activity in that slip system. It can be seen that the pyramidal slip system has high intensity along the crack path for both specimens. The c+a slip system is also high in certain areas for both specimens, especially for specimen 1. The basal slip system shows larger variations in intensity for both specimens and fewer areas with high intensity. The prismatic slip system shows very low Schmid factor intensity for specimen 2.

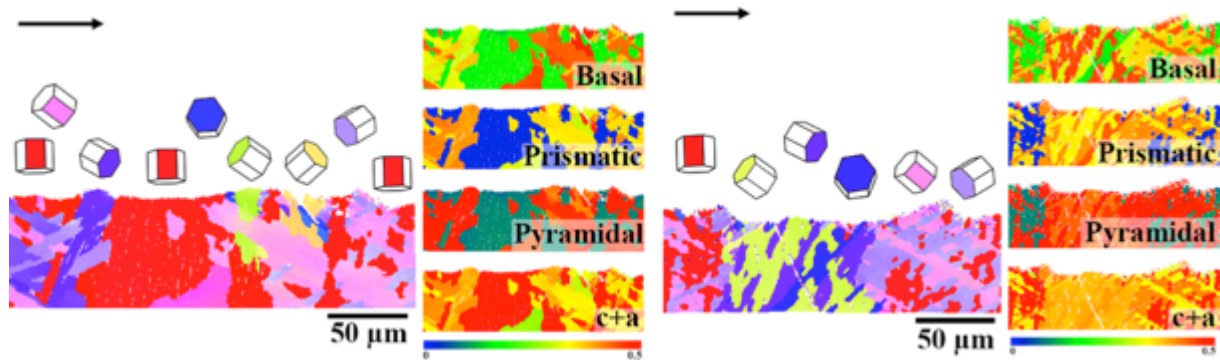
**Figure 10.** Inverse pole figure maps and the Schmid factor intensity map of the area A (left) and area B (right) of crack profile 1 of specimen 2. The black arrows indicate the crack direction.

In Figure 10, at higher magnification of specimen 2 in the squared areas A and B in Figure 8, it can be seen that a smooth crack path is maintained even if the crystal orientation changes along the crack path. This could be explained by the very high Schmid factor intensities available for the specific crystal orientations. For instance, it is clearly seen that for the [0001] orientation (red area), when the load is applied parallel to the c axis of the hcp crystal structure, the intensity of the c+a slip system is very high, as expected when deforming titanium alloys [21]. Here it could be noted that areas A and B are actually in the pre-crack region. However, for this particular case the pre-cracking and testing load are identical (500 MPa), and the distances from the notch to the investigated areas are long enough to avoid any influence from the stress field from the notch. Thus, the only difference between the crack generated under pre-cracking and testing conditions is the frequency (10 and 0.5 Hz, respectively). It has been shown previously that the room temperature crack growth rate in forged Ti-6Al-4V at R=0.1 was insensitive to test frequency for waveforms including 0.3 Hz, 25 Hz and 5 minute dwell at maximum load [22]. Thus, the current difference is not expected to significantly influence slip system activation or crack growth mechanisms, i.e the characteristics of the crack profile.

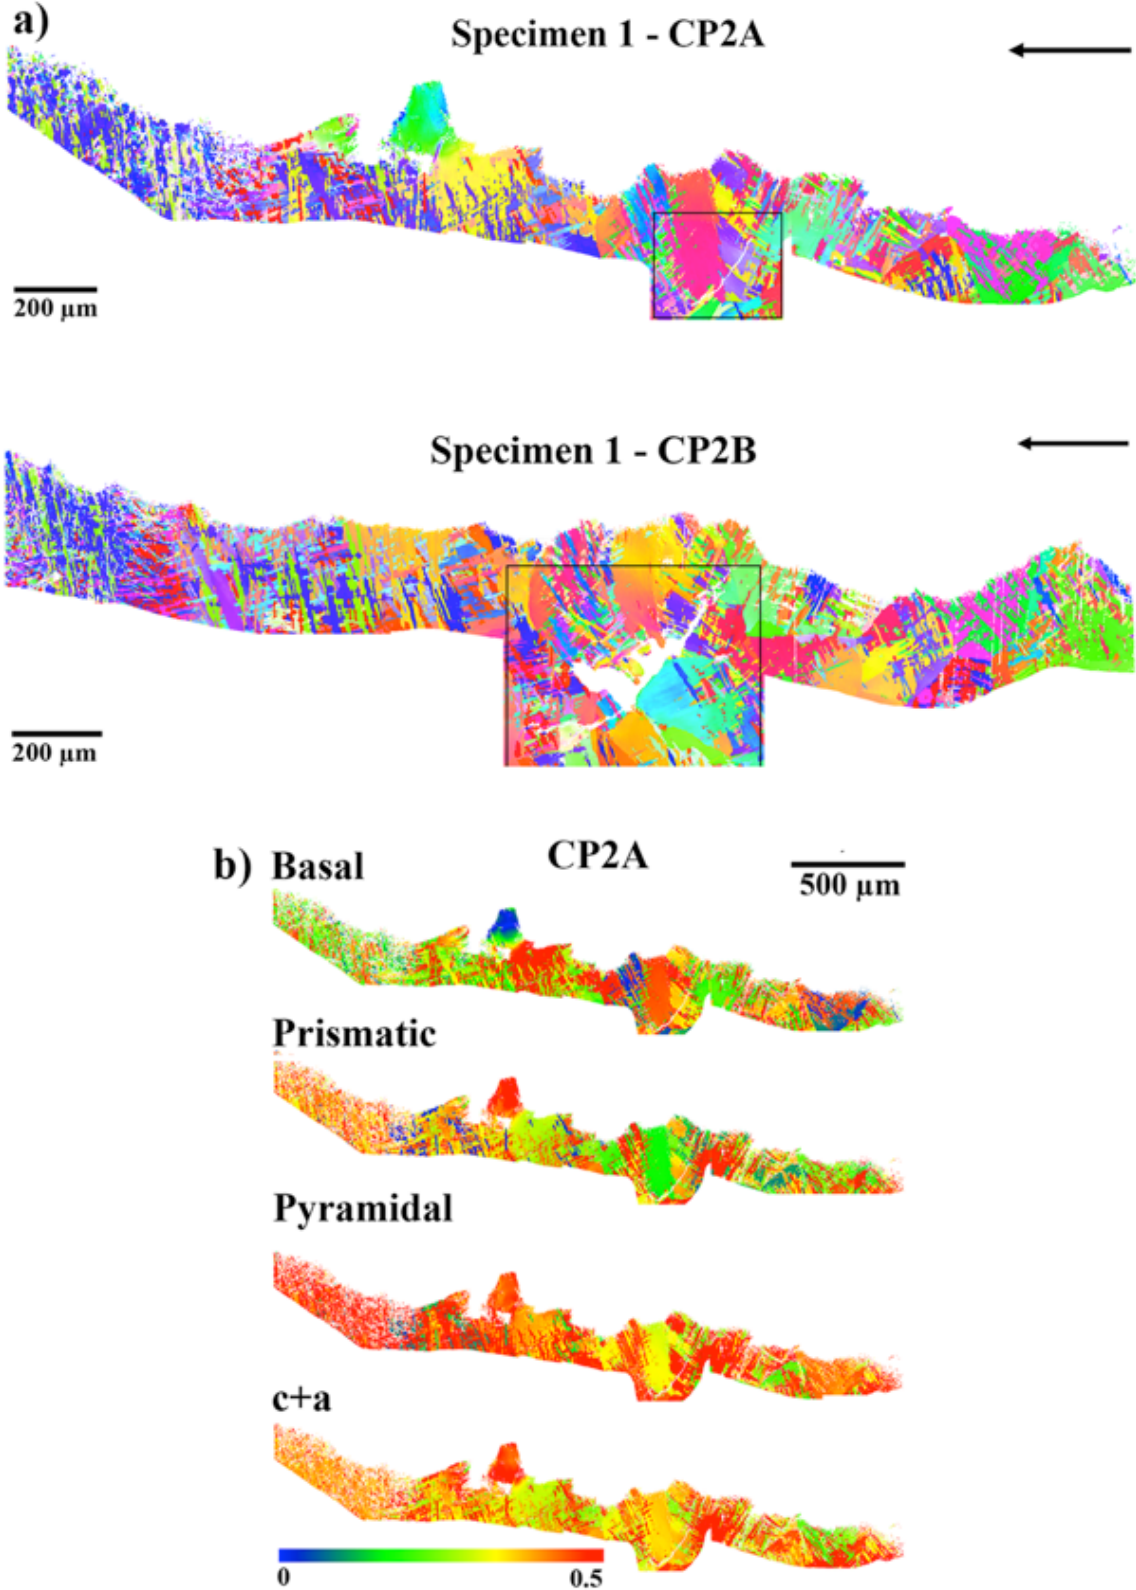
**Figure 11.** Inverse pole figure maps of crack profile CP2A and CP2B of specimen 1 (a), located as shown in Figure 6. Schmid factor intensity map of crack profile CP2A (b). The black arrows indicate the crack direction.

blue areas) or close to  $[01\bar{1}0]$  is at the surface of the crack profiles. Together with the observation in Figure 11, showing that the crack deviates around the area exhibiting the orientation close to  $[01\bar{1}0]$  and  $[\bar{1}2\bar{1}0]$ , a tendency for the  $[01\bar{1}0]$  orientation to influence the crack path characteristics is observed in the present study.

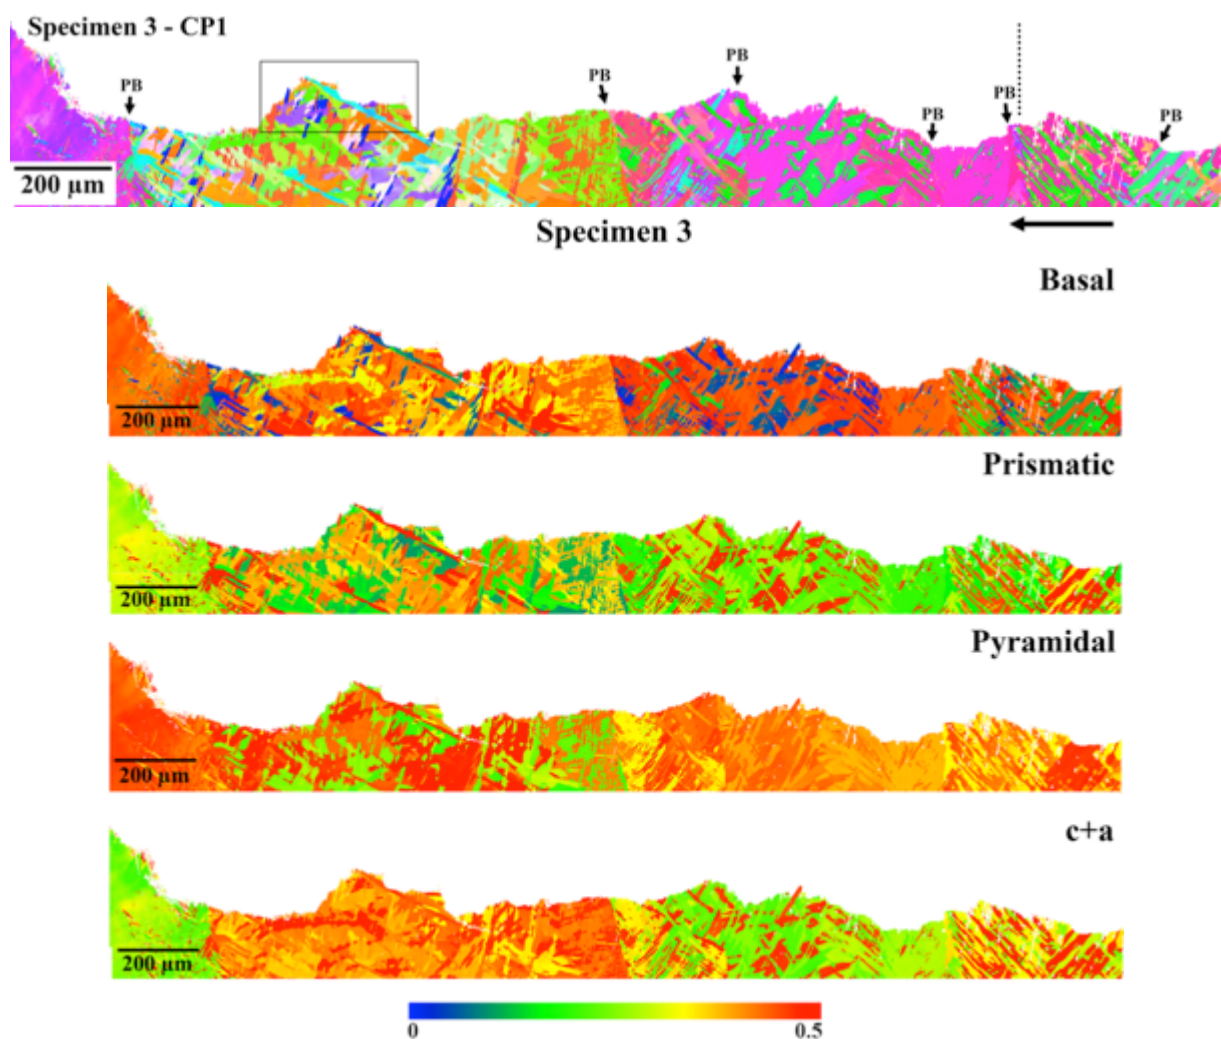
**Figure 12.** Inverse pole figure map of the crack profile CP1 of specimen 3 passing through several prior beta grains, prior beta grain boundaries (PB), and the Schmid factor intensity maps for the crack profile. The length of the pre-crack is indicated by a dotted line and the black arrows indicate the crack direction.

The crack profile of the perpendicular specimen, specimen 3, was also evaluated. Because of the orientation of the prior beta grains, the crack grows through several of them, see Figure 12, where the prior beta grain boundaries are indicated by PB in the IPF map. Even though the crack profile deviates close to some of the prior beta grain boundaries, the crack profile seems to be correlated both to the variation in crystallographic orientation and to the actual boundaries of the prior beta grains. The crystal orientation of the alpha phase is dependent on the crystal orientation of the prior beta phase. The initial alpha laths nucleate at the grain boundary according to the Burgers orientation relationship [27]. However, there are local variations of the crystal orientation of the alpha colonies within the prior beta grains influencing the crack profile as well. In Figure 12 the Schmid factor intensity maps for the crack profile are shown, which clearly indicate that there is no slip system exhibiting high intensity along the whole crack path available. This is connected to the numerous amounts of prior beta grains along the crack profile and the orientations within each grain.

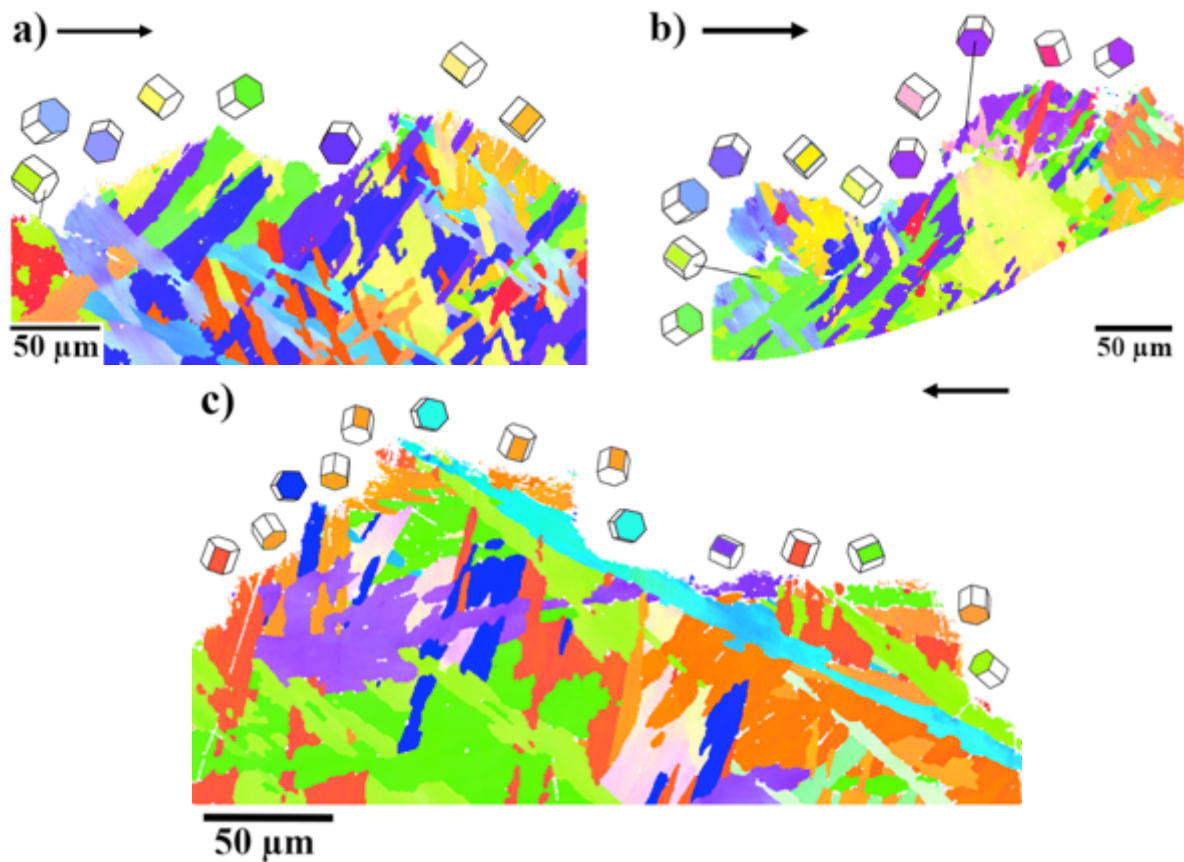
**Figure 13.** Inverse pole figure maps showing a) the area A and b) the area B along crack profile CP1 of specimen 1 and c) the highlighted area of the crack profile of specimen 3. The black arrows indicate the crack growth direction.

In Figure 13, selected areas in Figure 8 and 12, for the specimens 1 and 3 are shown, respectively. One common observation for both specimens is that the  $[01\bar{1}0]$  orientation (see

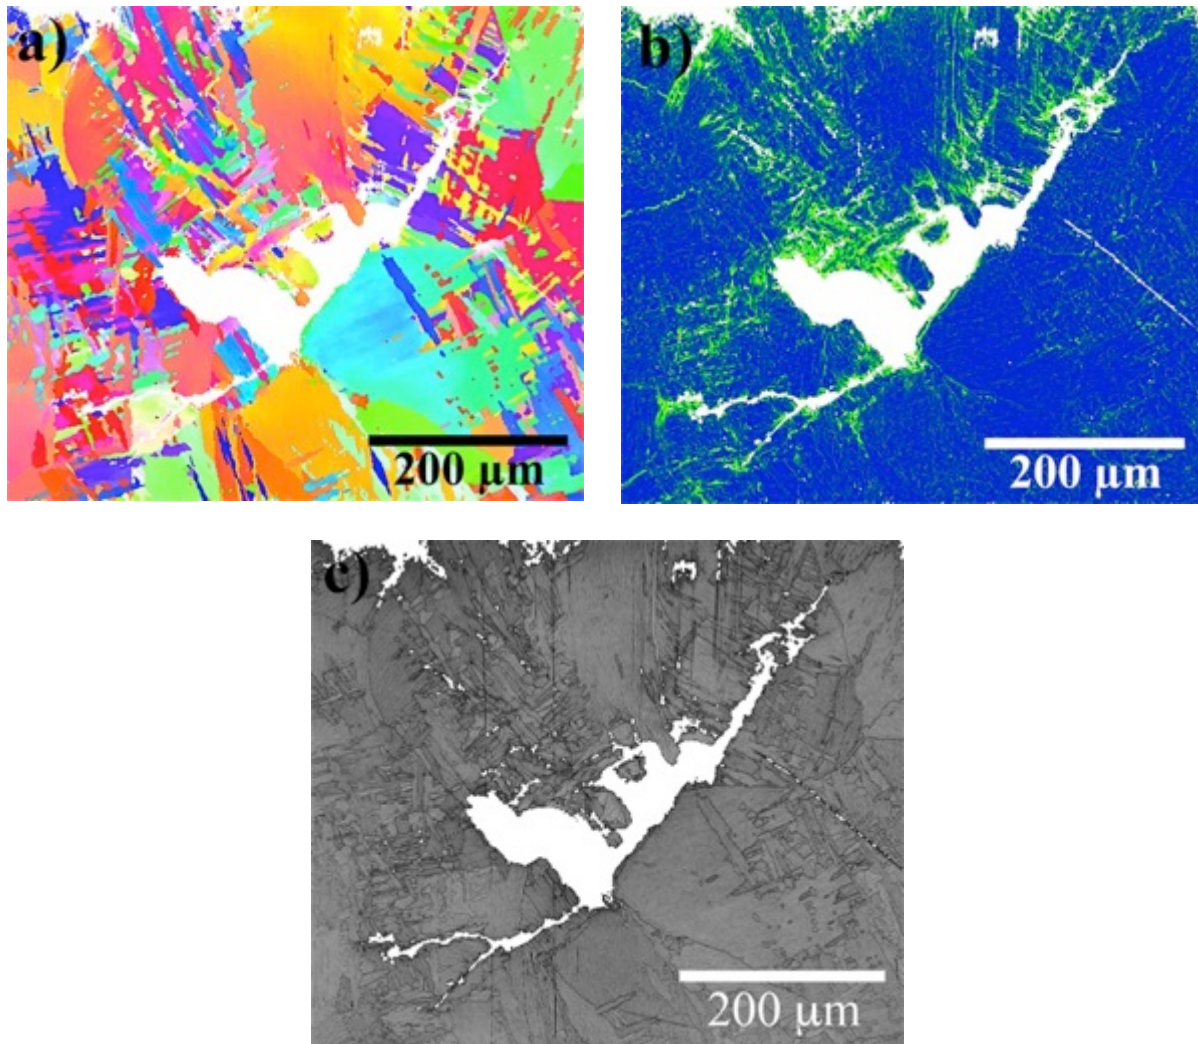
**Figure 14.** *Inverse pole figure map (a), local misorientation map (b) and the image quality map (band contrast) (c) of the lack of fusion defect present in crack profile CP2B of specimen 1.*

Along crack profile CP2B of specimen 1 a large lack of fusion (LoF) defect is observed, (marked with a square in Figure 11). In Figure 14 the IPF map and the local misorientation map around the LoF defect are shown. In the IPF map it is clearly seen that the LoF defect “cuts off” the continuous formation of microstructure during the LMwD process. Small areas of various crystallographic orientations are found around the LoF defect, which refers to the solidification just before the preferably oriented dendrites outgrow the less preferably oriented dendrites. Furthermore, in the local misorientation map, large zones of plastic deformation closest to the free surface of the defect are evident, representing the inhomogeneous stress distribution generated by the LoF defect because of its asymmetrical shape.
