## **Water and ammonia evaporation in a compost bedded pack dairy barn with under floor aeration**

Paper Number: 141899106

Bjarne Bjerg and Ilka Klaas, University of Copenhagen, Denmark

Written for presentation at the  
2014 ASABE and CSBE/SCGAB Annual International Meeting  
Sponsored by ASABE  
Montreal, Quebec Canada  
July 13 – 16, 2014

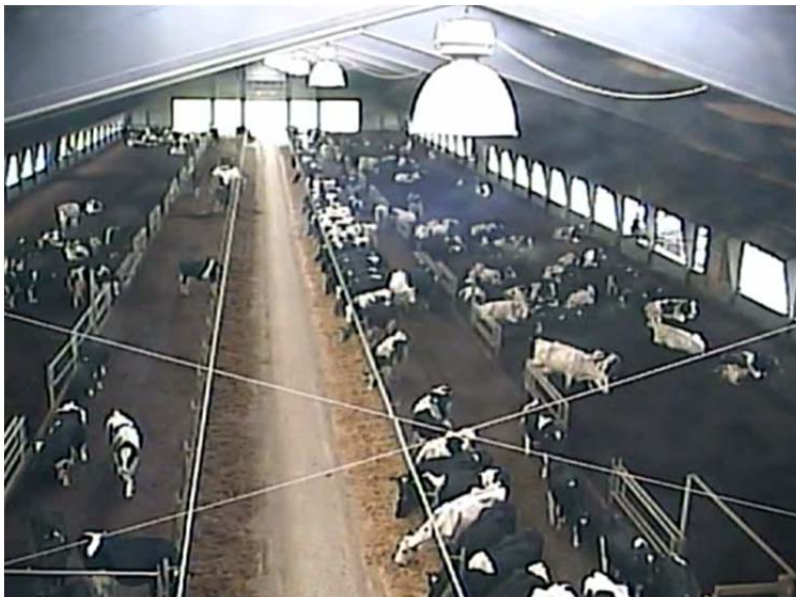
The barn was designed with a 4 m wide solid floor feeding place between the feed table and a 12 m wide compost area, see Figure 1.

*Figure 1. Overview picture of the investigated barn.*

The feeding place had a 5 % slope towards draining slots in the middle and an automatically scraper system was installed to remove the manure each second hour in order to fulfil the Danish requirements for low ammonia emission animal housing.

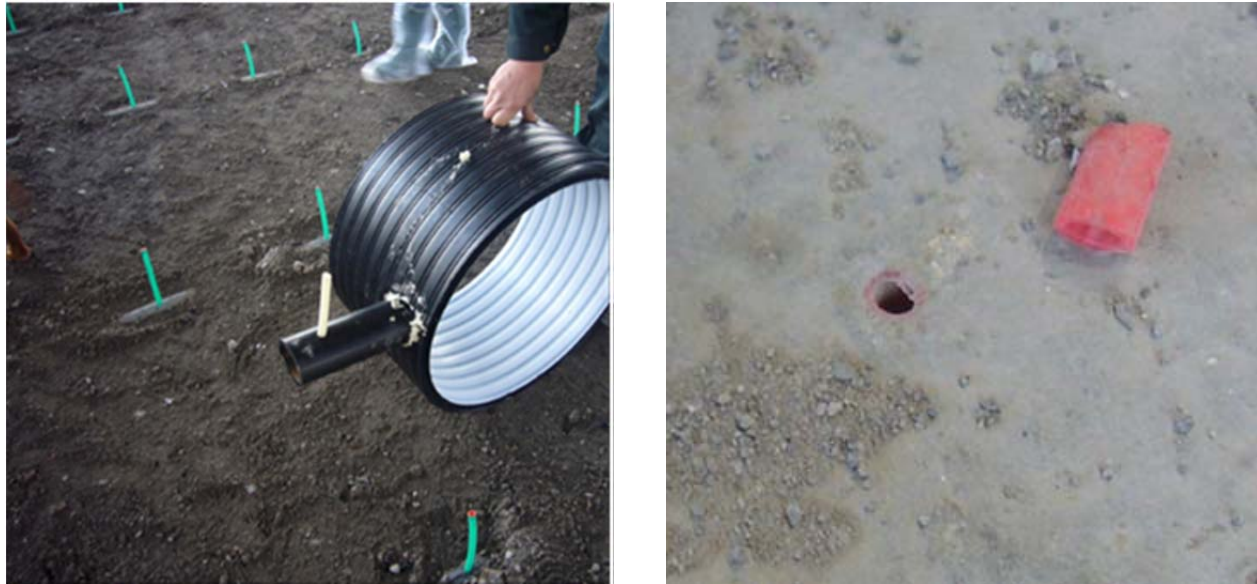
The under floor aeration system were design with a 600 mm main tube in the ground just outside each side of the building. The main tube supplied a 76 mm cross tube, for each 1125 mm, embedded in the concrete floor beneath the compost bedded pack. Each cross tube supplied a 10 mm vertical tube per 600 mm which led the

air through the solid floor into the compost bedding, see figure 2.

*Figure 2. Tube system for aeration of the CBP. The picture to the left shows the vertical tubes before laying the concrete floor, and an illustration of the junctions of the three tube types. The picture to the right shows a vertical tube cut off at the height of the finished floor.*

The installed fans have the capacity to deliver a flow of approximately  $5 \text{ m}^3\text{h}^{-1}$  through each of the 2480 holes in the floor of the investigated CBP at a back pressure of 900 Pa. Measured back pressure was typically 950 Pa before and 850 Pa after the daily stirring of the CBP. The aeration system was operated 5 minutes each second hour during the winter period, and at daytime only during the summer period.

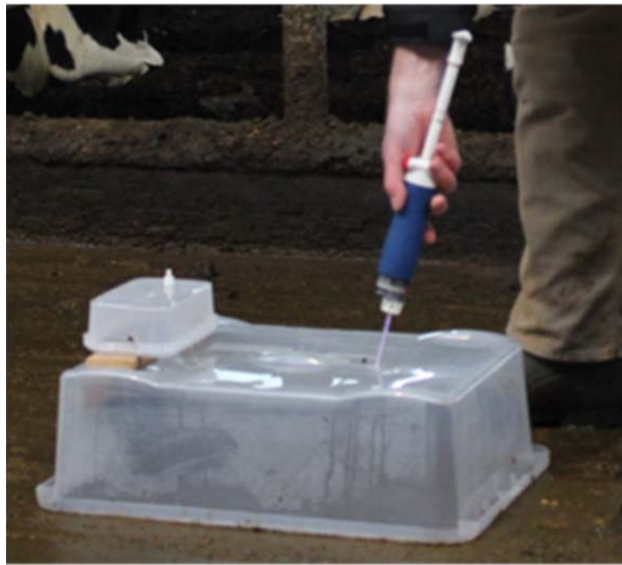
A 15 cm high simple plastic box was used as a primitive flux chamber to measure the ammonia emission from the CBP and from the scraped solid floor feeding place, see Figure 3. Inside the chamber a computer fan was installed to ensure an appropriate air mixing. A Kitigawa AP-20 sampling pump and ammonia detection tubes (105SD) were used for the ammonia concentration measurements. The detection limits of the used detection tubes was 0.5 ppm and according to the instruction manual a sampling time of 1 minute was used. An earlier study (Kousgaard, 2011) showed that the ammonia increase in the chamber began to decline 1 minute after the chamber was placed on the surface. Therefore the ammonia measurements were conducted from 45 to 105 seconds after the chamber was placed on the floor. Because of declining air flow through the detection tubes during the 1 minute sampling period it was assumed that the measured ammonia concentration reflected the concentration 60 second after the chamber was placed on the surface. Generally the background concentration in the barn was below the detection limit of 0.5 ppm and therefore no background concentration was taken in to account in the calculation of the ammonia emission.

Figure 3. Simple flux chamber and a Kitigawa AP-20 sampling pump with 105SD detection tube for determination of ammonia emission.

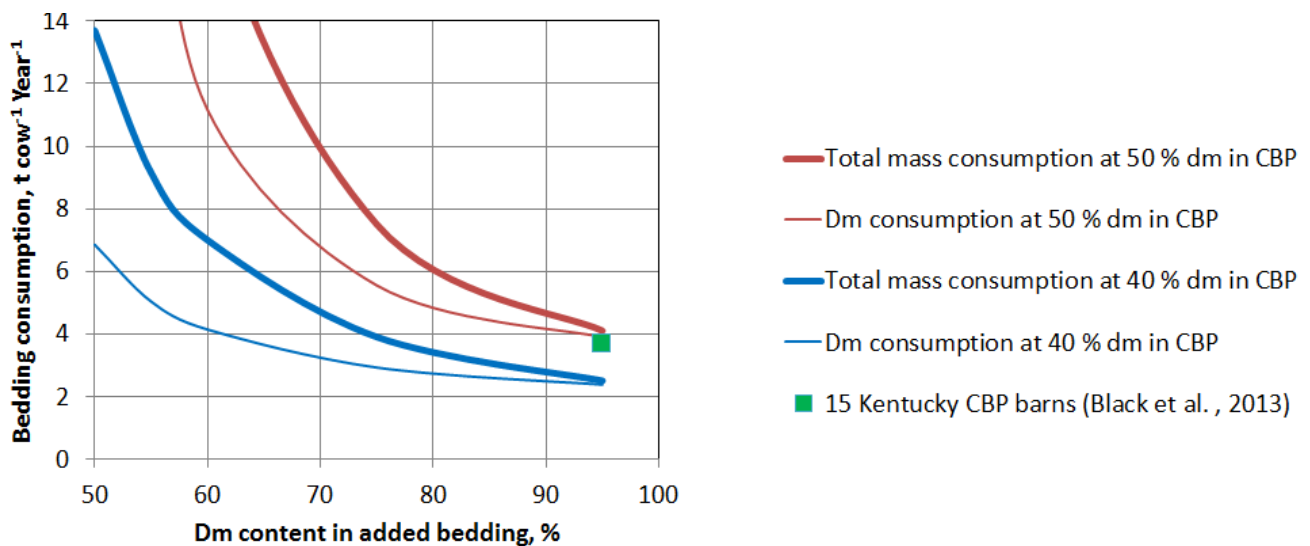
The finding that the water evaporation was insufficient to increase dm content during the winter period is of great relevance in relation to estimate the need for bedding material to ensure appropriate dm content in the bedding (40 – 60 % according to Black and Bewley (2013)). Figure 6 shows calculated expected yearly requirement for bedding material to ensure either 40 or 50 % dm in the CBP. The calculation is based on equation 1 and the following assumptions;

- For a five month winter period the water evaporation is insufficient to increase the dm content.
- During the winter period the addition of manure in the compost is  $4.9 \text{ t (12 \% dm) cow}^{-1}$
- No bedding material is required during a 7 month summer period.
- Dm content in bedding material is between 50 and 95%.

Figure 6. Calculated required bedding material to maintain either 40 or 50 % dm in CBP. The green bullet shows average bedding material consumption at 15 Kentucky barns that used kiln-dried shavings or sawdust as bedding material.

Figure 6 illustrates that a high dm content in the added bedding materials is essential to reduce the material consumption, and that it requires a significant increase in added bedding material to elevate the dm content in the CBP from 40 to 50 %.

The green bullet in the graph shows the average use of bedding material in 15 Kentucky CBP barns that all used kiln-dried shavings or sawdust as bedding material (Black et al., 2013). The authors informed that the daily consumption were  $0.05 \text{ m}^3 \text{ cow}^{-1}$ . This value was converted to the unit used in the graph by assuming a material density of  $200 \text{ kg m}^{-3}$  and a dm content of 95 %, and it indicates that the curves in graph may be consistent with the Kentucky experience.

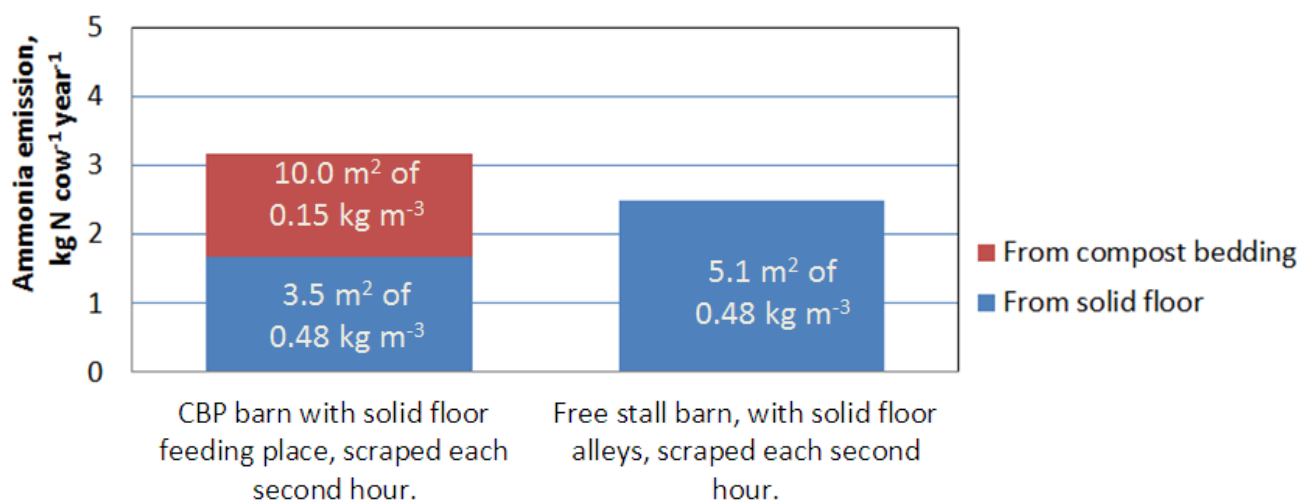
For  $10 \text{ m}^2$  of compost area per cow and  $3.5 \text{ m}^2$  of solid floor feeding place per cow the total ammonia emission was calculated to  $3.2 \text{ kg N year}^{-1} \text{ cow}^{-1}$ , see figure 7. A comparable free stall barn with a solid floor alleys of  $5.1 \text{ m}^2 \text{ cow}^{-1}$ , and using the mentioned emission of  $0.48 \text{ kg N year}^{-1} \text{ m}^{-2}$ , will cause an ammonia emission of  $2.5 \text{ kg N year}^{-1} \text{ cow}^{-1}$  (assuming no emission form the cubicles). This indicates that the emission from the compost bedded pack barn is approximately 30 % higher than from a comparable free stall barn, and this is due to the large surface area per cow on the CBP.

Figure 7. Estimated ammonia emission from a compost barn and from a free stall barn based on simple flux chamber measurements on CBP and on solid floor scraped each second hour.

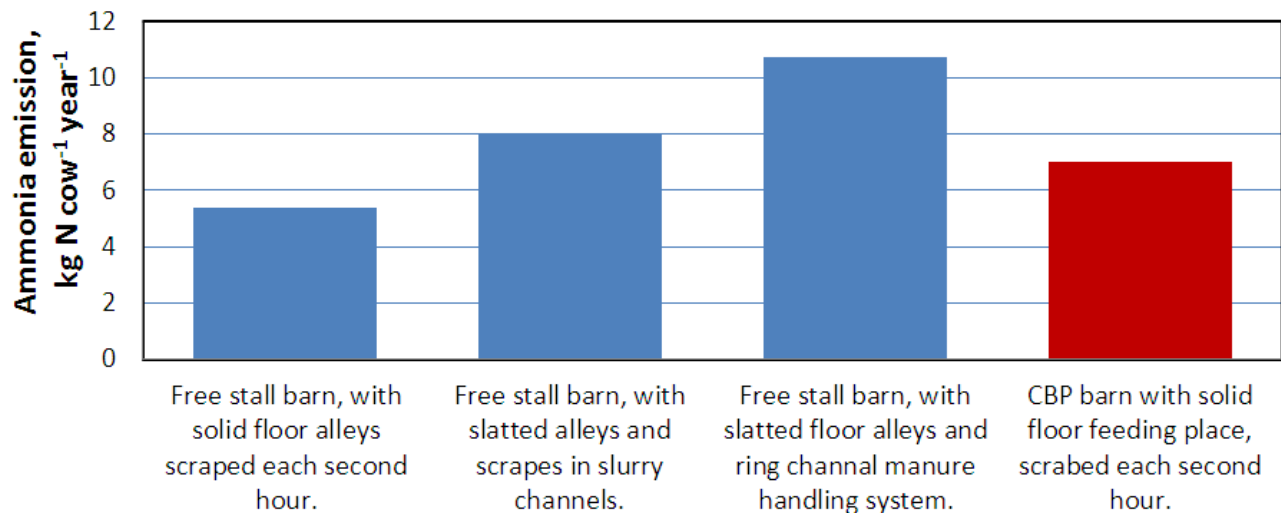
Figure 8 illustrates the expected ammonia emission from three frequently used free stall housing system mentioned in the Danish standard figures for animal manure (Poulsen 2012). The red bar illustrates the emission from a CBP barn assuming that the emission is 30 % higher than from a free stall barn with solid floor alleys scraped each second hour. The graph indicates that the ammonia emissions observed from the Danish GBP barn lies within the variation that exists between the free stall housing that is frequently used in Denmark.

Figure 8. Expected ammonia emission from three frequently used free stall housing system mentioned in the Danish standard figures for animal manure and expected comparable emission from a CBP barn.
