Assessment of Photovoltaic Module Failures in the Field

Report IEA-PVPS T13-09:2017

IEA PVPS Task 13, Subtask 3
Report IEA-PVPS T13-09:2017
May 2017

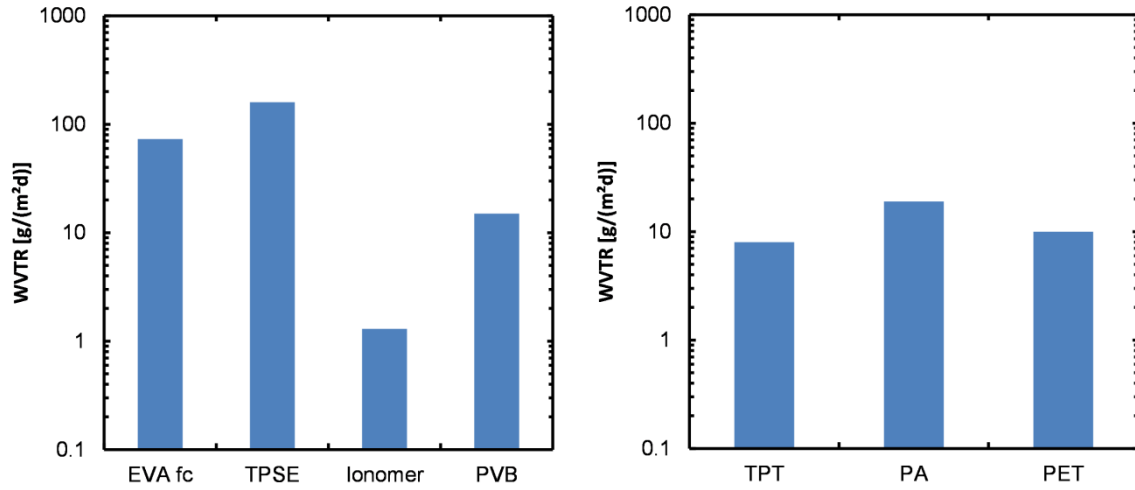
Fig. 2: Water vapour transmission rate (WVTR) through encapsulants, ethylene vinyl acetate (EVA), thermoplastic silicone elastomer (TPSE), an ionomer, and polyvinyl butyral (PVB), and through backsheets Tedlar-polyester-Tedlar (TPT) foil, a polyamide (PA) sheet, and a polyethylene terephthalate (PET) composite films. Adapted from [16].

Relative water vapour transmission rates are needed to understand the environment within a PV module. With the exception of the ionomer encapsulant, it can be seen in Fig. 2 that moisture generally transmits much more rapidly through encapsulants than through backsheets when measured at 85°C [16].

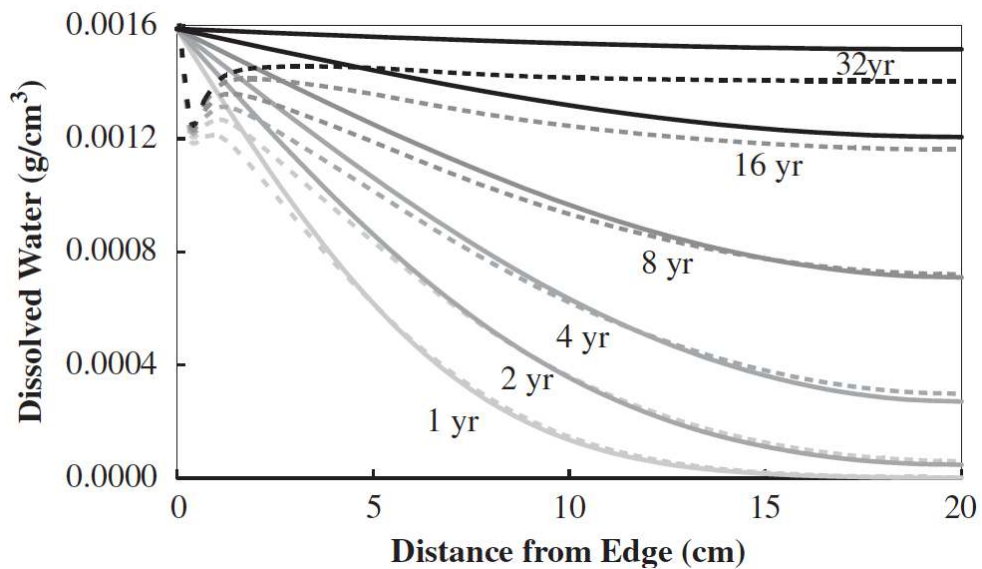
Fig. 3: One-dimensional model of moisture ingress in double-glass laminate construction using EVA. Solid lines and dotted lines are achieved at using two different methods. $T = 27:1^{\circ}\text{C}$ and $\text{RH} = 71.2\%$ (the average conditions for Miami) [34].

Simply using moisture barrier materials is insufficient because issues such as adhesion and transport of moisture at interfaces and openings must be considered. Mobil Solar/ASE America type 300-DGF/50 modules produced for a period of several years around 2001 have frequently been seen in the field exhibiting delamination, Fig. 4. These are glass/glass construction and from the literature and visual inspection, these modules had a specific ionomer encapsulant [35] that has proven to have insufficient adhesion. Delamination occurred frequently over the junction boxes and at the edges. Corrosion in these modules was facilitated by delamination, which permitted direct exposure of cell materials to moisture, in the form of liquid water, from the environment. It can be seen that glass/glass construction does not necessarily eliminate moisture ingress into the modules, which can also be understood in view of the results in Fig. 3.

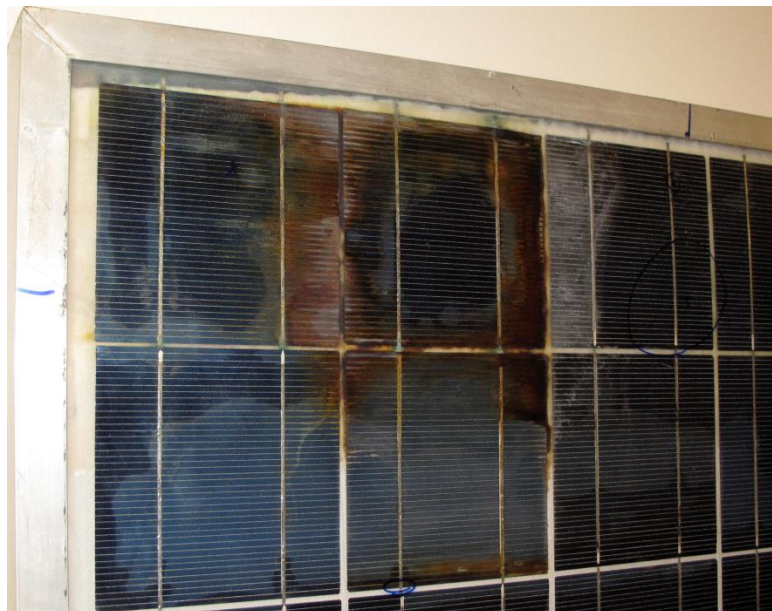
Fig. 4: Glass/glass module with specific ionomer encapsulant type that has proven to have insufficient adhesion, showing delamination and corrosion.

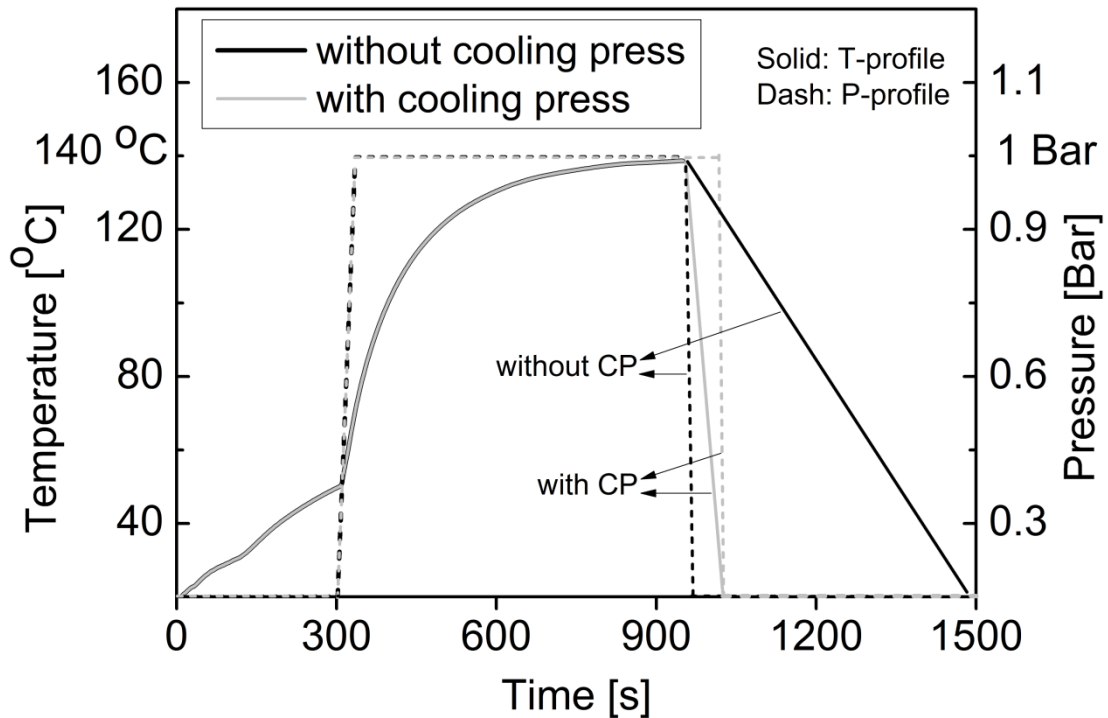
Fig. 6: Temperature and pressure profiles of the EVA encapsulation process of PV modules with cooling in air and accelerated cooling under pressure.

After the curing step, the lower chamber is vented to 1 bar. After that, the module is removed from the curing chamber and cools either uncontrollably in the air or in a controlled cooling press. The temperature - pressure - time (T-P-t) profile of both processes are shown in Fig. 6.

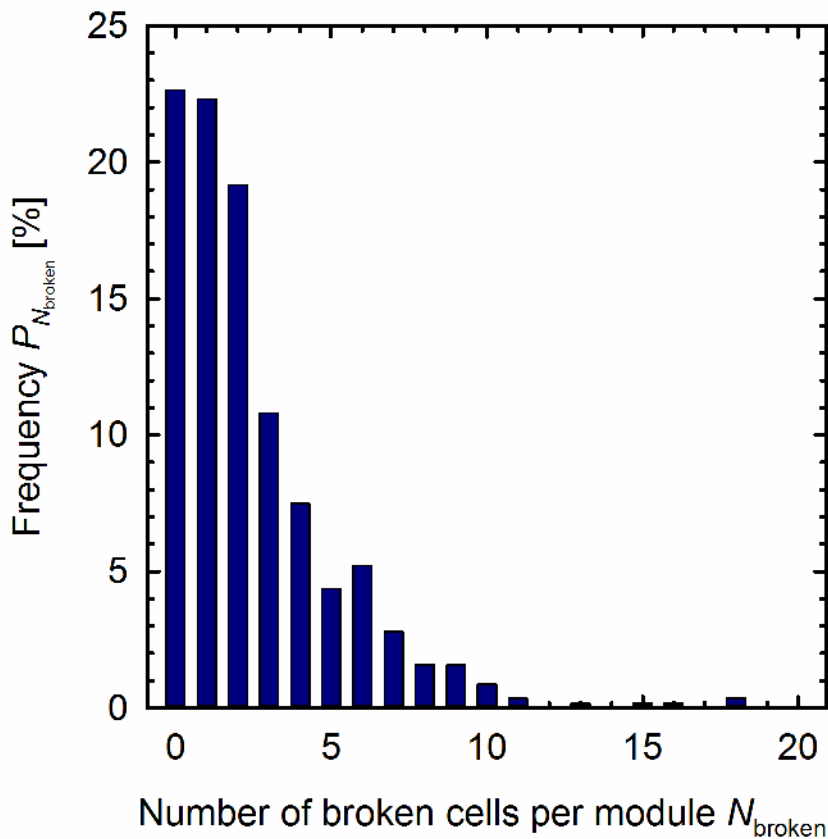
Fig. 10: Typical distribution of cell cracks per module in a PV-system.

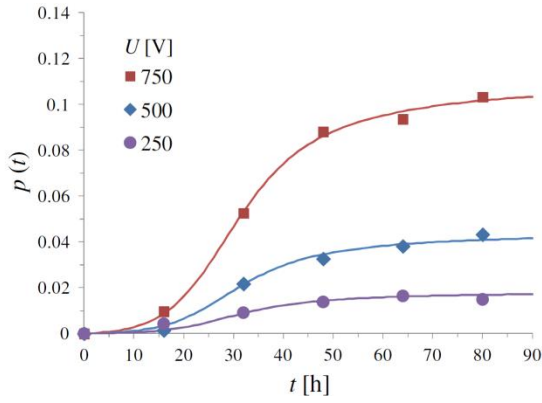
Fig. 13: Power degradation as function of the time with the system voltage as parameter. Reprinted from Hattendorf 2012 [133].

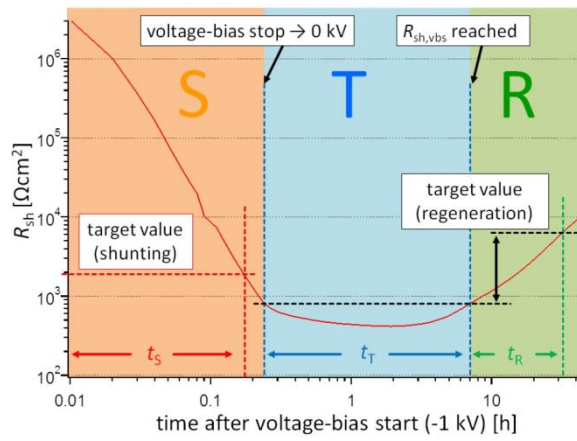
Fig. 17: Evolution of the shunt resistance with sequenced applied voltage. Reprinted from Taubitz 2014 [135].

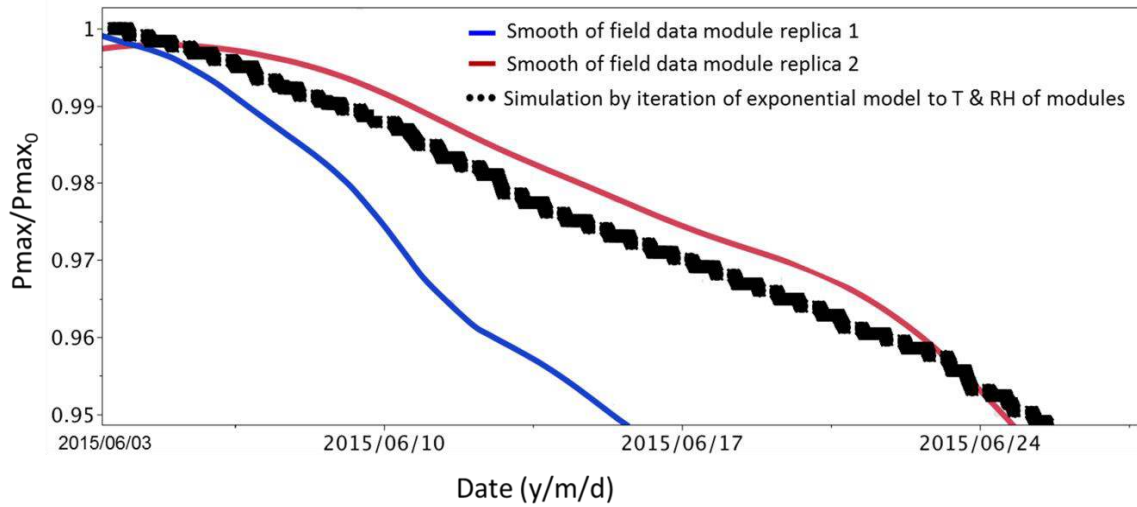
Fig. 20: Iteration of the chamber test-derived exponential model to 20-s interval data for CdTe module temperature T and surface humidity H in Florida and its correspondence to the measured module power P_{max} for two fielded replicas.

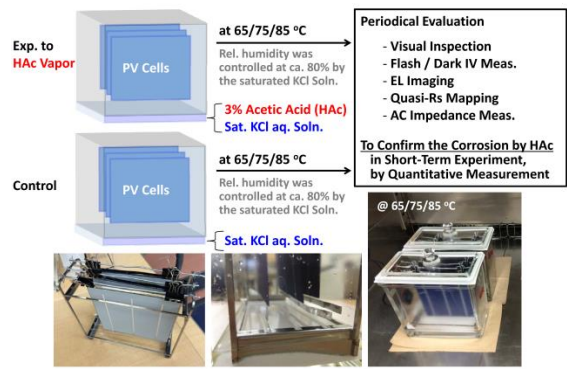
Fig. 23: Experimental setup for the exposure of bare PV cells to HAC vapour.

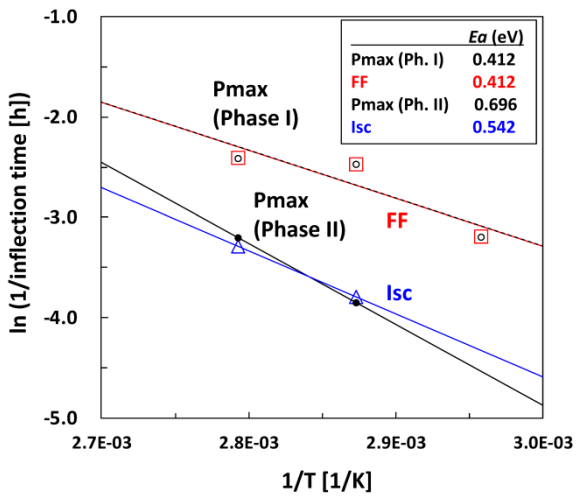
Fig. 25: Arrhenius plot and activation energies for I/V curve parameter during the degradation of PV cells exposed to HAc vapour.

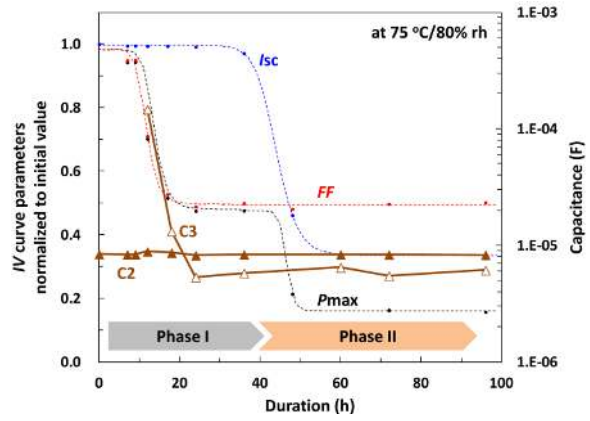
Fig. 26: Development of novel capacitor C3 during degradation of PV cells exposed to HAc vapour.

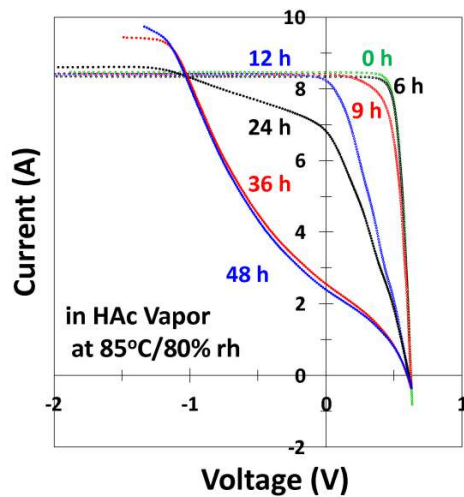
Fig. 29: Evolution of I-V-curve in PV cell exposed to HAc vapour at 85°C/80% rh. The cell starts to lose its diode blocking characteristic in reverse bias after 24 h.

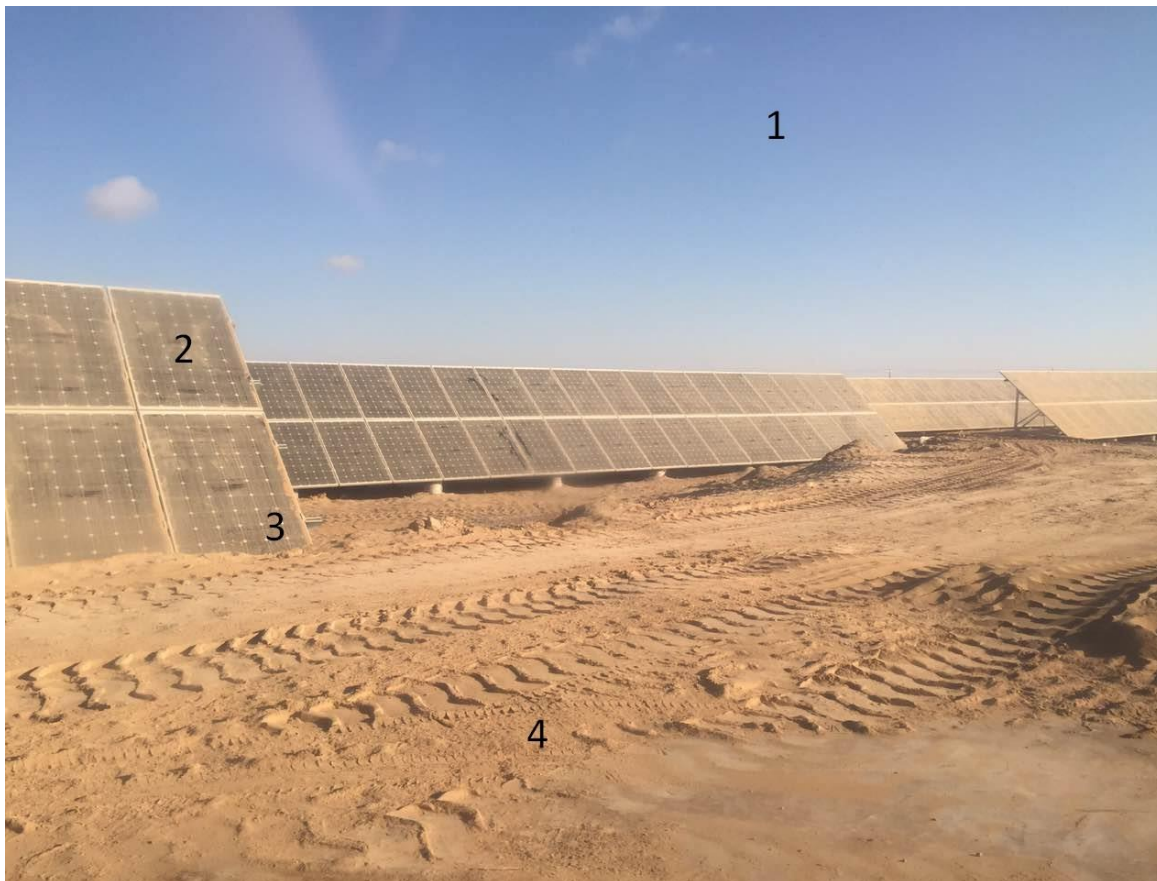
Fig. 32: Factors influencing dust soiling of PV modules in desert regions: 1 Climatic impact, ambient dust concentration, 2 Glazing characteristics, adhesion effects, non-uniform soiling, 3-Installation conditions, 4-Surrounding environment, dust particle characteristics. Photo: TÜV Rheinland Group

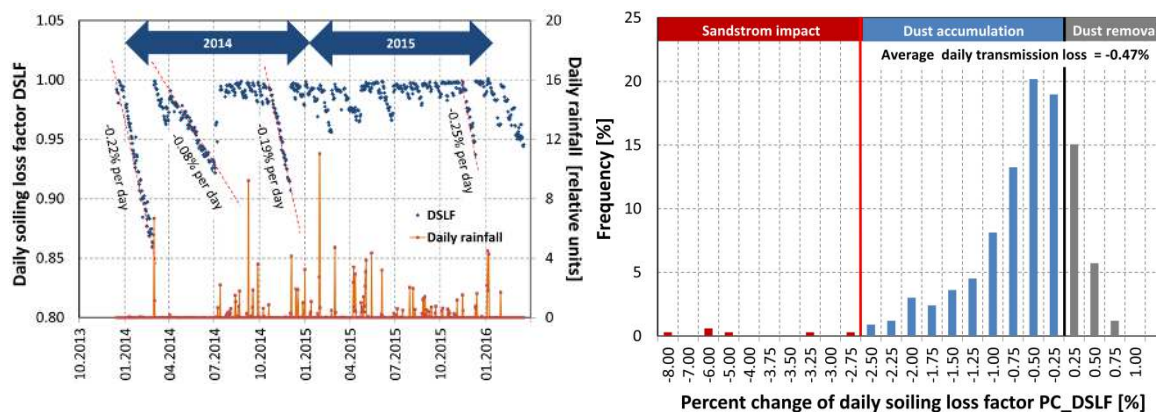
Fig. 33: Time evolution of Daily Soiling Loss Factor (DSLIF) at a location in Arizona desert.

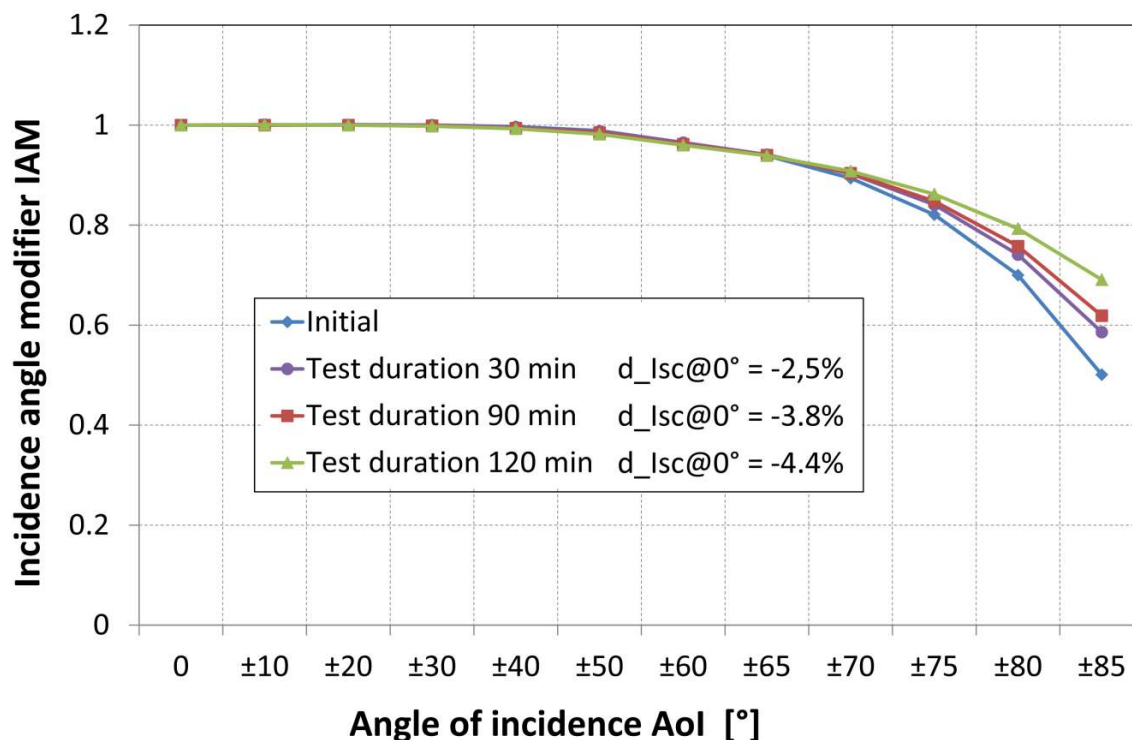
Fig. 36: Change of the angular characteristic of a PV module with AR coated glass caused by blowing sand test in accordance with MIL-STD-810G.

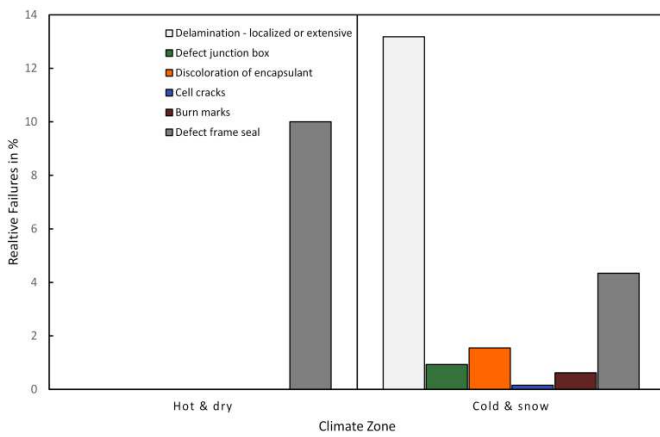
Fig. 61: Distribution of CdTe and CIGS module failures in the field classified in different climate zones according to Köppen-Geiger climate classification system [209].

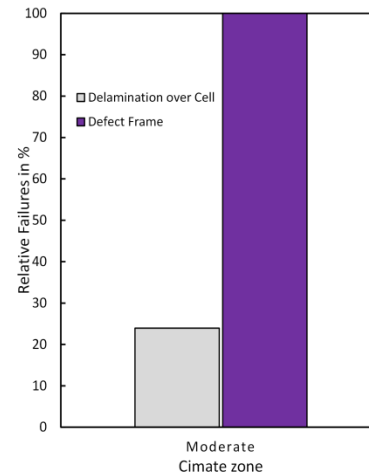
Fig. 62: Distribution of amorphous silicon module failures in the field classified in different climate zones according to Köppen-Geiger climate classification system [209]. The amorphous silicon modules were installed more than 30 years prior to inspection.

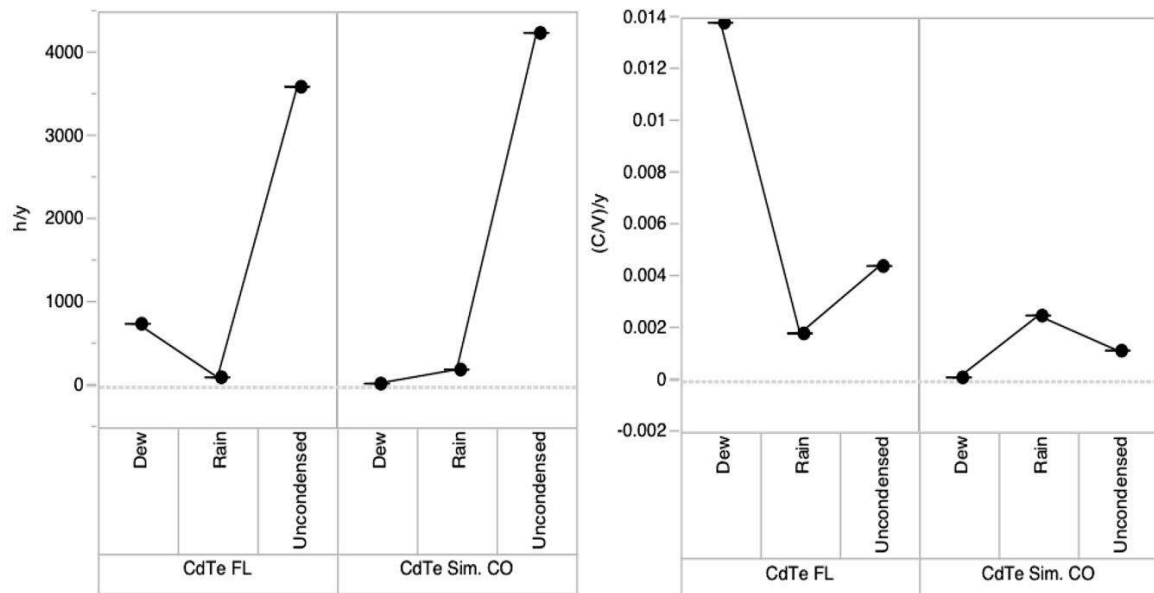
Fig. 70: (a) Time at each surface state, and (b), charge transferred for a CdTe module measured in Florida (FL) and simulated in Colorado (CO).
