PDHonline Course C682 (4 PDH)

Five-By-Five: The Making of the Pentagon

The Making of the Pentagon

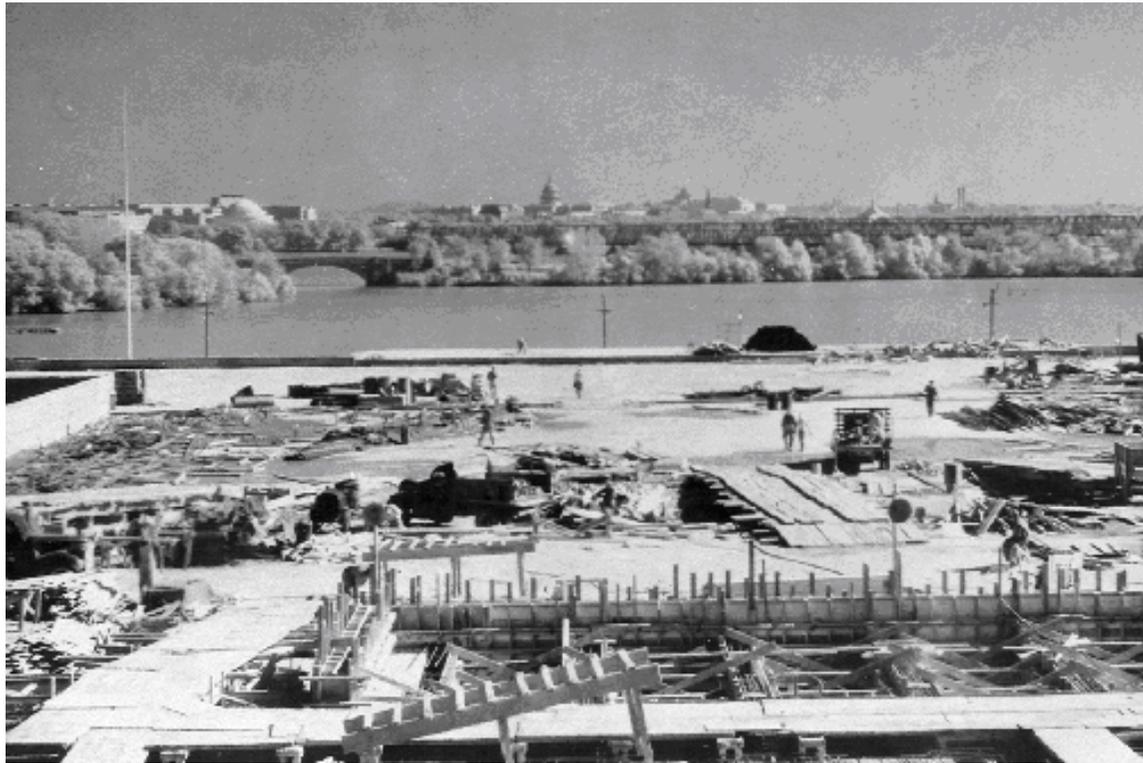
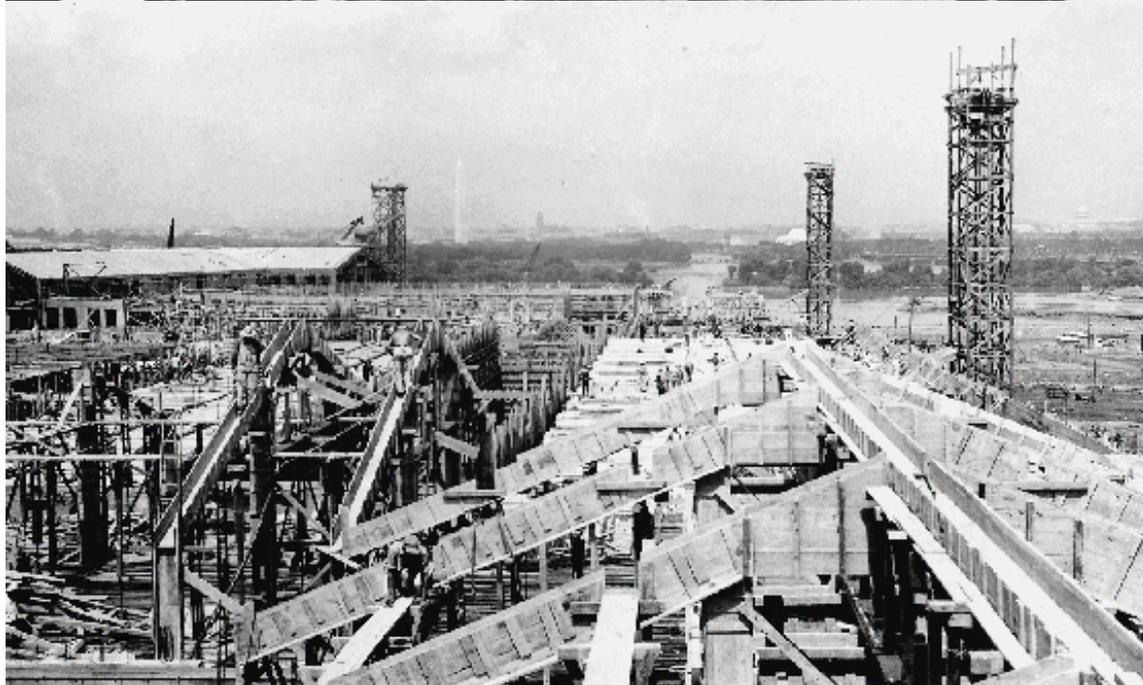
RE: the Pentagon’s designers minimized and/or avoided using critical war materials whenever and wherever possible (enough steel was saved to build a Battleship). They substituted concrete ramps for passenger elevators and used concrete drainpipes rather than metal. Also, they eliminated bronze doors, copper ornaments and metal toilet partitions, and avoided any unnecessary ornamentation. To build the foundation, 5.5 million cubic yards of earth and 41,492 concrete piles were needed. A total of 680K tons of sand and gravel was dredged from the *Potomac River* and processed into concrete for the colossal project. The soil conditions of the Pentagon site, located on the Potomac River floodplain, presented challenges to engineers, as did the varying elevations across the site, which ranged from 10 to 40-feet above sea-level. Two retaining walls were built to compensate for the elevation variations, and cast-in-place piles were used to deal with the poor soil conditions.

“...By choosing a framework of reinforced concrete, architects and engineers have saved thousands of tons of steel for war needs. They have built a permanent building, they point out, for little more than the cost of a temporary one...”

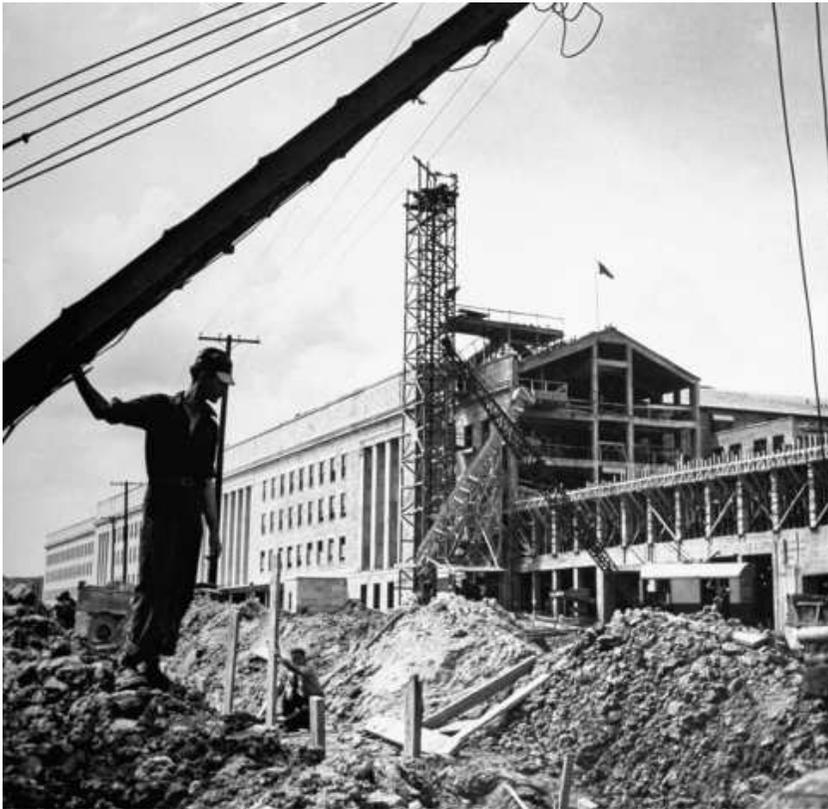
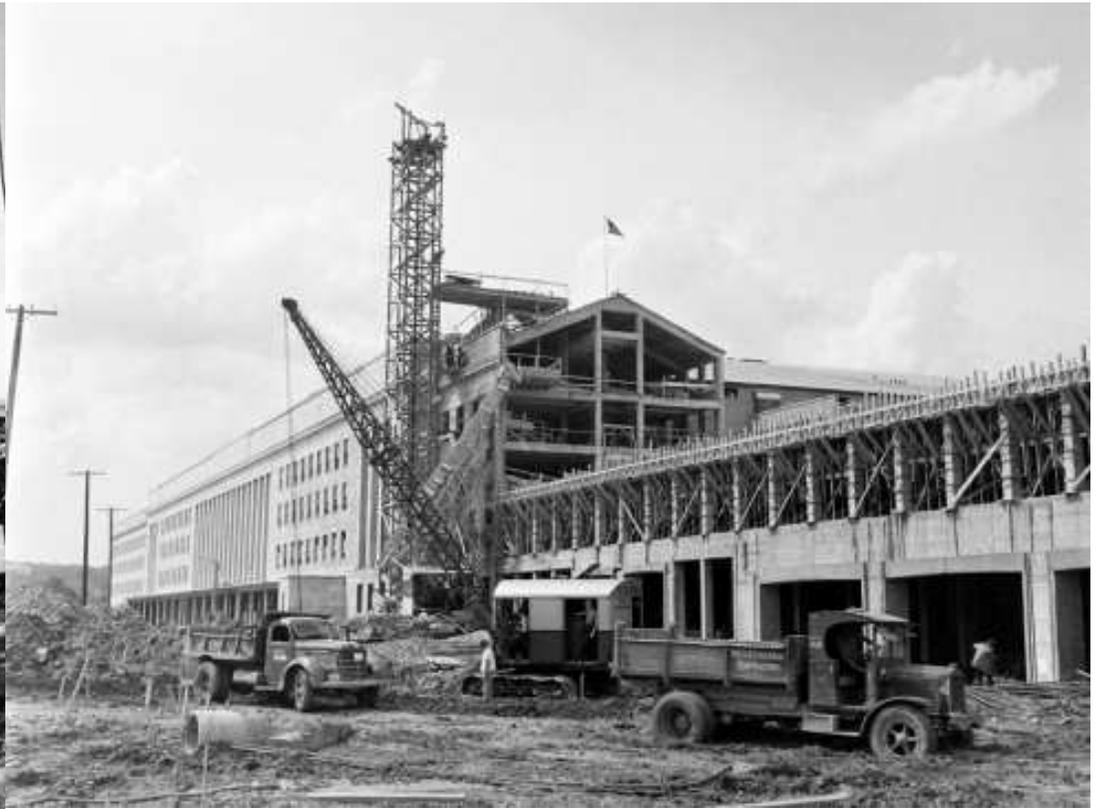
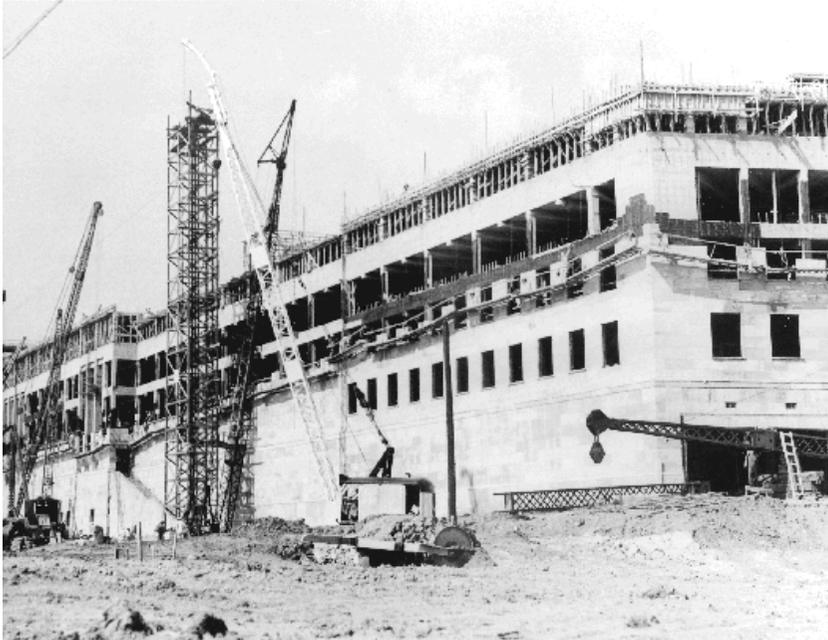
Left T&B: concrete foundation and formwork underway for the new War Dept. HQ

Top L&R: caption: “In a May 1943 issue, *LIFE* magazine noted that the exterior of the Pentagon ‘...has a gray limestone facade, although more than half of the building’s substance is sand and gravel dredged from the bottom of the Potomac River...’”

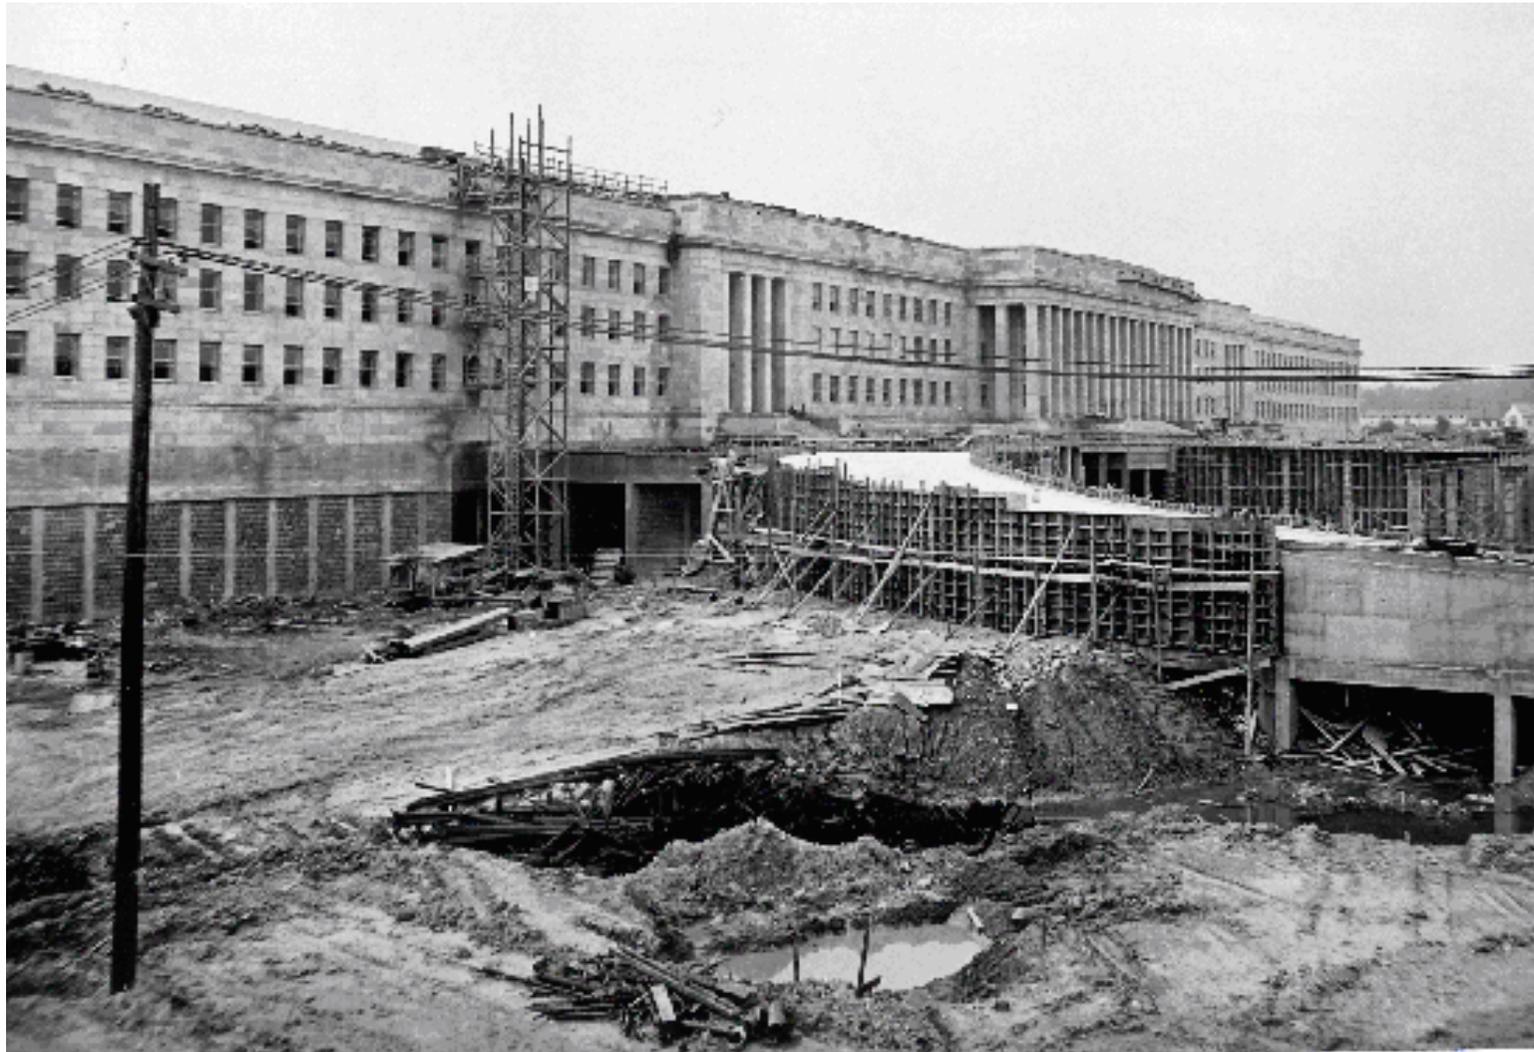
Left: caption: “The Pentagon’s facade under construction”

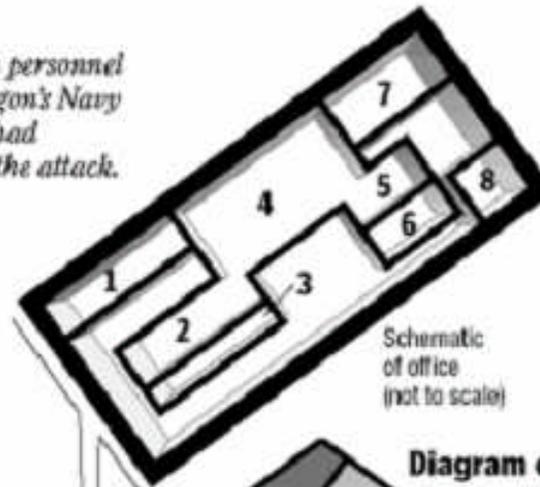
More than half of the active duty and civilian personnel the Navy lists as missing worked in the Pentagon's Navy Command Center. The first-floor Navy office had recently been renovated but was destroyed in the attack.

- 1 Meteorology
- 2 Watch Team (Duty Captain)
- 3 Support
- 4 Communications
- 5 Technical
- 6 Operations
- 7 Conference Room
- 8 Intel

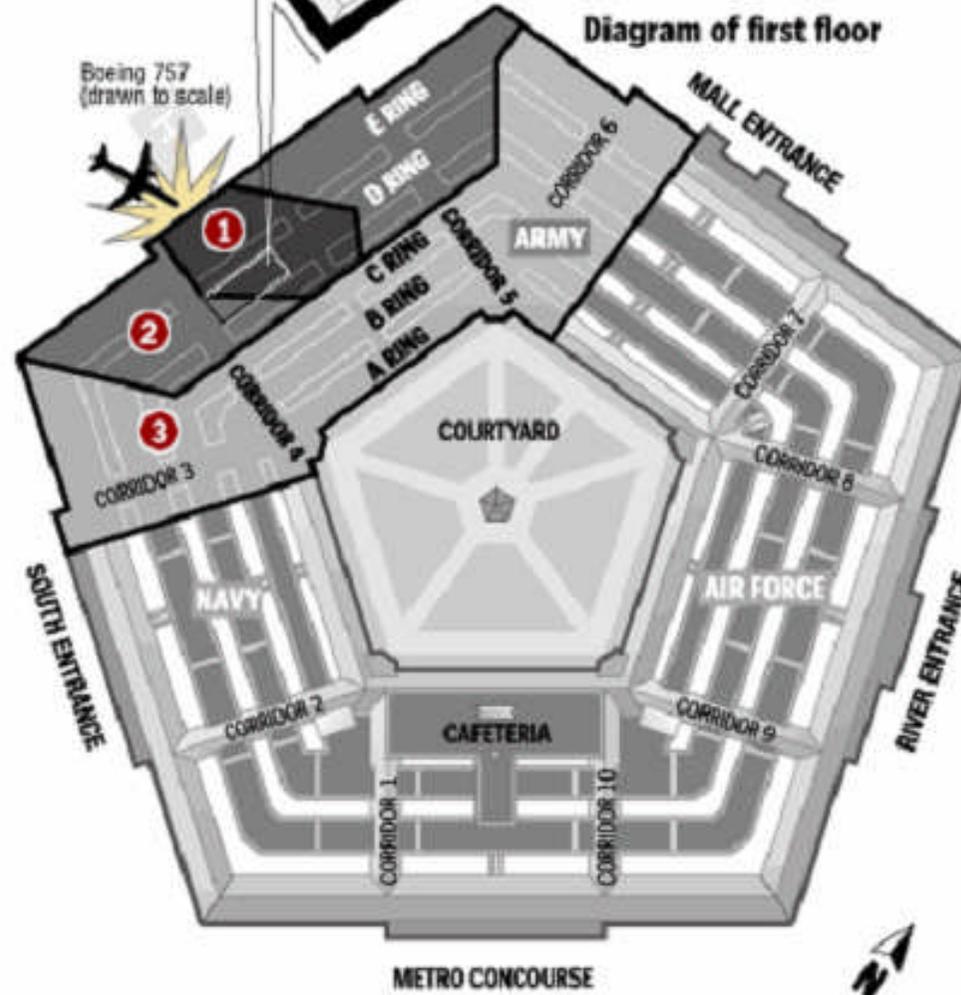
Degree of damage

- 1 Structural:** Catastrophic damage was done to support columns on the first and second floors.
- 2 Fire:** Fireballs—fed by the jet's fuel—exploded and spread laterally down the hallways of E and D rings. Under the slate roof, spot fires continued to burn as late as Thursday night.
- 3 Water:** Water damage extends through roughly a third of the Pentagon as a consequence of firefighting efforts.

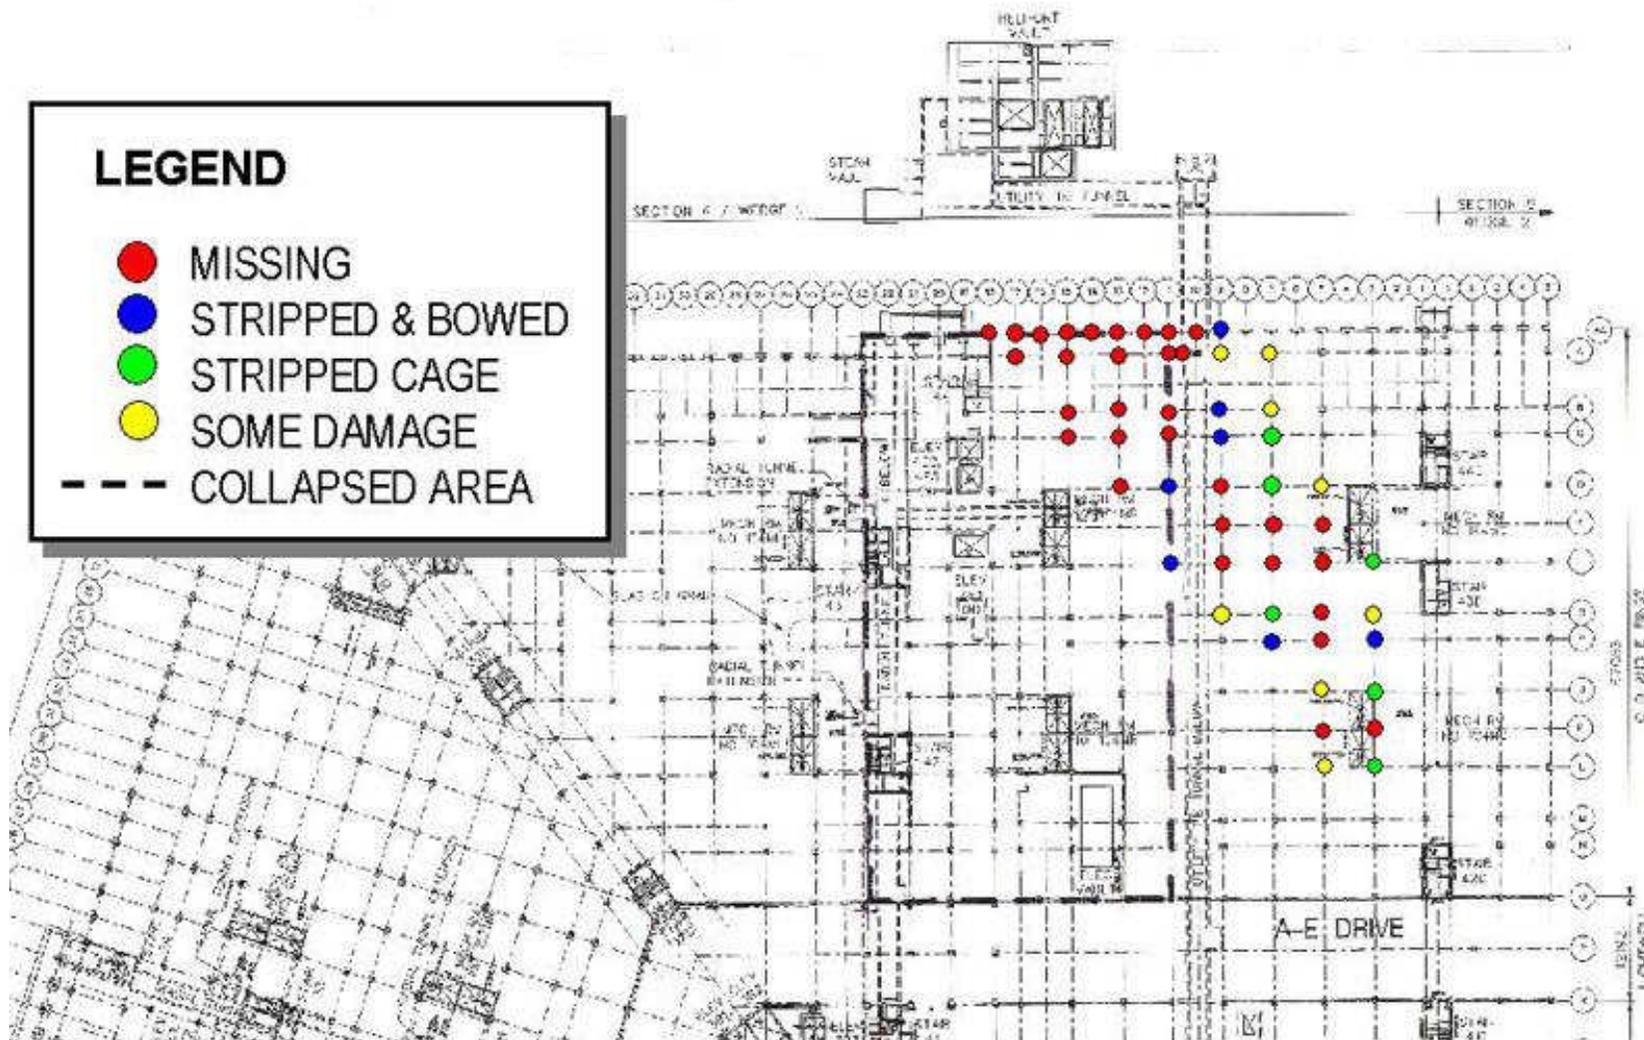
STRUCTURAL INTEGRITY

“...The primary structure of the Pentagon is 42,420 steel-reinforced concrete columns. Of these, only 32 were destroyed and 15 seriously damaged. As recovery efforts continue, the structure is being shored up with pressure-treated wood posts to protect against further collapses...”

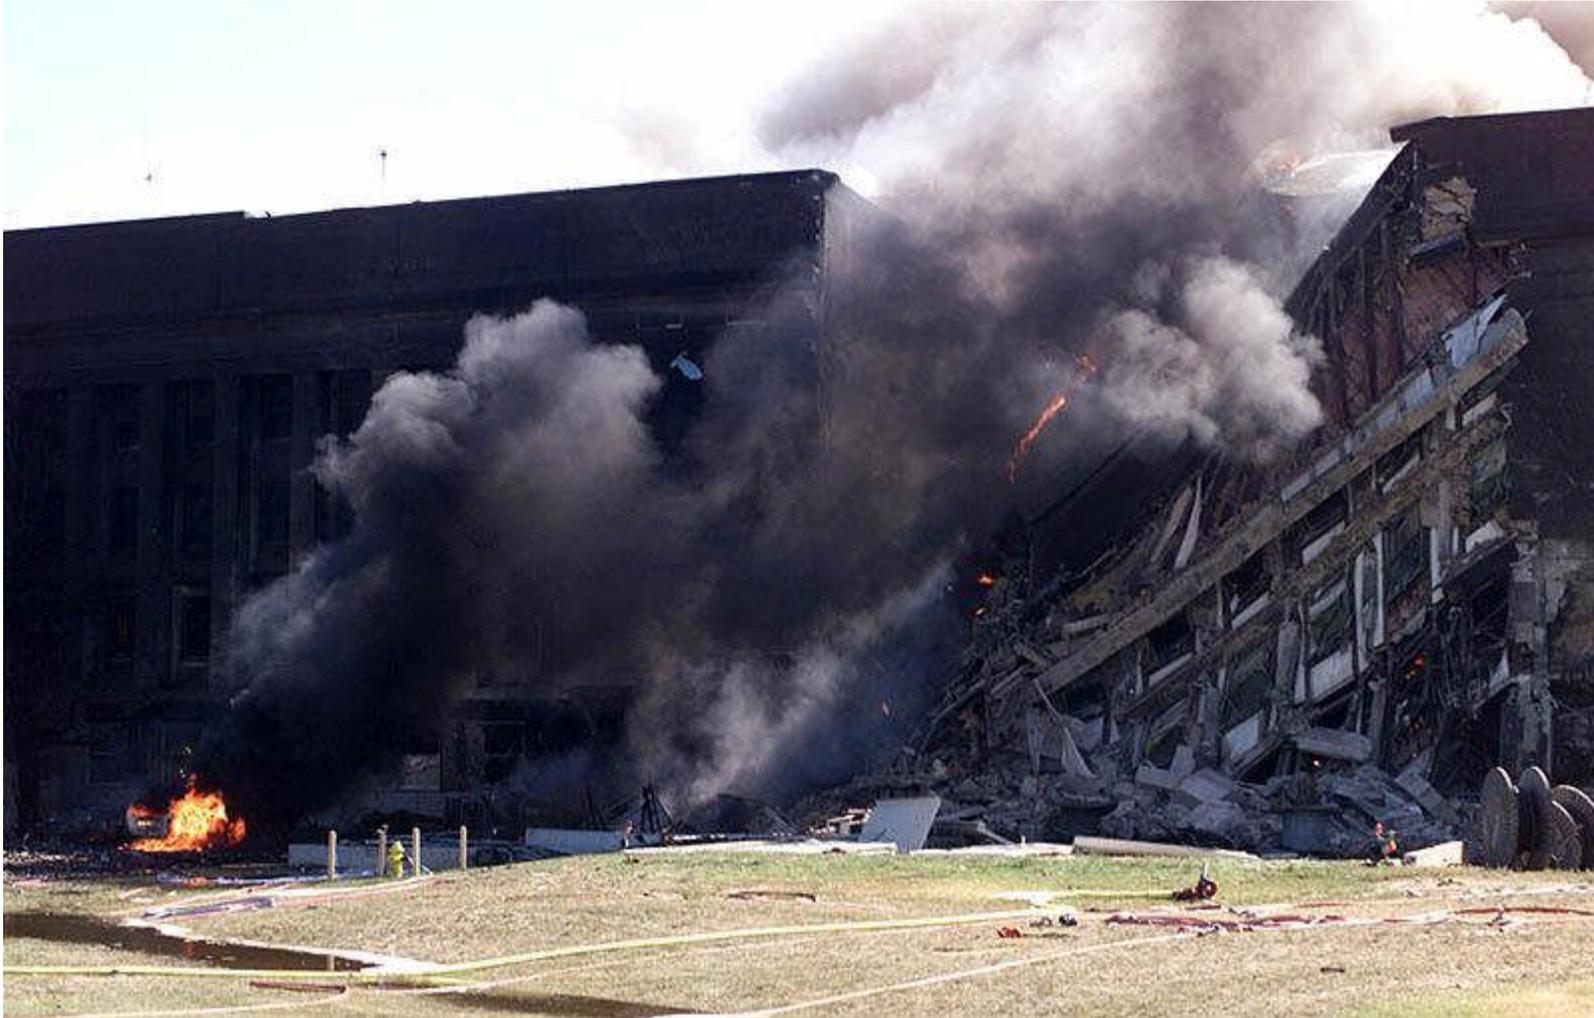
“Looking at some of the concrete that’s been fire-damaged, we can see how the cracking proceeds through the aggregate. This tells us a lot about the temperatures the concrete reached. We decided to say to heck with it and not do a surgical type of repair, which is what we thought we would do initially. We decided to take out a large section and demolish the whole thing.”

RE: APS concluded that the concrete in the stricken area was irreparably damaged. Instead of working with the Pentagon’s remaining columns and beams, they determined that it would be best to remove it all and start over. As such, an area 300 by 150-feet by five stories tall was demolished.

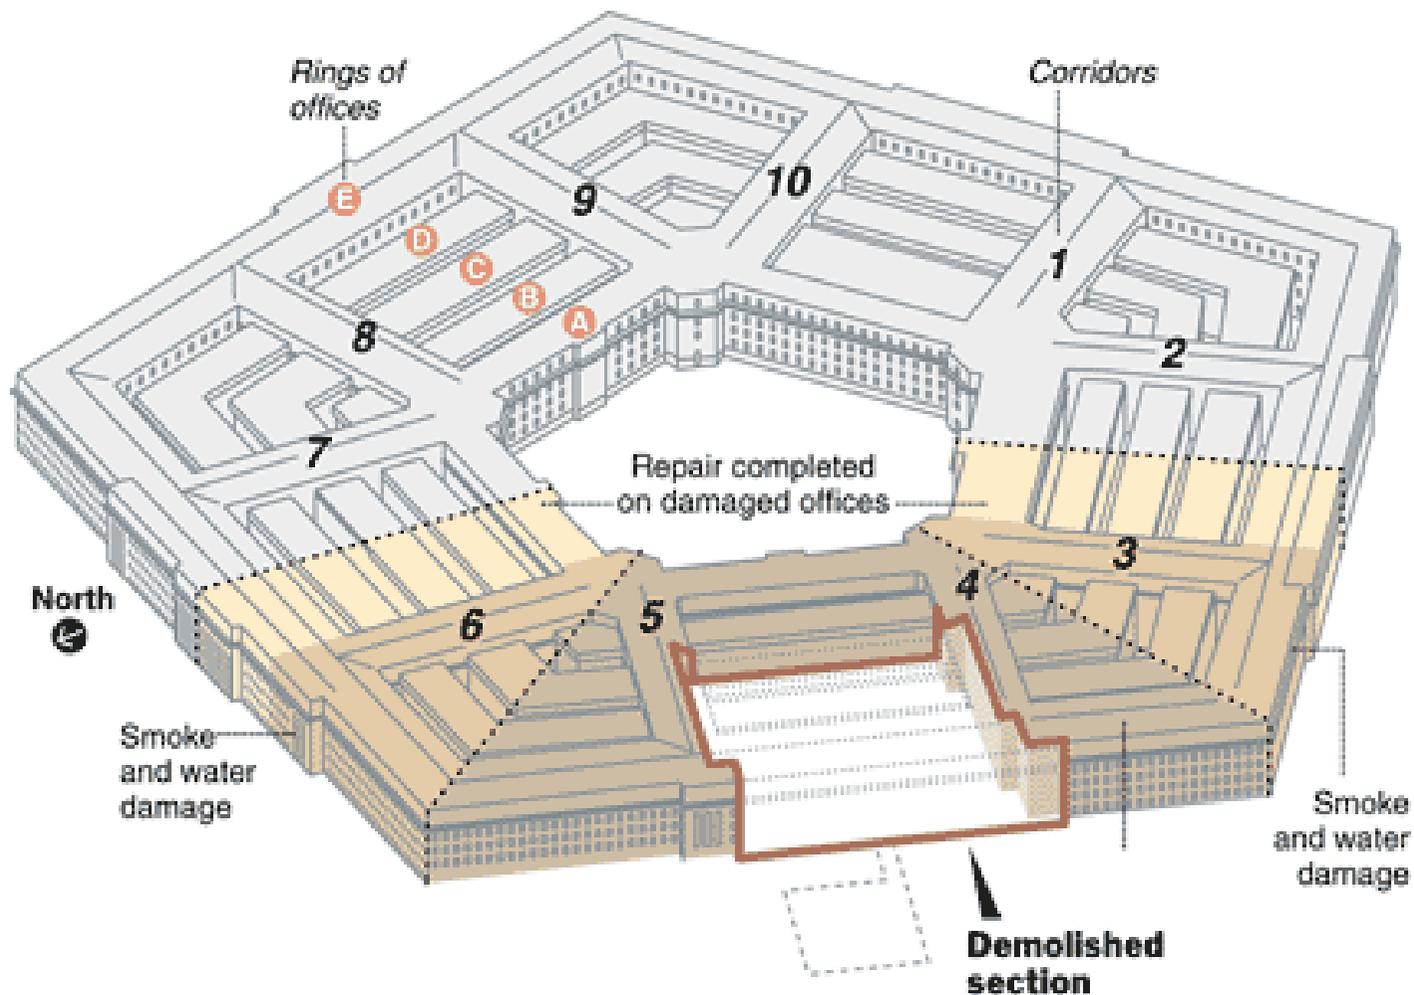
Above: caption: “Exterior: The rebuilt facade will be made from the same Indiana limestone as the original stone facing. Underneath the facade, however, reinforced concrete will replace the original brick walls. Office Space: Some of the offices damaged by smoke and water have been reoccupied, but much of the interior walls, furniture, electrical wiring⁵⁹ and phone lines had to be replaced.”

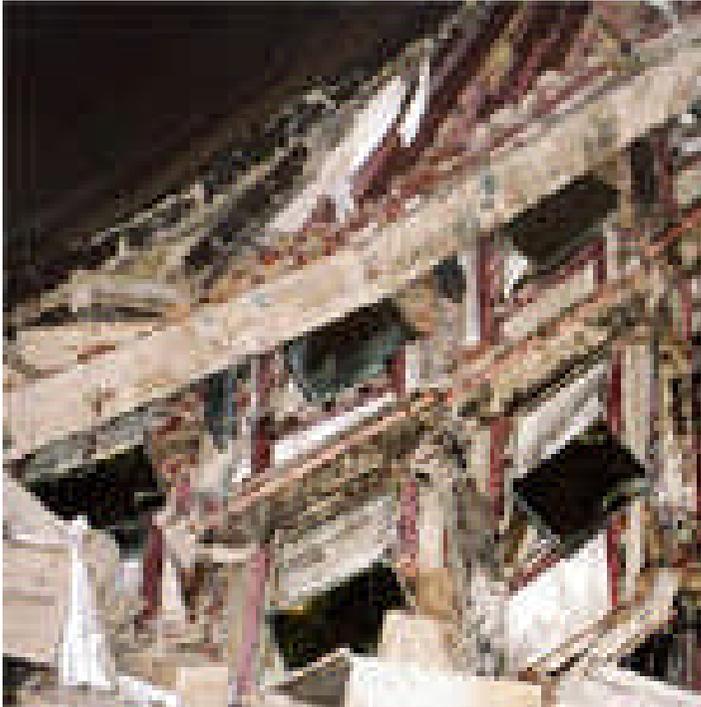
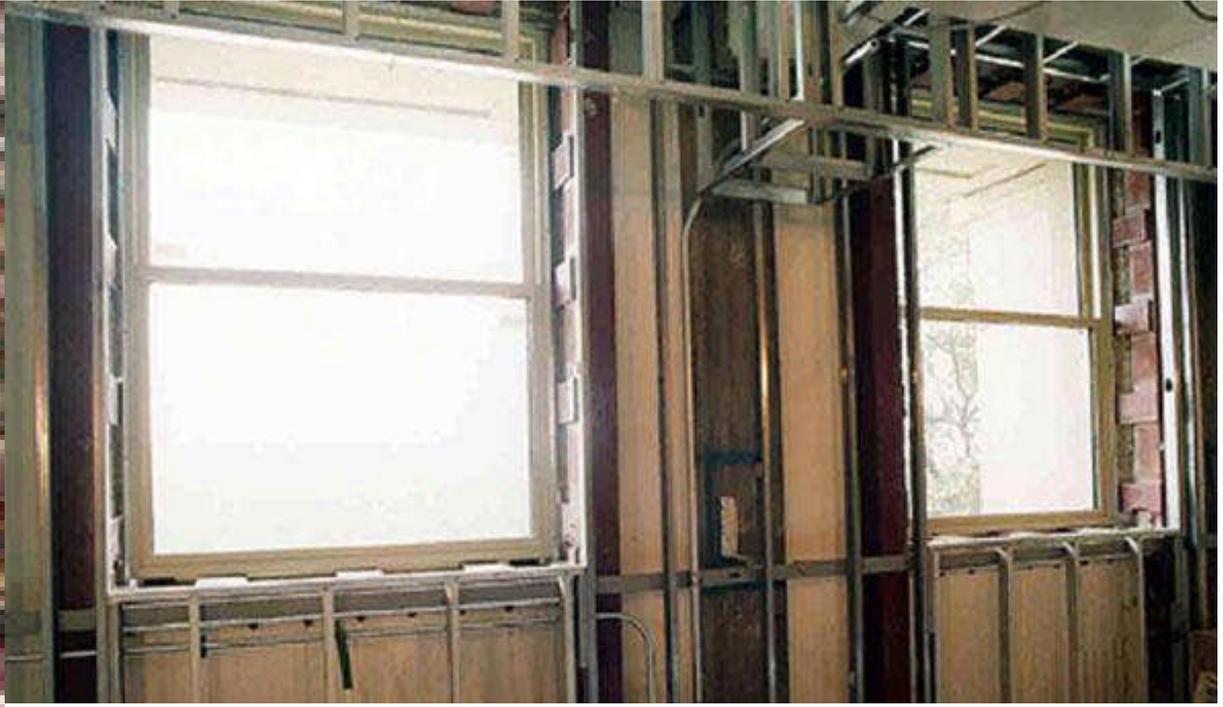
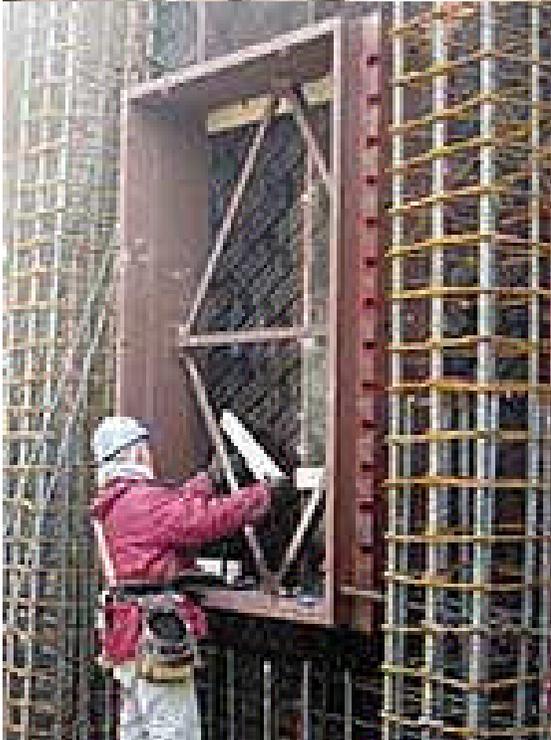
Top Left: caption: “When the Pentagon collapsed, the structure was held together by the ‘web’ of steel columns and beams, show in maroon, which are bolted together at the floors.”

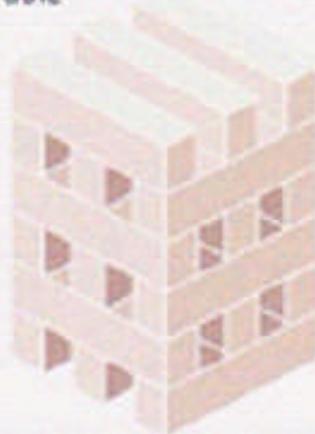
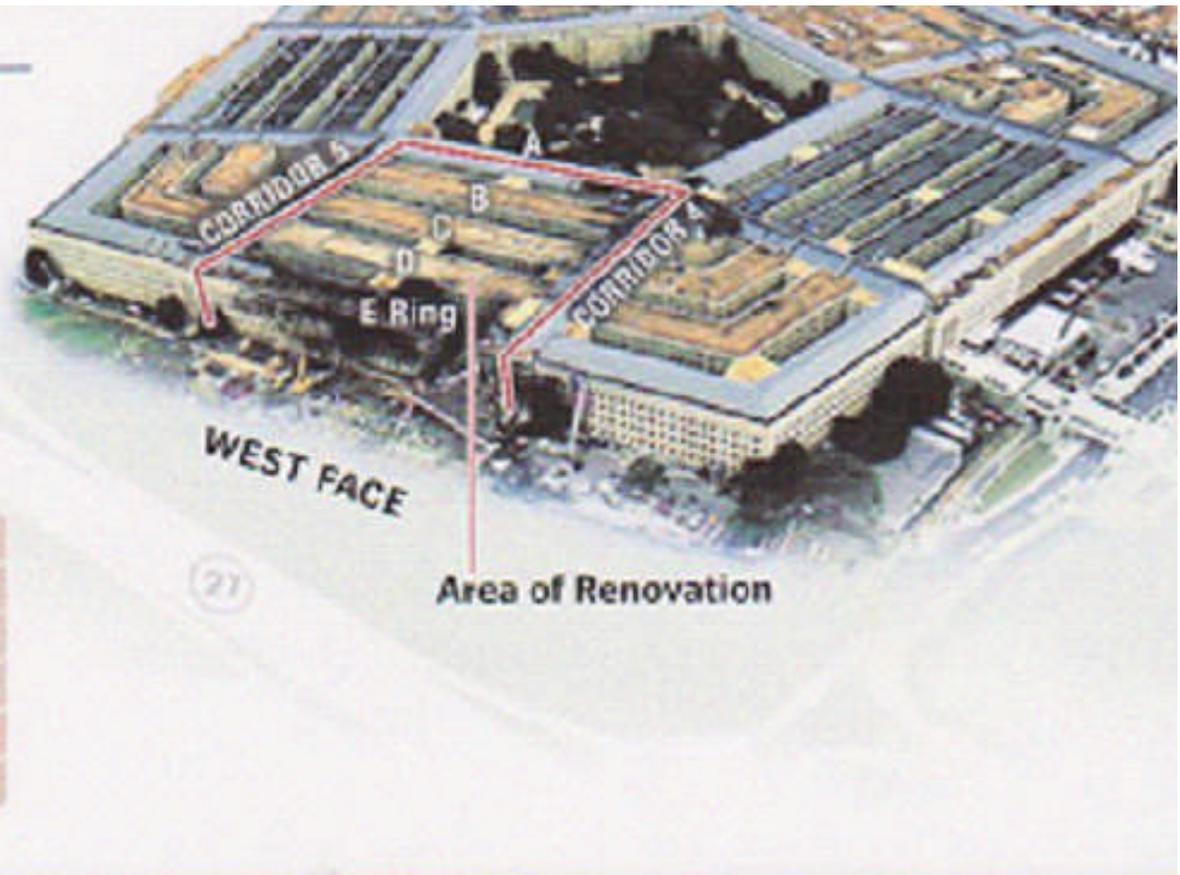
STABILIZATION *Immediate Aftermath*

The plane and subsequent blast traveled at a 45-degree angle into the west face of the building. The outer three rings—E, D and C—between Corridors 4 and 5 were heavily damaged.

Massive fireballs—fed by fuel from the plane—destroyed many of the concrete support columns. Workers constructed makeshift columns from timber before they were able to fully assess the damage. About 10,000 tons of debris were removed in the first few weeks.

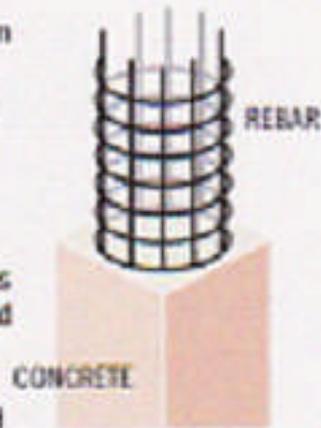
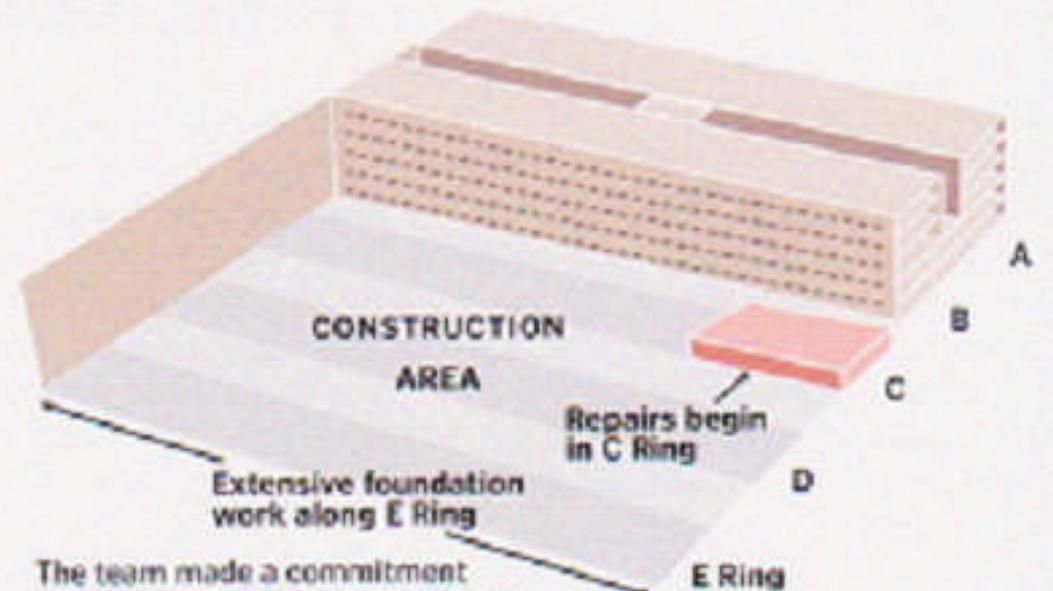
Following the original design of the building and maximizing the strength of the columns, each new column began with a steel cage of spiral rebar. The rebar was joined to 1.25-inch, high-strength stainless steel dowel rods and planted into the foundation. Formwork was secured around the rebar cages, and
