**PDHonline Course C682 (4 PDH)**

## ***Five-By-Five: The Making of the Pentagon***

*Instructor: J.M. Syken*

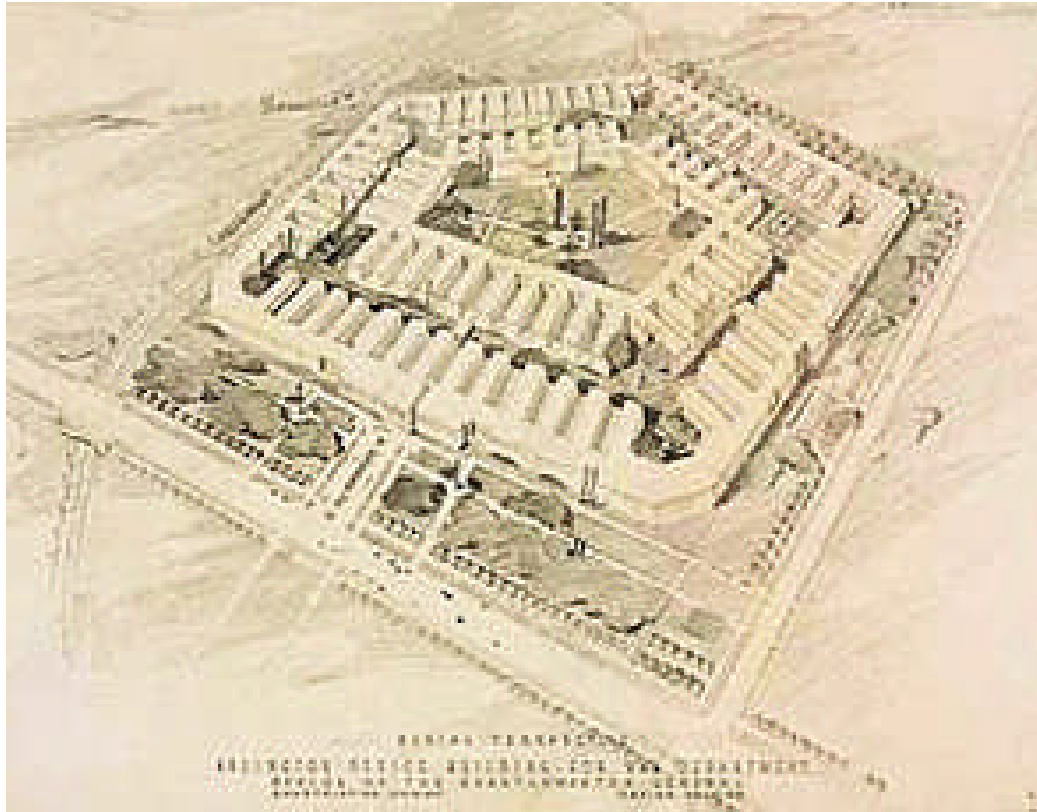
**It Fits**

***“...There were many problems with the irregular design. The pattern was awkward, and the routes between wings of the two buildings were circuitous. Lacking symmetry, with rows of wings sticking out, the building was frankly quite ugly. Yet, given the site, the pentagonal design had one overriding virtue, Stathes remembered more than 60 years later: ‘It fit.’...”***

***“...Finally, guided by the odd shape of the plot, they designed an irregular pentagon. A sketch by Socrates Thomas Stathes, a young War Department draftsman, showed a square with a corner cut off, more or less matching the tract’s shape. It was really two buildings, a five-sided ring surrounding a smaller one of the same shape...”***

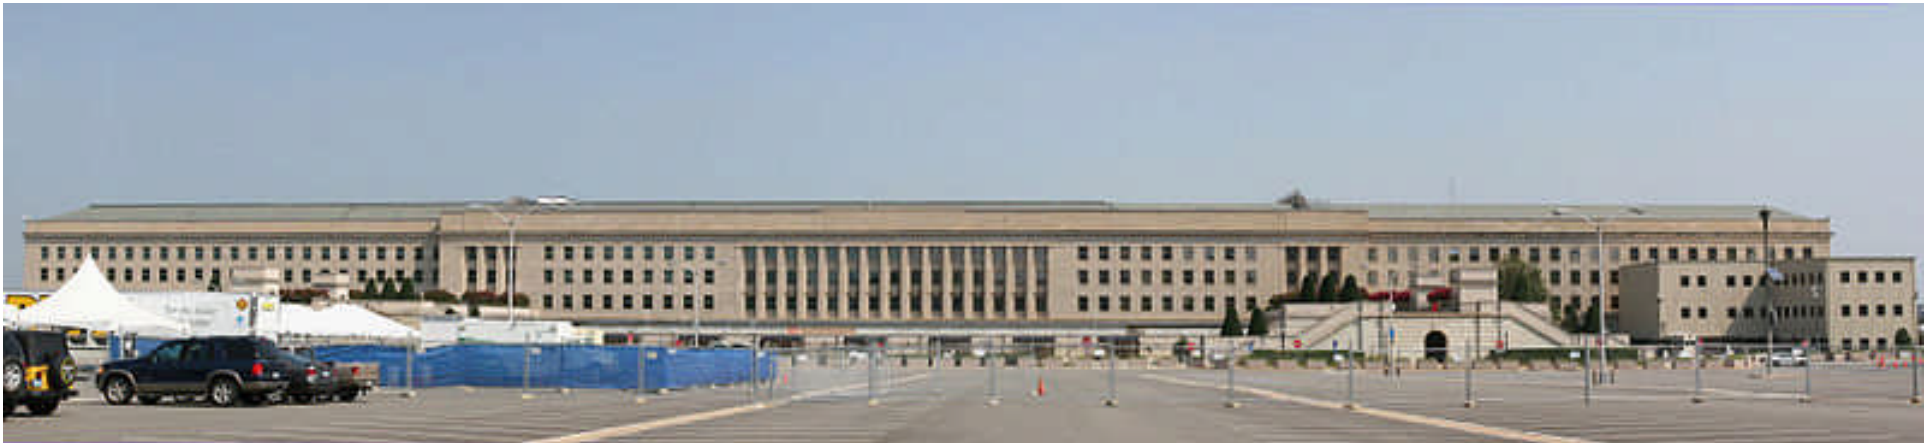
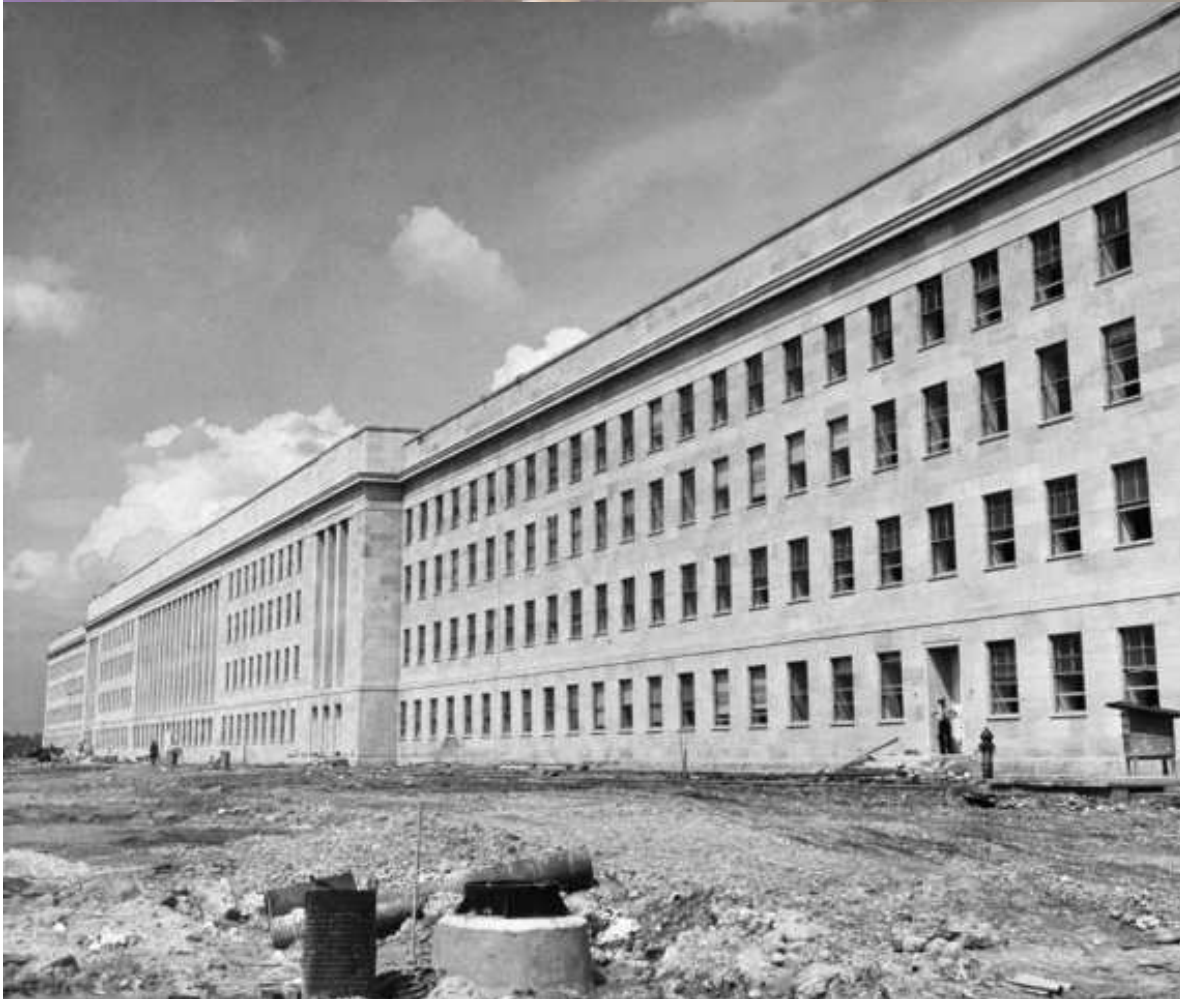
***“...The Pentagon shape was dictated by economical and functional reasons. If the building had been made circular, construction would have been more costly. The Pentagon shape permitted rectangular construction of the sections...The architects ruled out plans for one long building because offices in the far ends would have been nearly a mile apart. As it is, no two offices are more than half a mile apart on the same floor...”***

***Above: the Pentagon from the south parking lot***

***Left: view showing one of the five sides of the Pentagon during construction***

***“...Planning this architect’s dream called for the aid of geometry. In theory a perfect circle would be ideal for access to all offices. More practical structurally, a ring of straight sections would approach a circle closely enough...”***

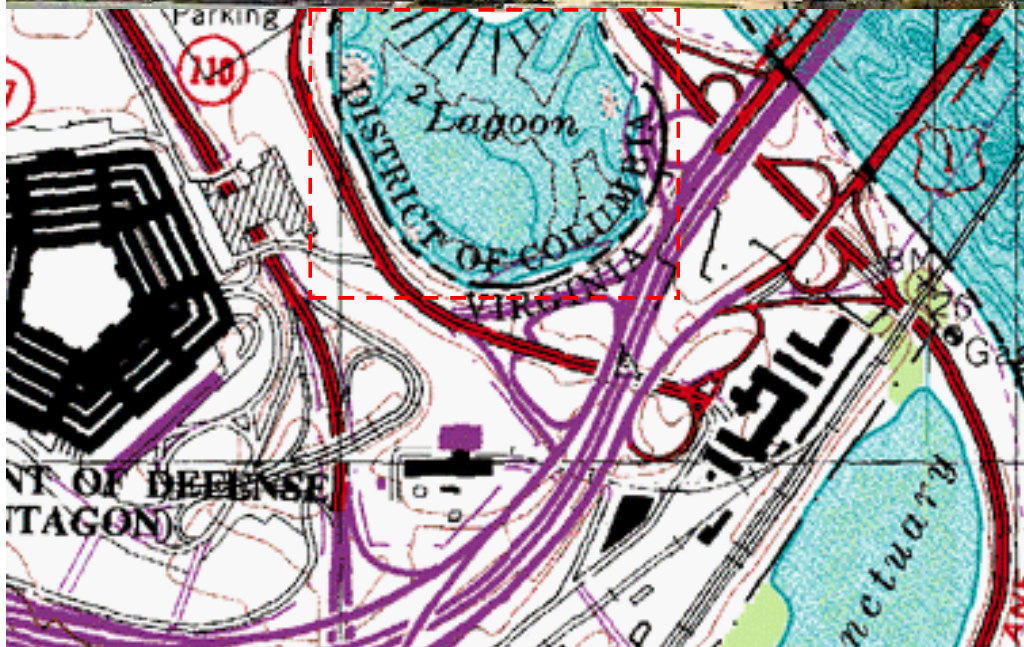
The *Pentagon Lagoon* was created during construction of the building as a result of dredging sand and gravel for concrete and to obtain fill for landscaping. The lagoon is also the location of the water intake for the Pentagon's Heating & Refrigeration Plant. The *Roaches Run Waterfowl Sanctuary* lagoon, created during construction of the *George Washington Parkway* in the early 1930s, is used for the Heating & Refrigeration Plant's water discharge outfall.

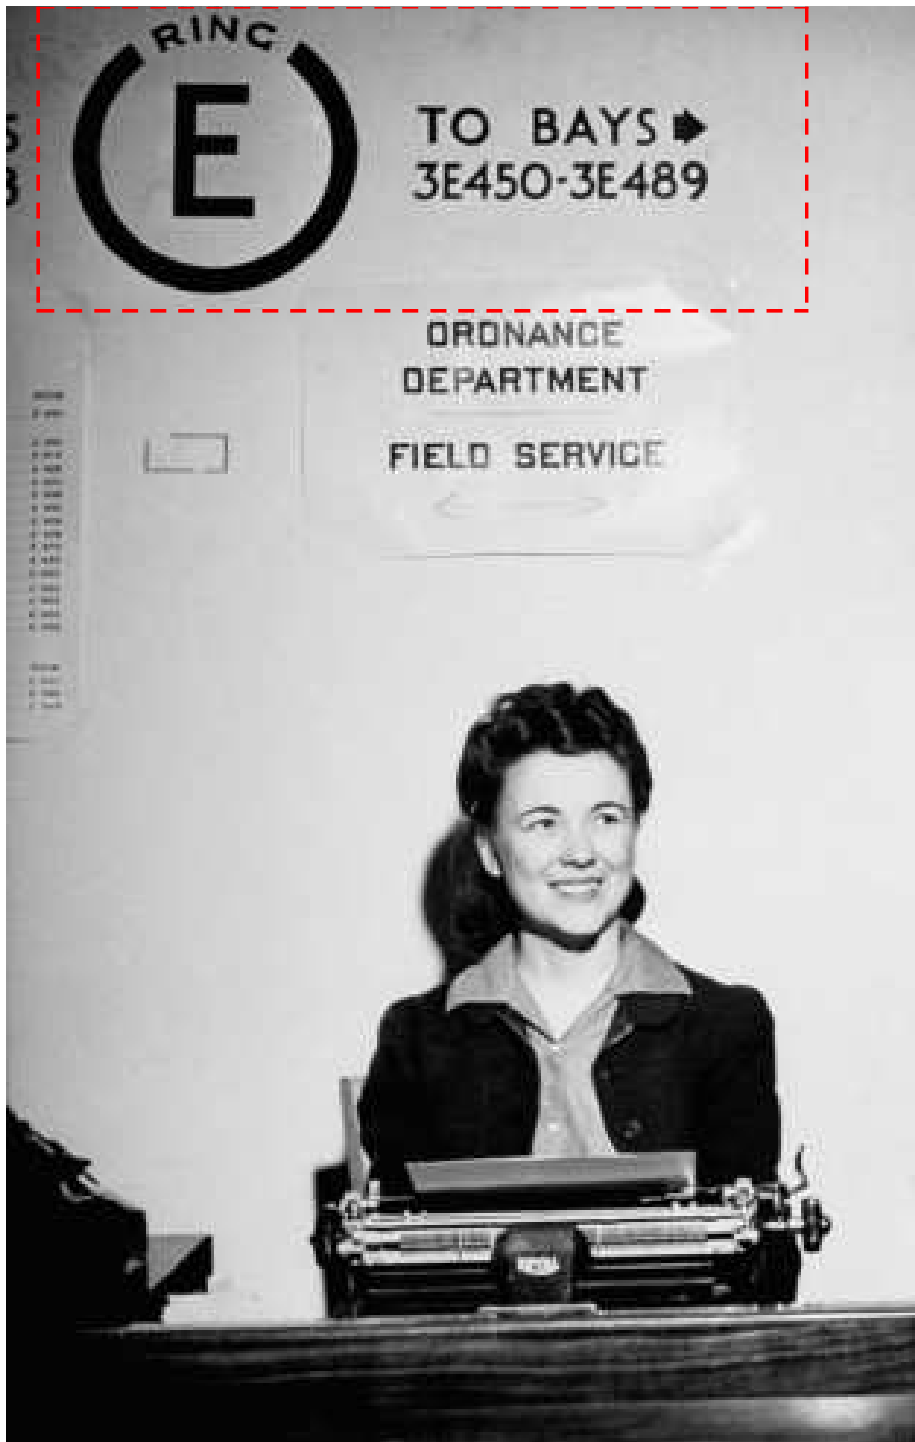
### **HOW TO FIND A ROOM IN THE PENTAGON:**

Each floor's layout has five pentagonal concentric rings which are connected by ten spoke-like corridors.

#### **EXAMPLE: to locate room 3D126:**

1. Go to the third floor, A ring
2. Proceed along the A Ring to the 1st corridor
3. Go down the 1st corridor to the D ring
4. Turn left and proceed to room or bay number 26

***“...The numbering system of the offices affords an understanding of the floor plans. To begin with, you must get a general picture of the Pentagon as a five-sided, five-story structure enclosing five concentric ‘rings’ of connected buildings. Ten ‘radial’ corridors, like spokes of a wheel, lead to the outside walls from the center court. Five ‘ring’ corridors spread out from the center, increasing in length toward the perimeter. The inner, or main ring, is numbered A and the others B, C, D and E, respectively. Branching from the rings are ‘bays.’ The number of an office must reveal floor, corridor, ring and bay. Thus, office 2E257 means second floor, E ring, second corridor and bay 57...”***

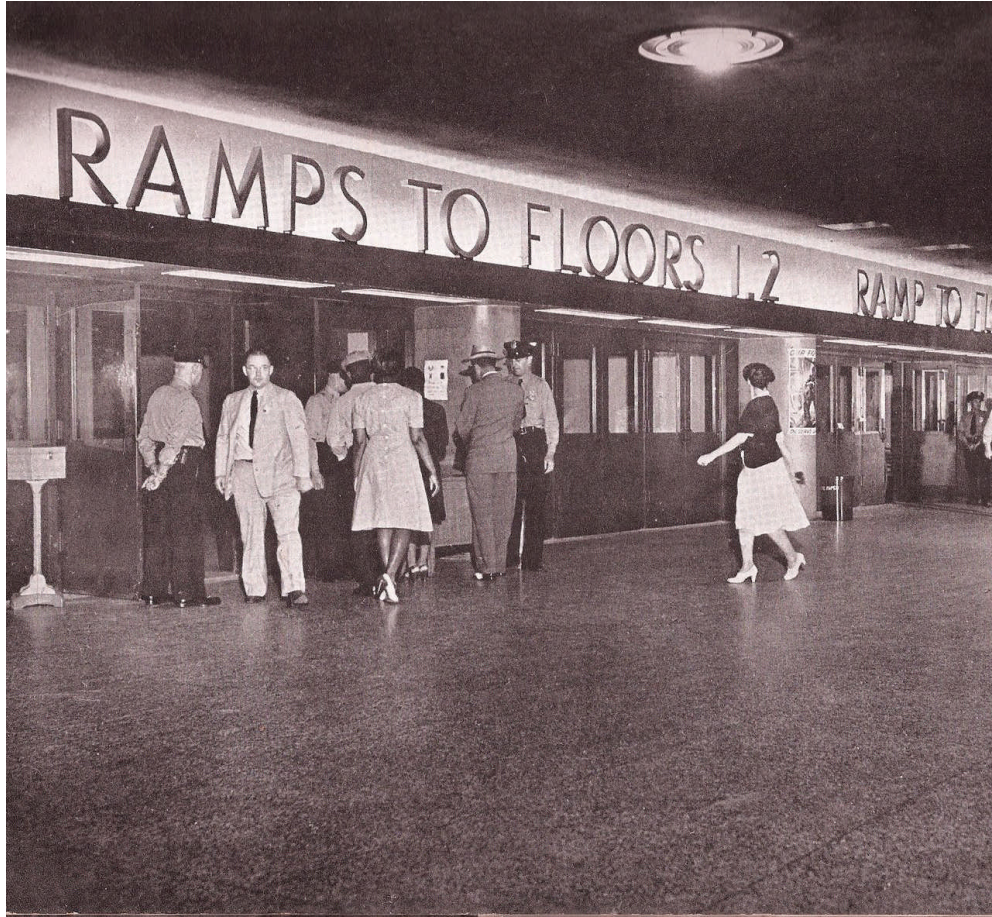
***“...Walls of the five floors are painted different colors so that one may ascertain location with ease. The ground floor is brown (the earth), the second floor green (grass), the third, fourth and fifth are officially and respectively, red, white and blue. The designers, however, softened the white to gray to soften the glare. Doors in the concourse which open on ramps leading to various floors are painted in five colors. The green doors open on a ramp leading to the second floor; the red doors guide workers to the third floor ramp...”***

***Left: caption: “Ramps lead from the Concourse to various floors. Guards posted at the doorways to the ramps check military passes and civilian's badges. Brief cases, packages, and papers are thoroughly inspected.”***

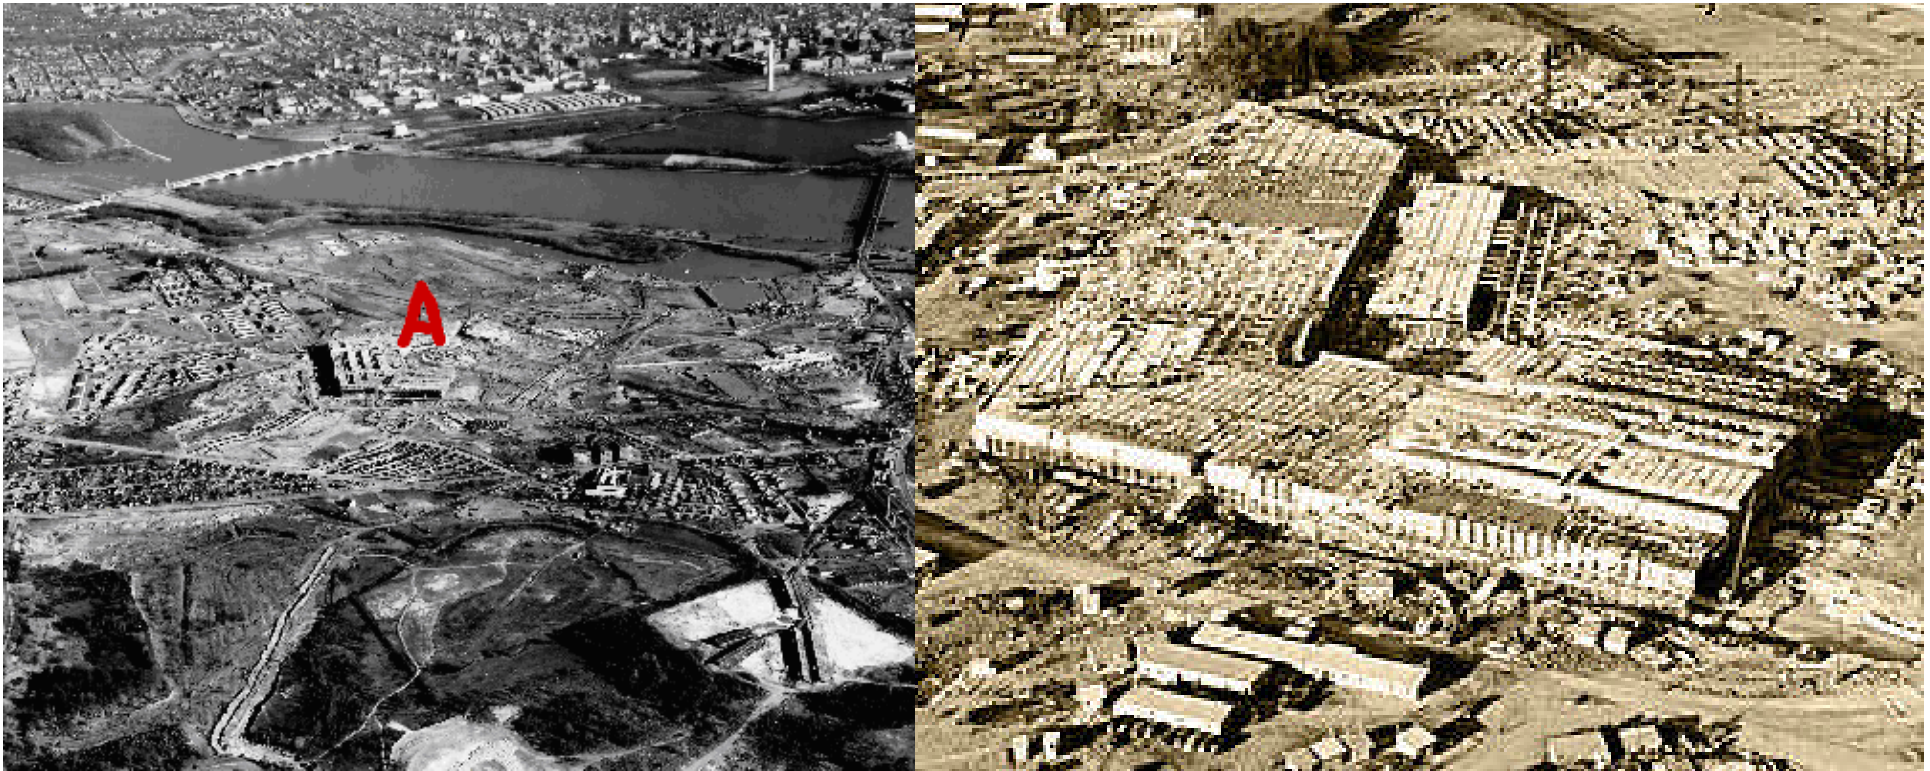
**Left: caption: “First floor forms in place (‘A’)”**

**Right: caption: “Aerial view of the first two Pentagon ‘spokes’ under construction”**

***“...the five sections were built clock-wise in a record-breaking 14 months under the general supervision of Lt. Col. Clarence Renshaw, Corps of Engineers, and J. Paul Hauck, project manager...”***

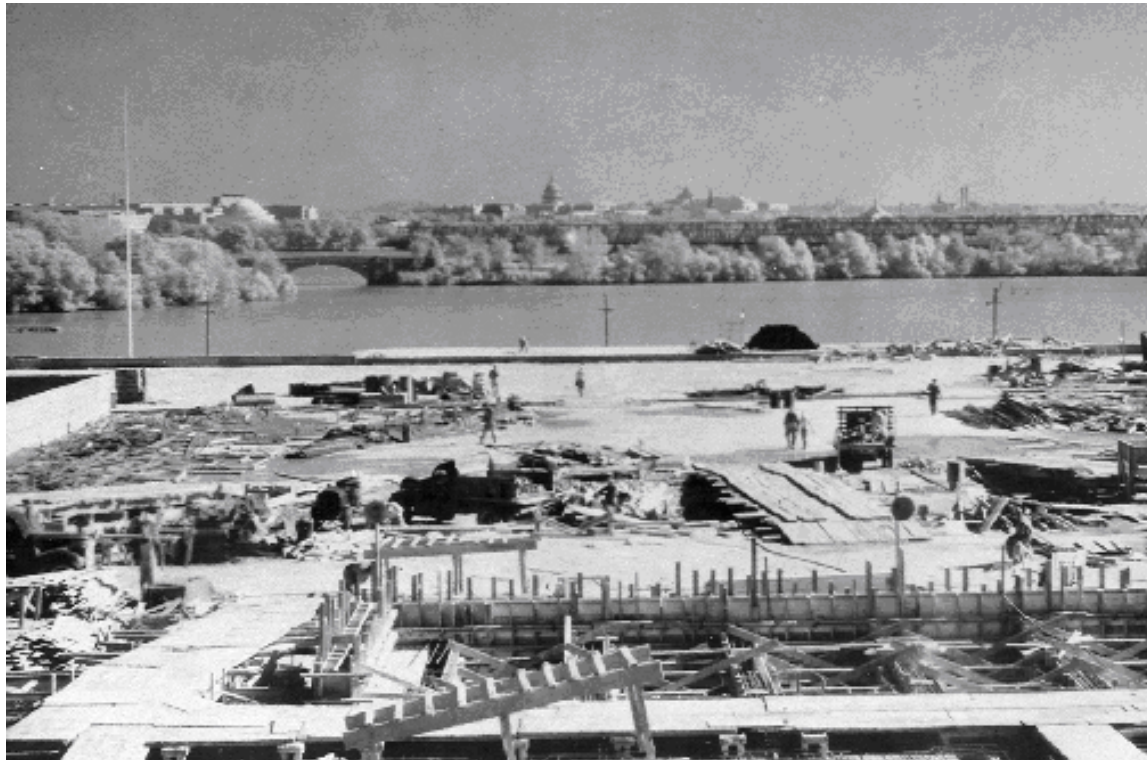
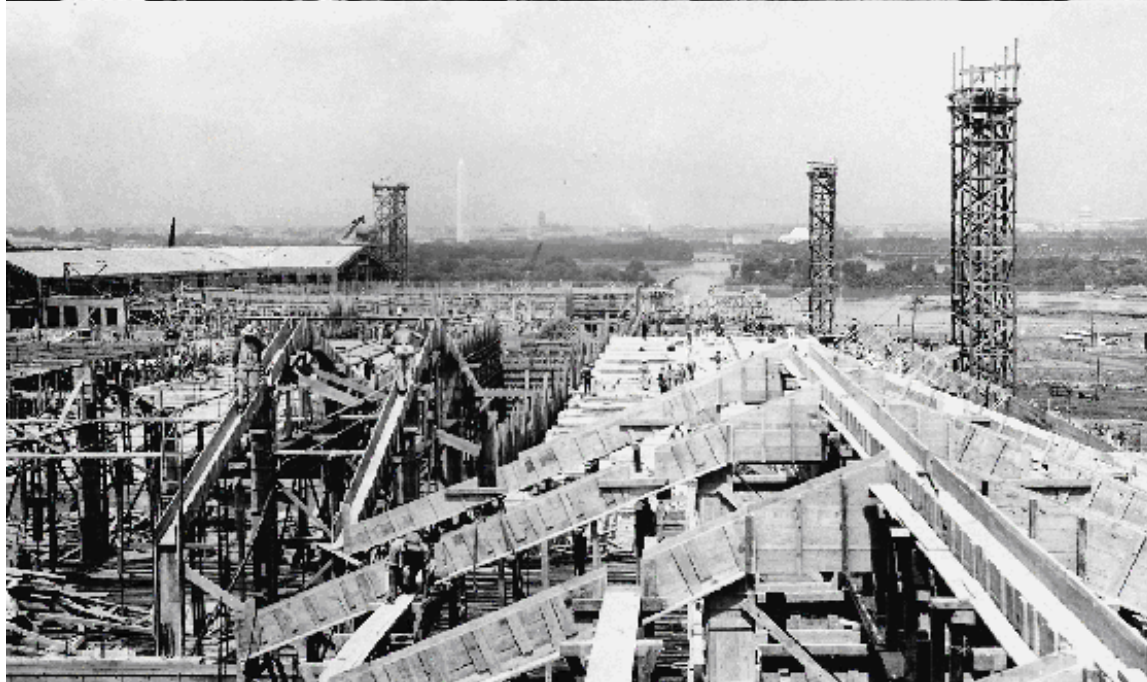
**RE: the Pentagon’s designers minimized and/or avoided using critical war materials whenever and wherever possible (enough steel was saved to build a Battleship). They substituted concrete ramps for passenger elevators and used concrete drainpipes rather than metal. Also, they eliminated bronze doors, copper ornaments and metal toilet partitions, and avoided any unnecessary ornamentation. To build the foundation, 5.5 million cubic yards of earth and 41,492 concrete piles were needed. A total of 680K tons of sand and gravel was dredged from the *Potomac River* and processed into concrete for the colossal project. The soil conditions of the Pentagon site, located on the Potomac River floodplain, presented challenges to engineers, as did the varying elevations across the site, which ranged from 10 to 40-feet above sea-level. Two retaining walls were built to compensate for the elevation variations, and cast-in-place piles were used to deal with the poor soil conditions.**

***“...By choosing a framework of reinforced concrete, architects and engineers have saved thousands of tons of steel for war needs. They have built a permanent building, they point out, for little more than the cost of a temporary one...”***

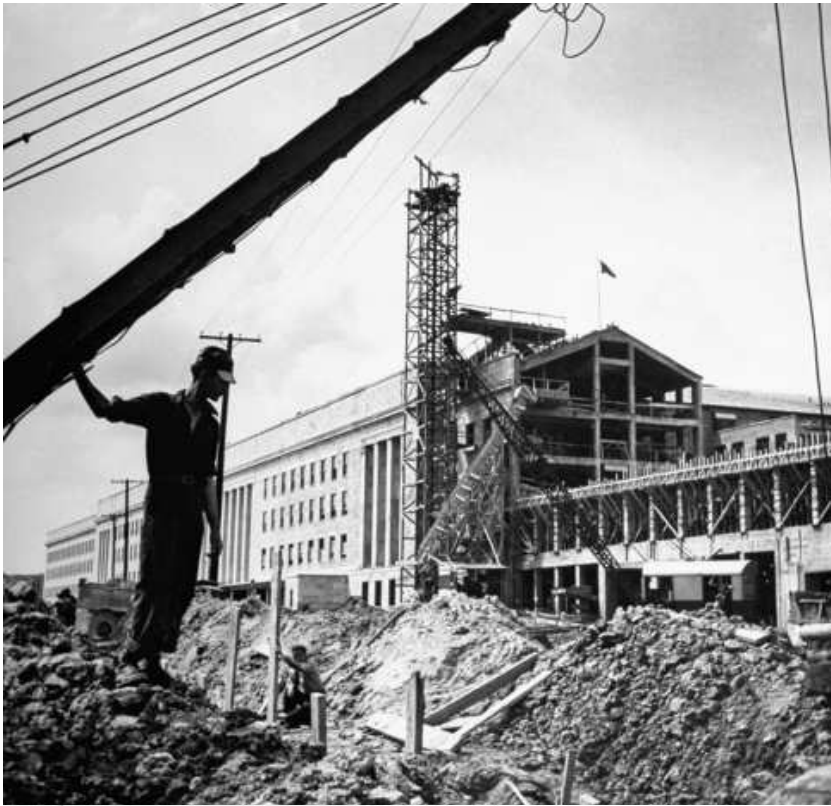
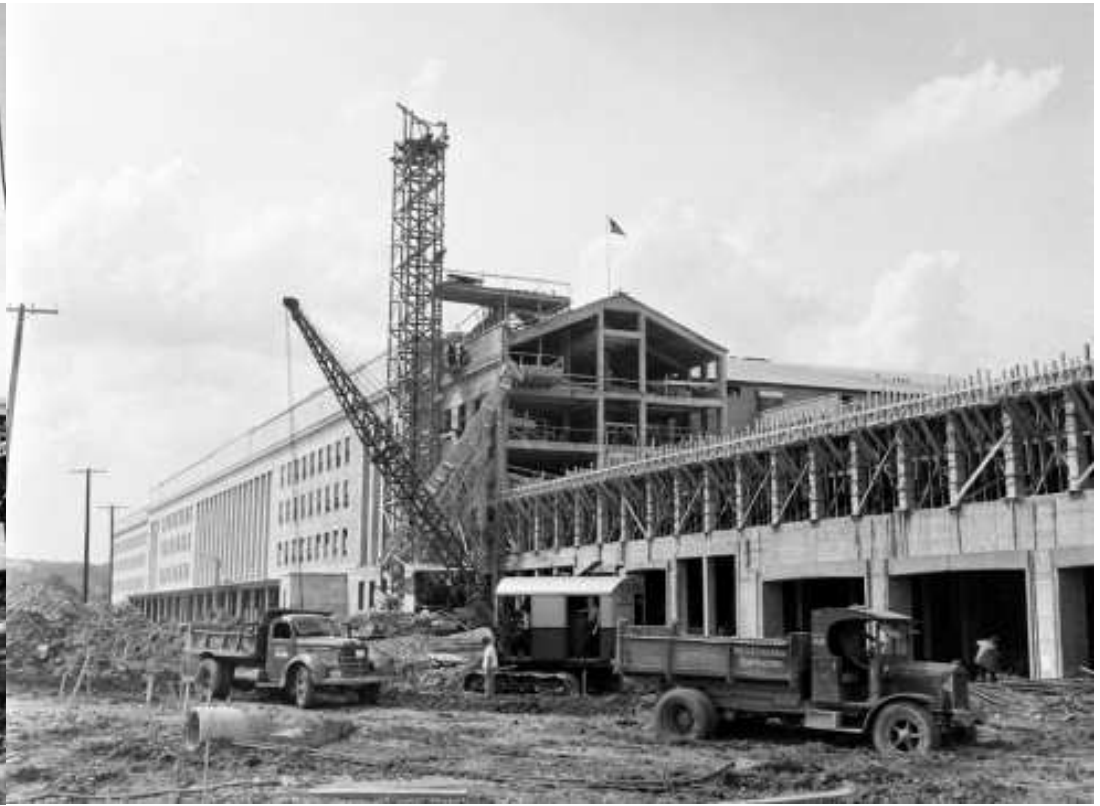
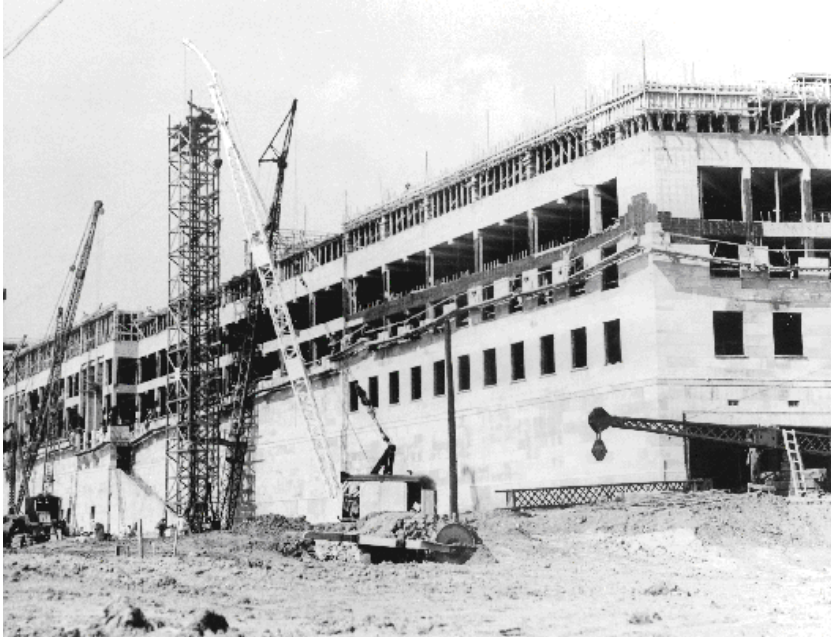
**Left T&B: concrete foundation and formwork under way for the new War Dept. HQ**

**Top L&R: caption: “In a May 1943 issue, *LIFE* magazine noted that the exterior of the Pentagon ‘...has a gray limestone facade, although more than half of the building’s substance is sand and gravel dredged from the bottom of the Potomac River...’”**

**Left: caption: “The Pentagon’s facade under construction”**

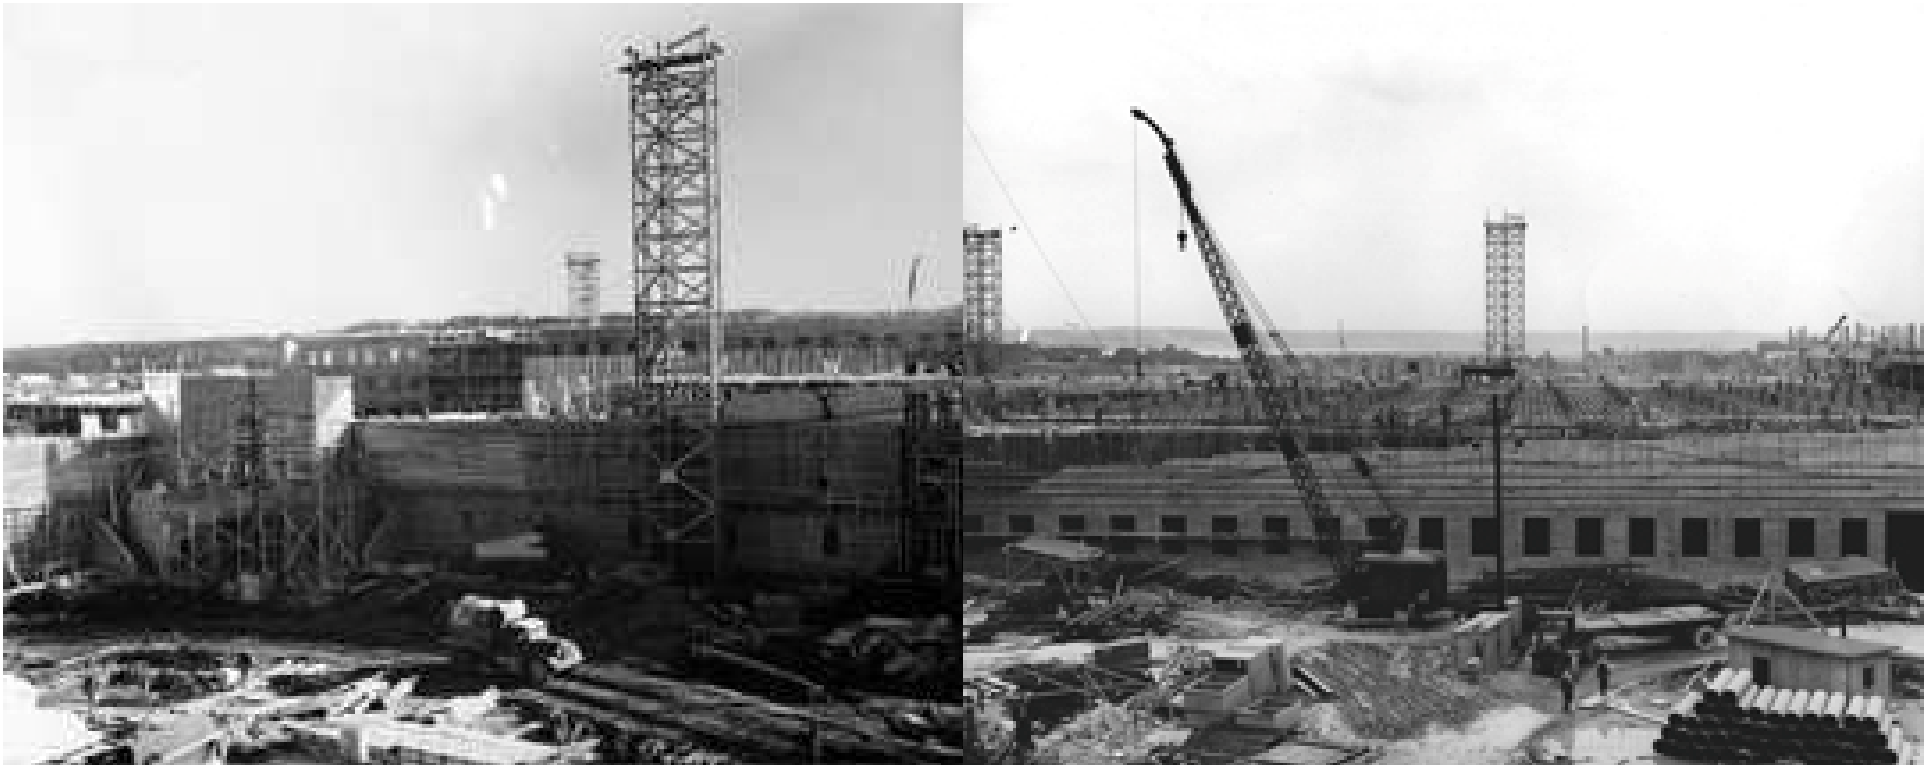
**Top Left:** caption: “Interior of the Center Courtyard During Construction. July 1, 1942. The wood forms used in casting the concrete walls can be seen. These forms, made from 6” & 8” wide boards, give the walls the texture we see today.”

**Top Right:** caption: “Center of the courtyard, West of the E section. July 1, 1942. Showing E Section, 2nd Floor - Floor Slabs ready to be poured. Note pan construction.”

**Left:** caption: “Taken from the roof of 703 Columbia Pike, Arlington, VA, Southeast of Bldg. July 1, 1942. Showing the intersection of A and E sections. Part of South Parking area in the foreground.”

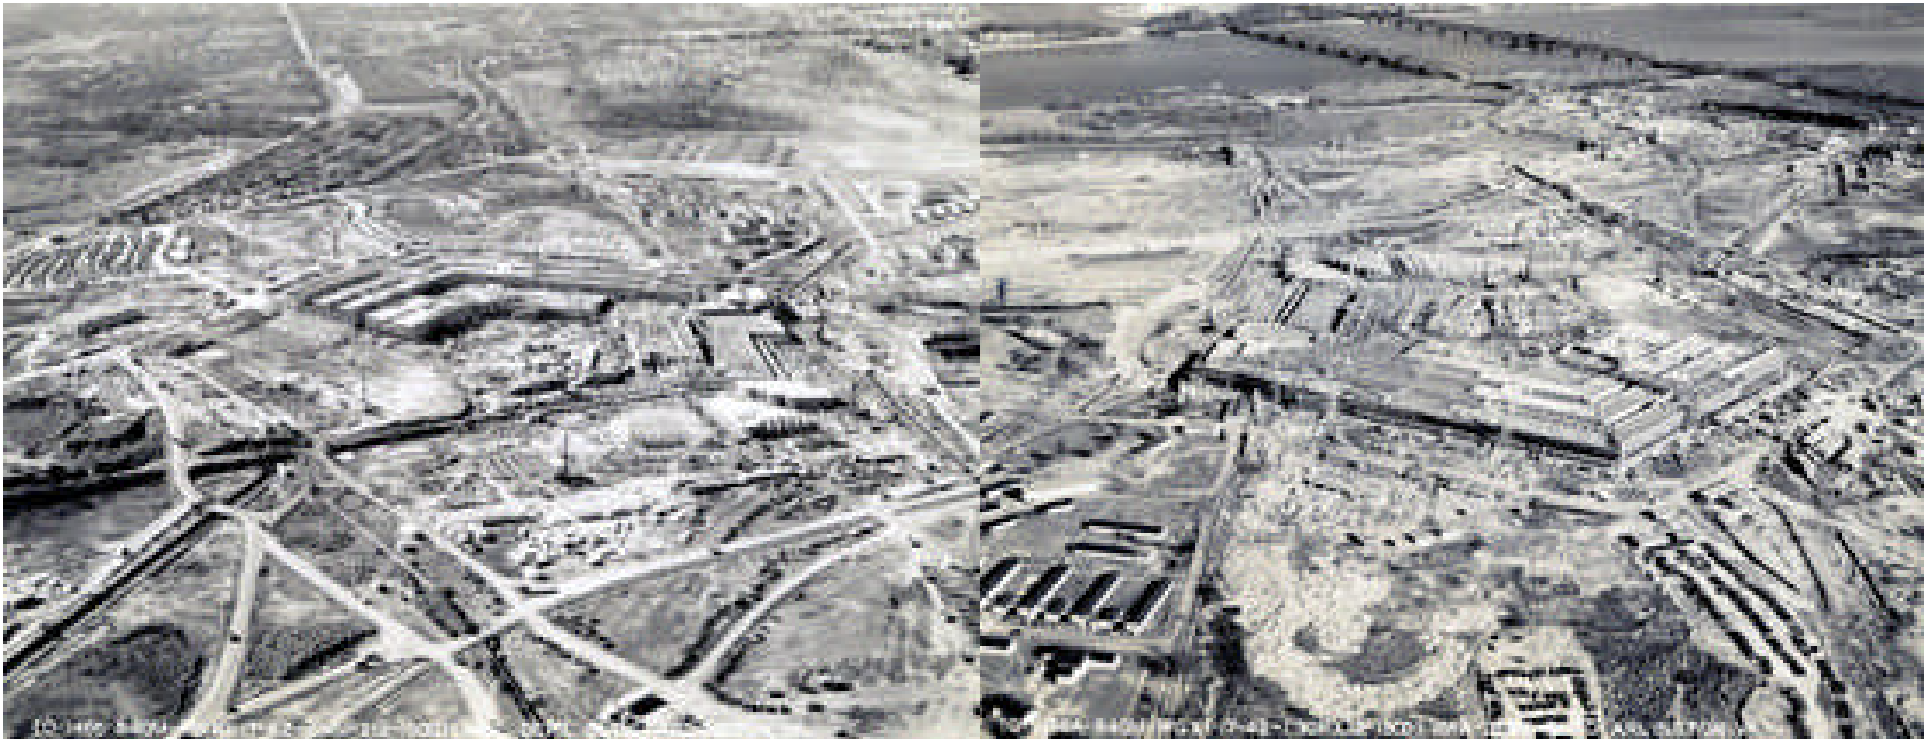
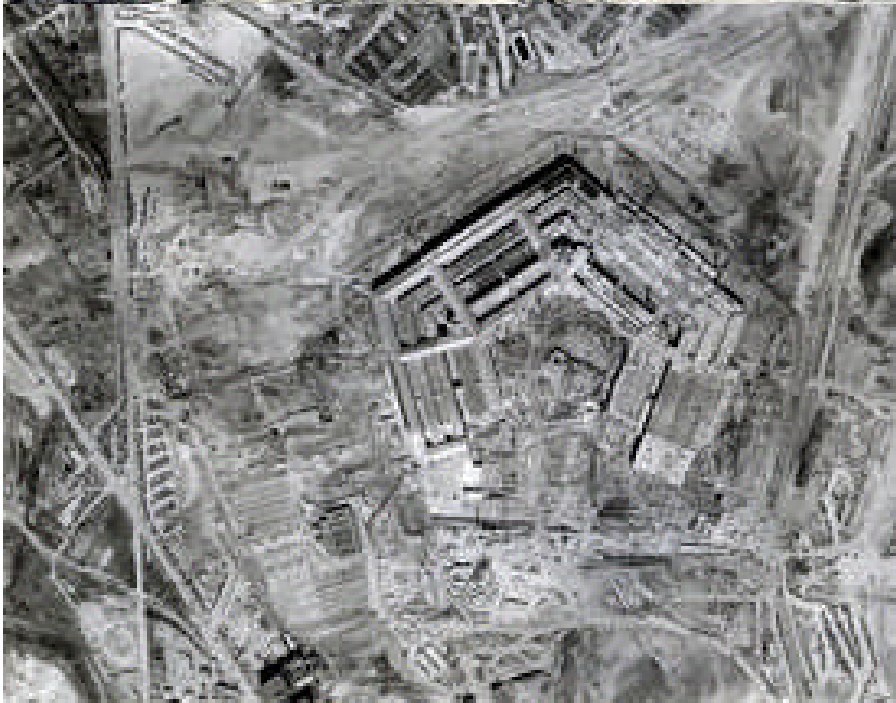
**Top Left:** caption: “January 17, 1942. Progress of the construction project”

**Top Right:** caption: “January 17, 1942. Showing entire building site, D section in foreground, B section in background.”

**Left:** caption: “1942. The building’s characteristic shape is readily apparent.”

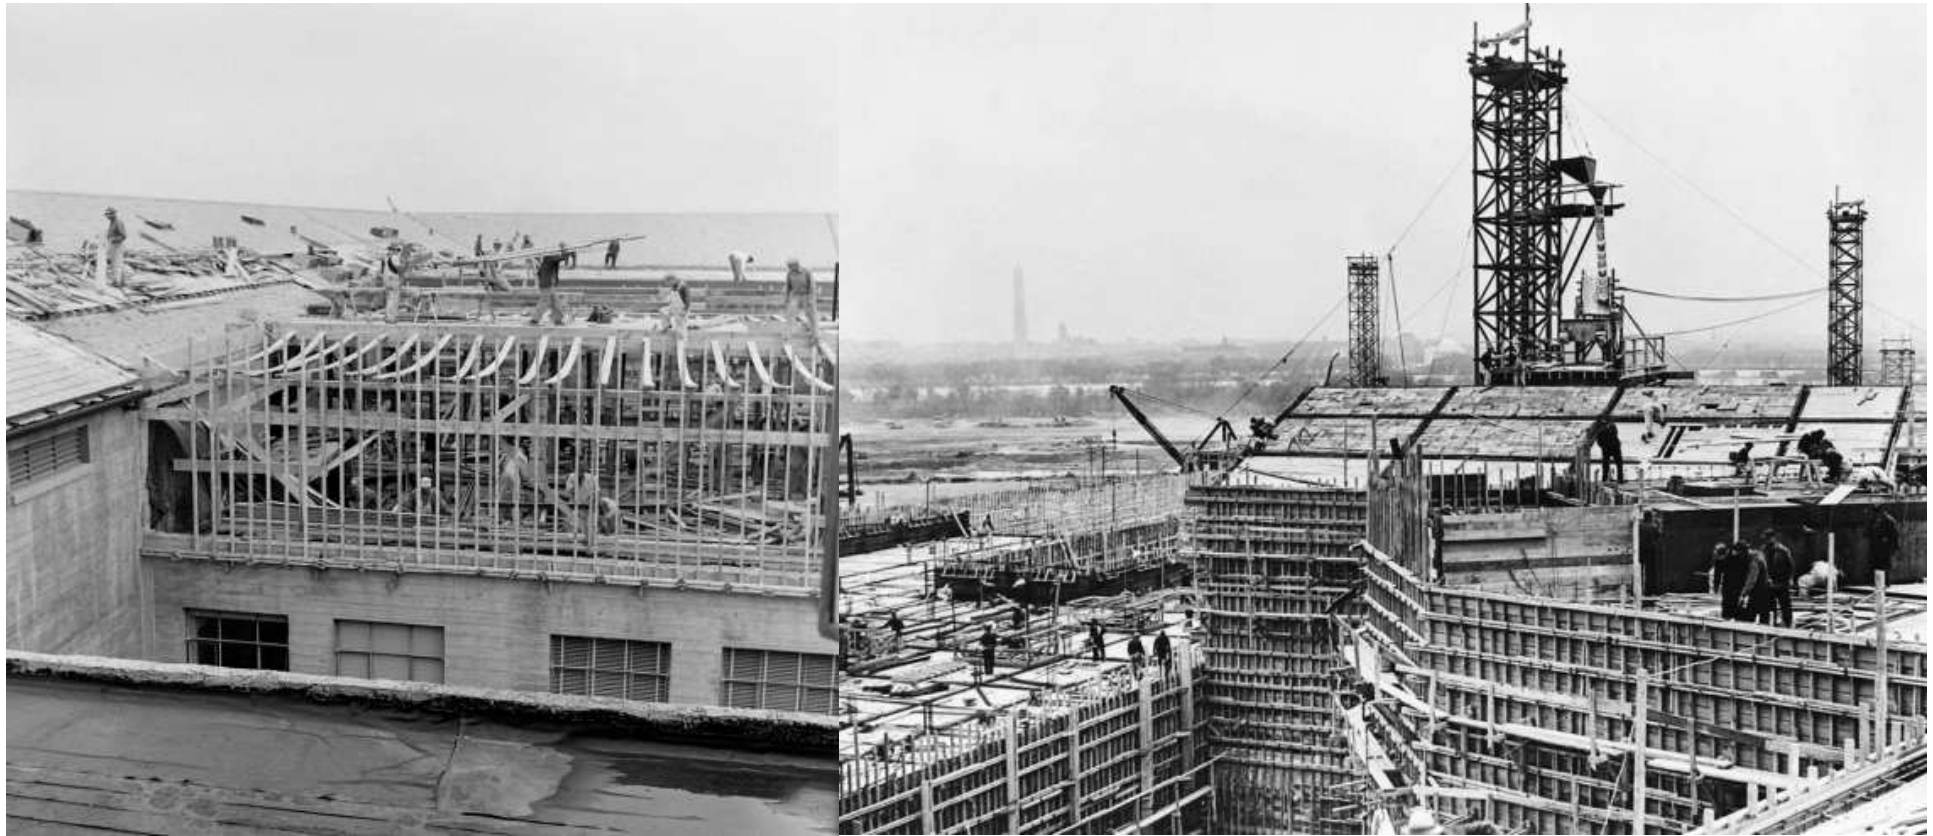
**Left: caption: “Perhaps no other single fact about the Pentagon’s construction is more amazing than this: when construction began on September 11, 1941, *LIFE* reported, the groundbreaking took place ‘only two weeks after the designing of the structure commenced.’”**

**Right: caption: “Workers would ultimately complete seven floors for the Pentagon: five of them above the ground and two beneath.”**

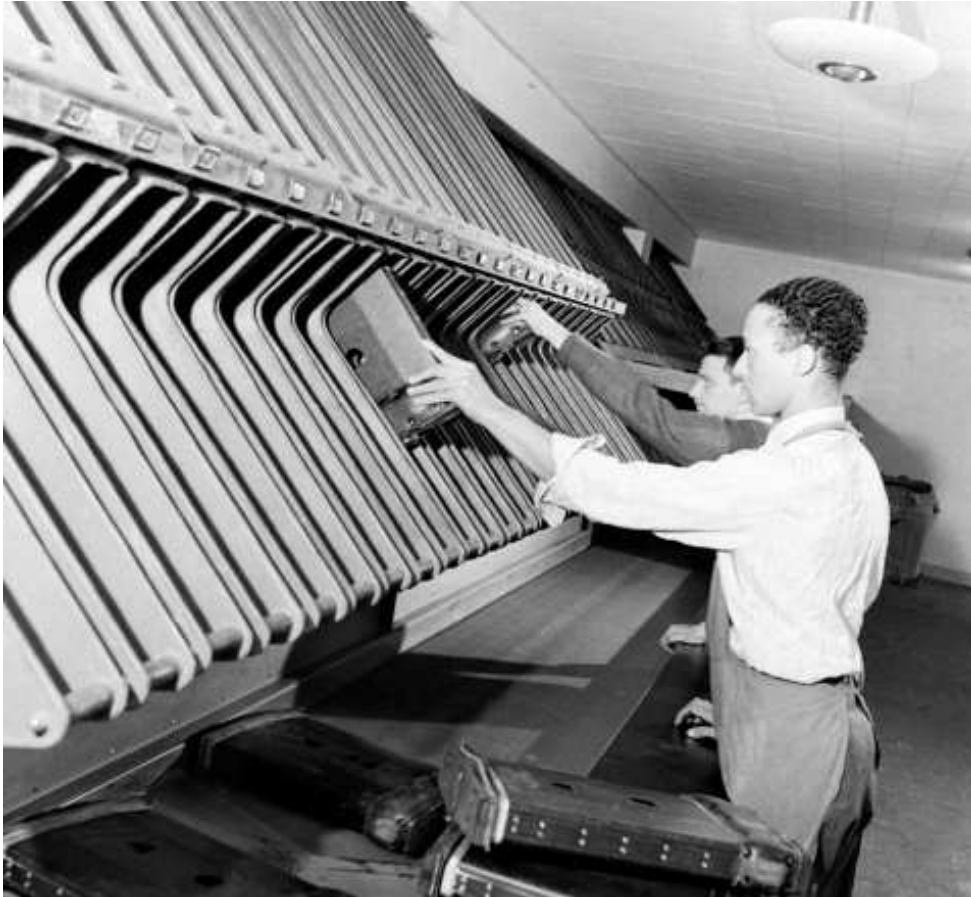
***“...Within the building, dispatches and written memoranda travel by messenger, or are shot through a pneumatic tube system in conveyors that accommodate flat documents up to 10 by 14 inches in size...”***

***Left: caption: “Sending files via the Pentagon’s pneumatic tube system - an old-school delivery mechanism that, as late as the mid-1980s, was still handling more top-secret information than the Defense Department’s computers”***

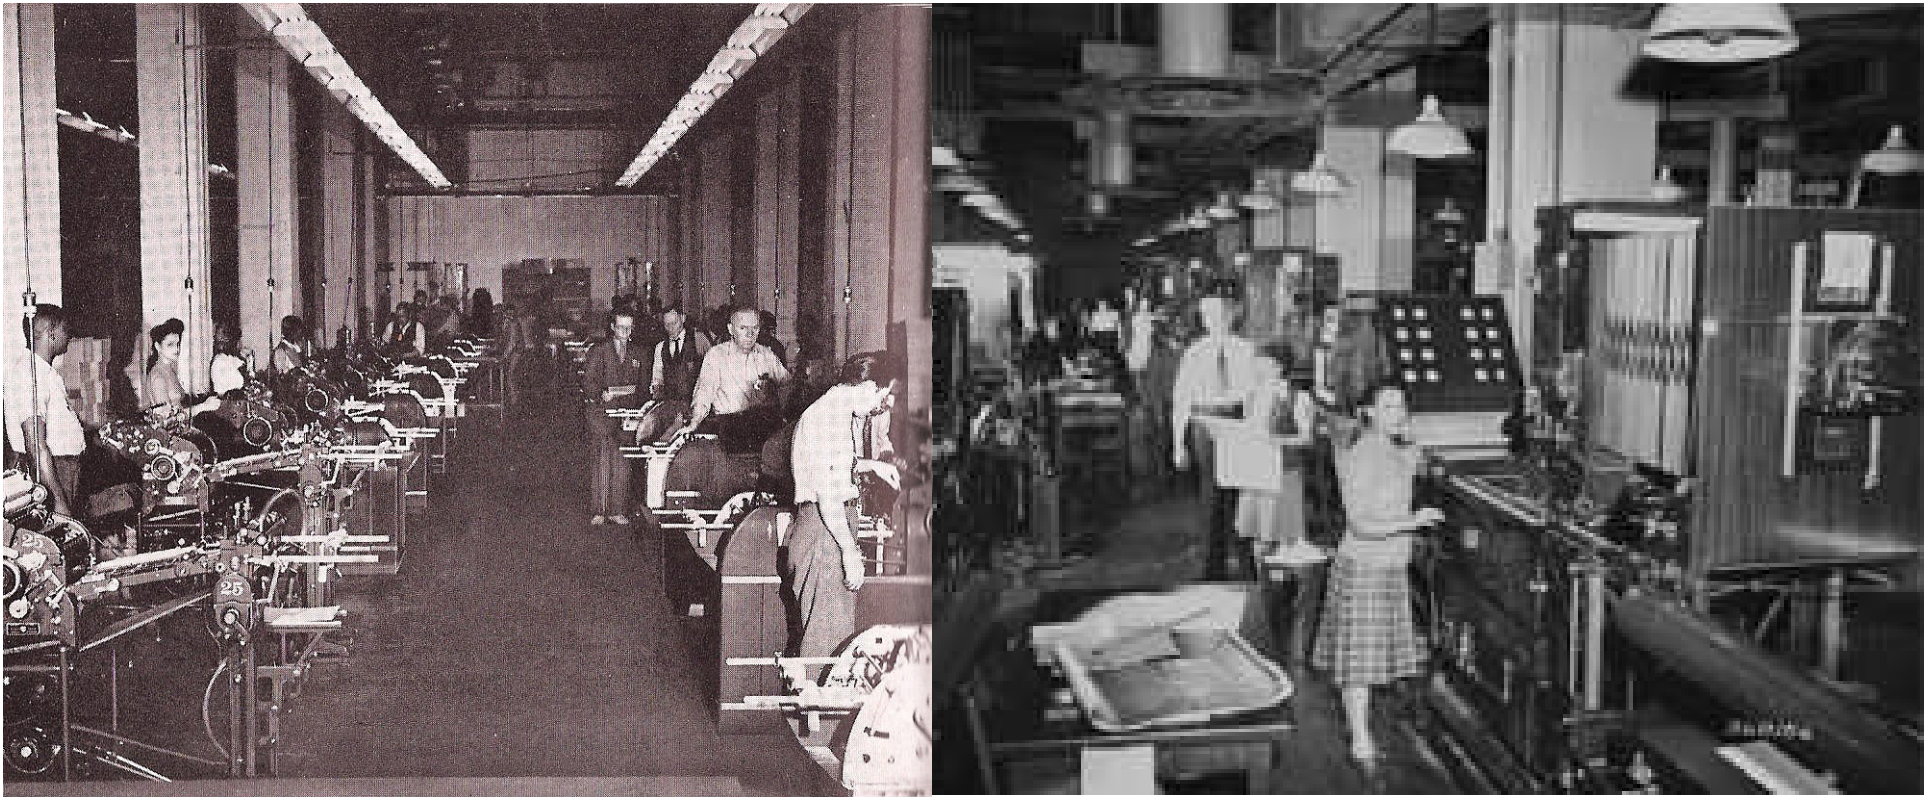
**Right: caption: “The Pentagon’s Photostat Room, 1944. The large stationary cameras on the right were used to make photographic copies and enlargements. These unwieldy machines and the accompanying chemical developing process were eventually replaced by modern photocopiers.”**

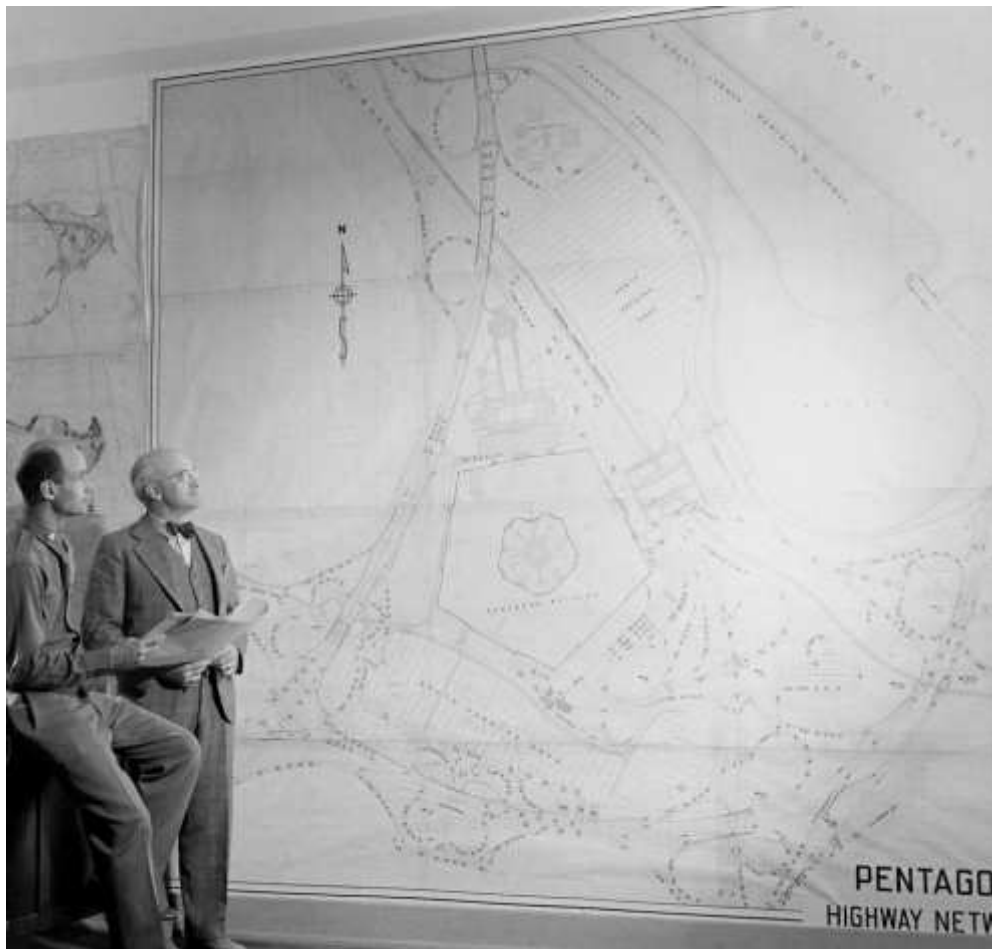
**Left: caption: “A massive map provides an overview of the Pentagon highway network. With a complex housing roughly 23,000 workers and 16 parking lots for over 8,000 cars, new roads to accommodate the traffic were a necessary part of the construction.”**

**The Pentagon site originally contained three cloverleaf interchanges that were among the earliest such structures constructed in the *United States*. These freeway-scale interchanges were necessary to handle traffic associated with the large number of people working in the building.**

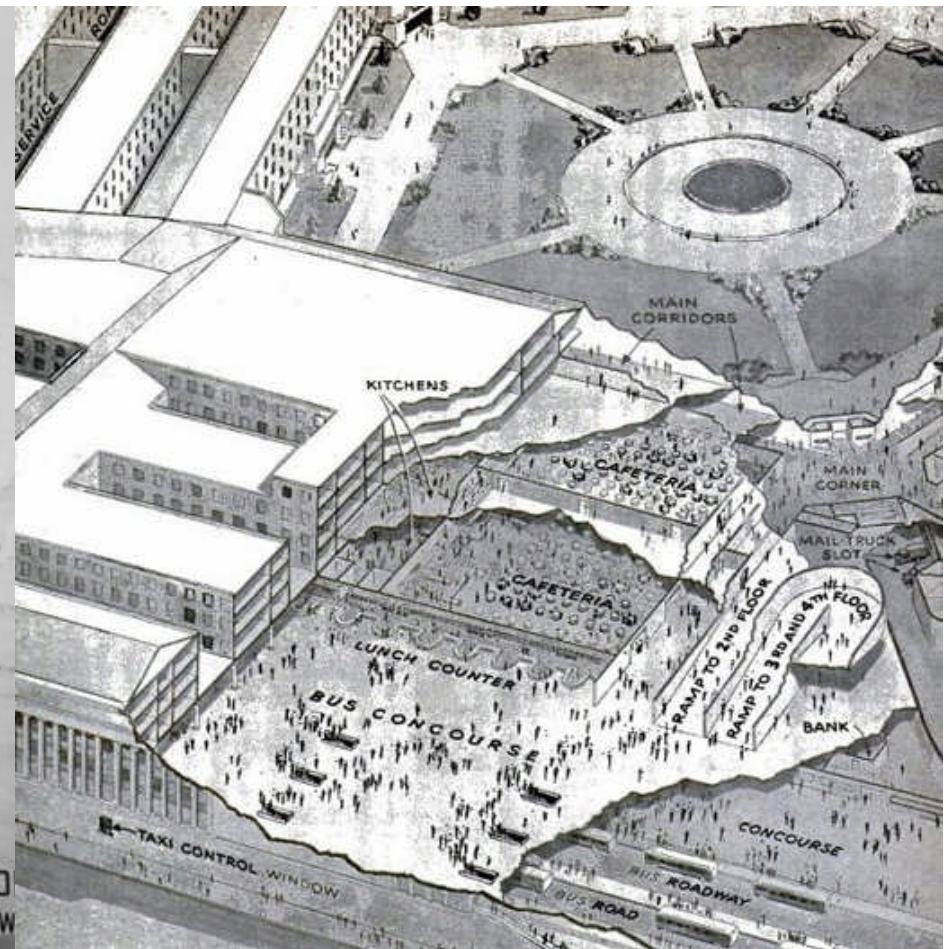
**Right: caption: “Highways run right into the big Pentagon Building with provisions for arrival or departure by bus of 30K persons an hour”**
