**PDHonline Course C682 (4 PDH)**

## ***Five-By-Five: The Making of the Pentagon***

*Instructor: J.M. Syken*

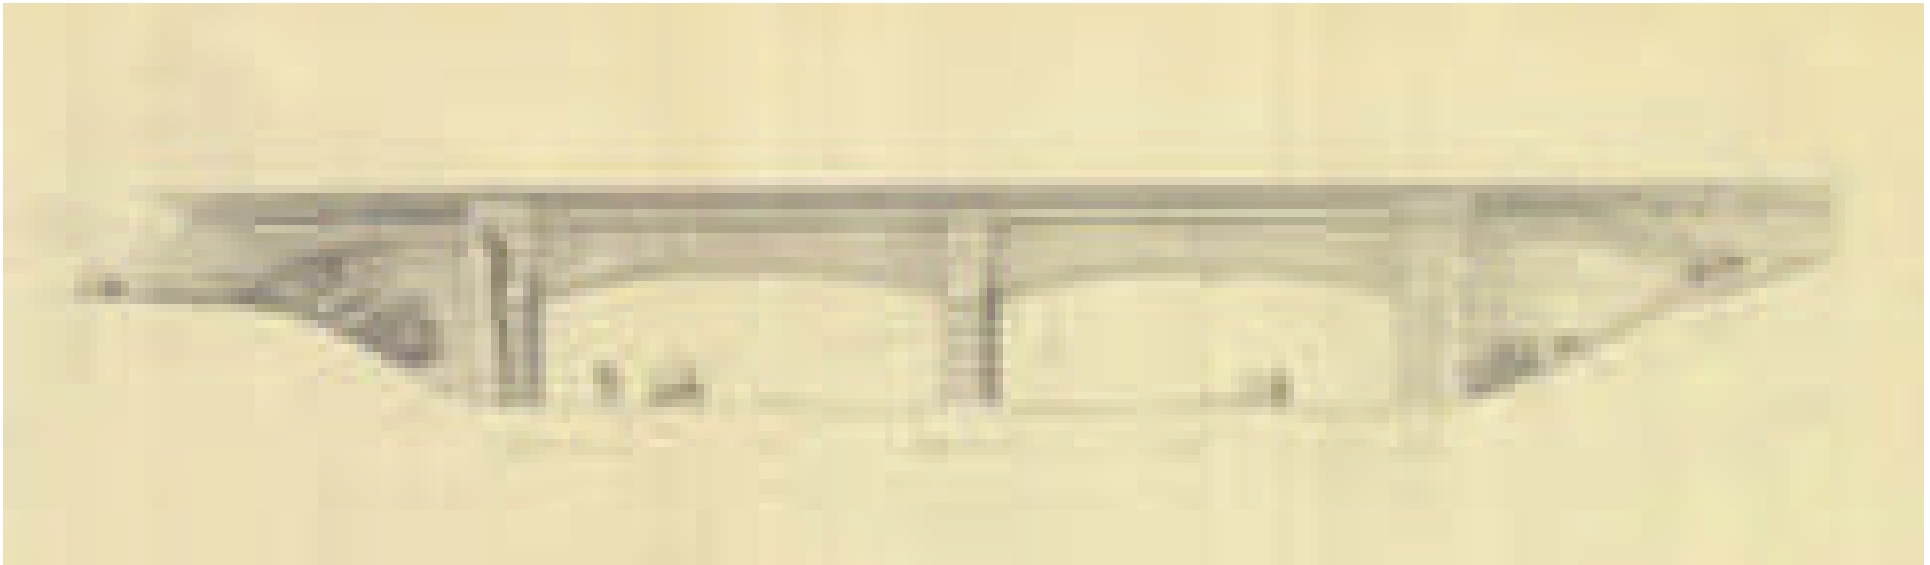
***Above: caption: “Bridge No. 1 Alternate Design E – Pentagon Road Network (10/06/1941)”***

***“...Traffic moves in and out of the grounds on a specially built highway system. Forty miles of 24-foot paved roads approaching the building connect with three main highways outside the grounds. Twenty-one bridges provide grade separations at all crossings on the ‘reservation’ and no stop lights break the flow of traffic. The highway system was worked out by the War Department in cooperation with the Public Roads Administration...”***

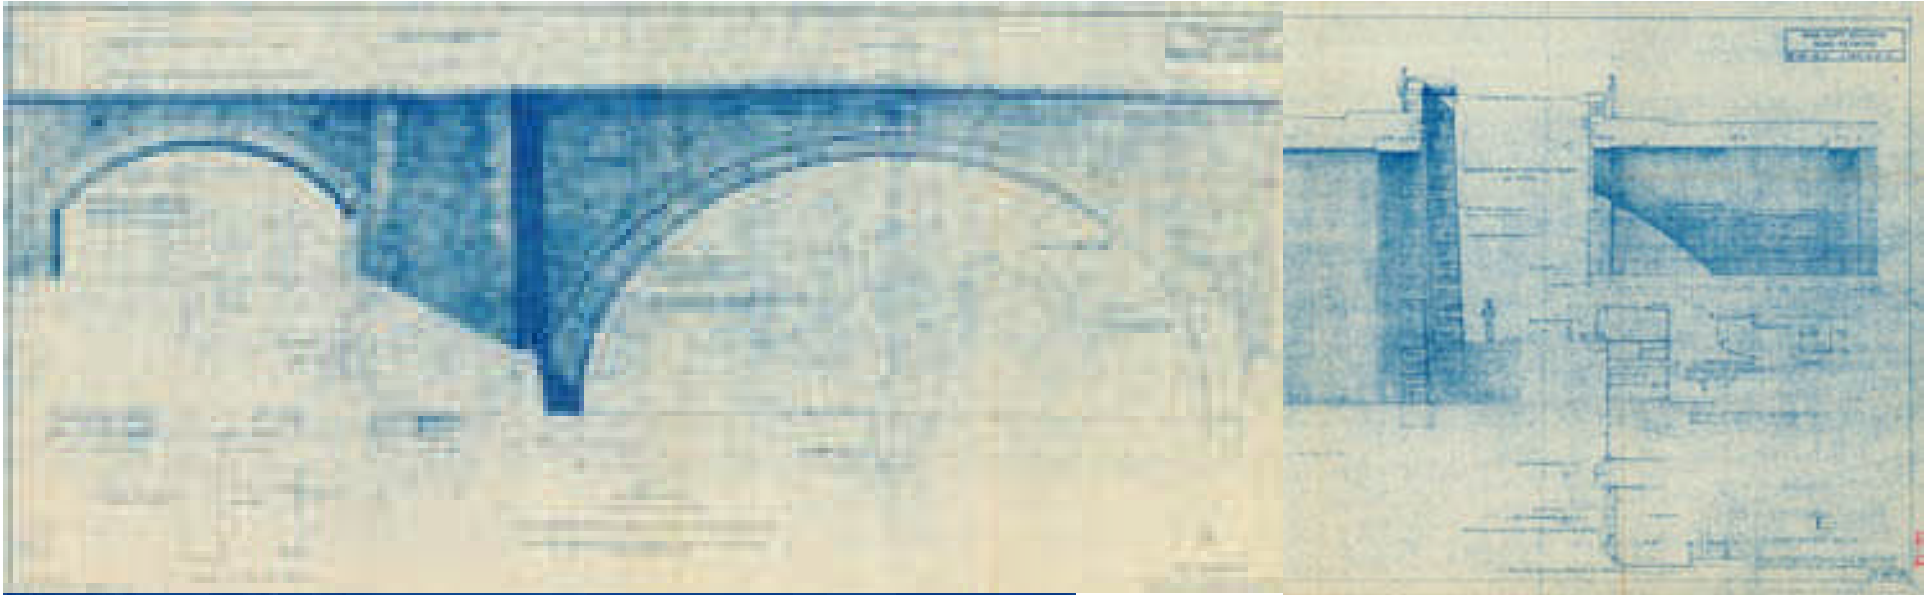
**Top Left: caption: “Bridge No. 3 Detail Elevation – Pentagon Road Network (10/28/1941)”**

**Top Right: caption: “Bridge No. 3 Details – Pentagon Road Network (10/28/1941)”**

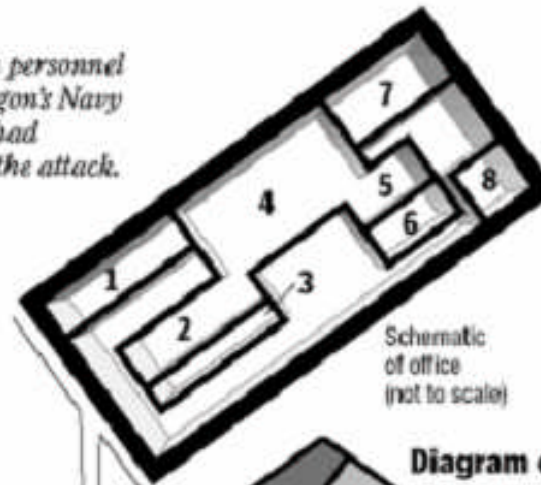
More than half of the active duty and civilian personnel the Navy lists as missing worked in the Pentagon's Navy Command Center. The first-floor Navy office had recently been renovated but was destroyed in the attack.

- 1 Meteorology
- 2 Watch Team (Duty Captain)
- 3 Support
- 4 Communications
- 5 Technical
- 6 Operations
- 7 Conference Room
- 8 Intel

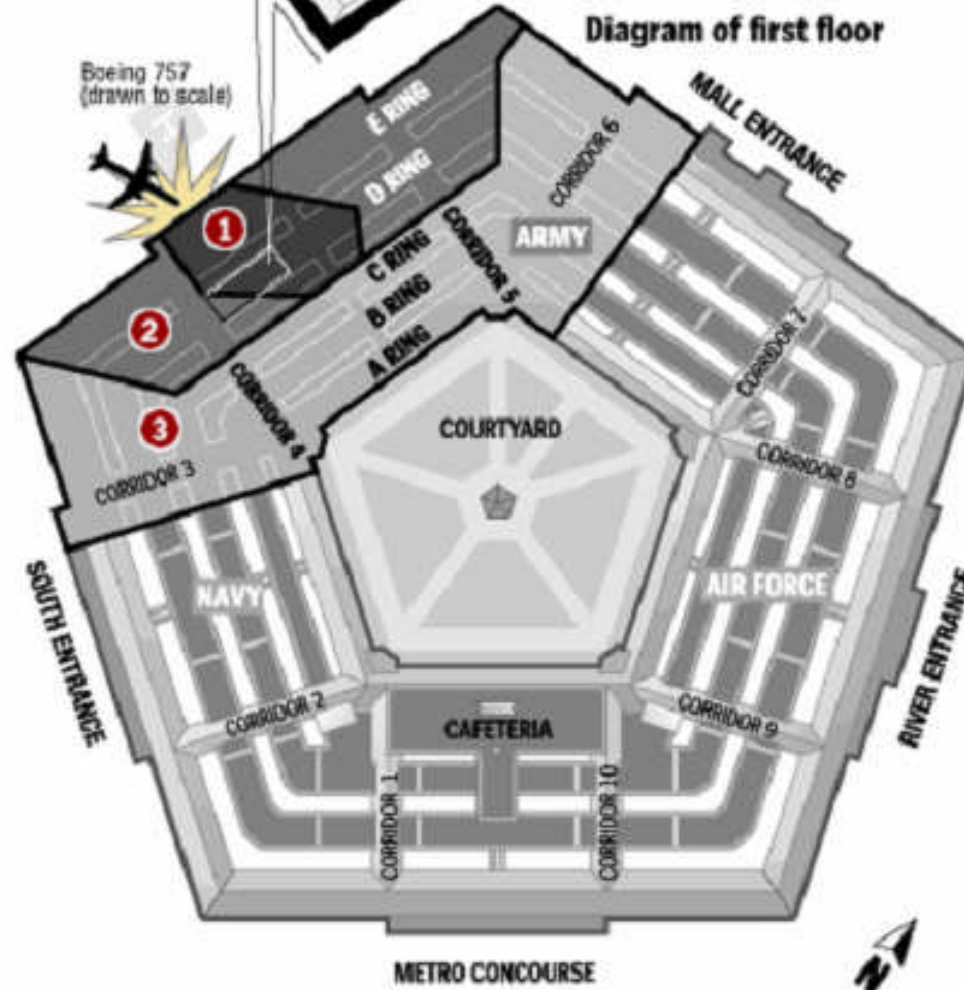
## Degree of damage

- 1 Structural:** Catastrophic damage was done to support columns on the first and second floors.
- 2 Fire:** Fireballs—fed by the jet's fuel—exploded and spread laterally down the hallways of E and D rings. Under the slate roof, spot fires continued to burn as late as Thursday night.
- 3 Water:** Water damage extends through roughly a third of the Pentagon as a consequence of firefighting efforts.

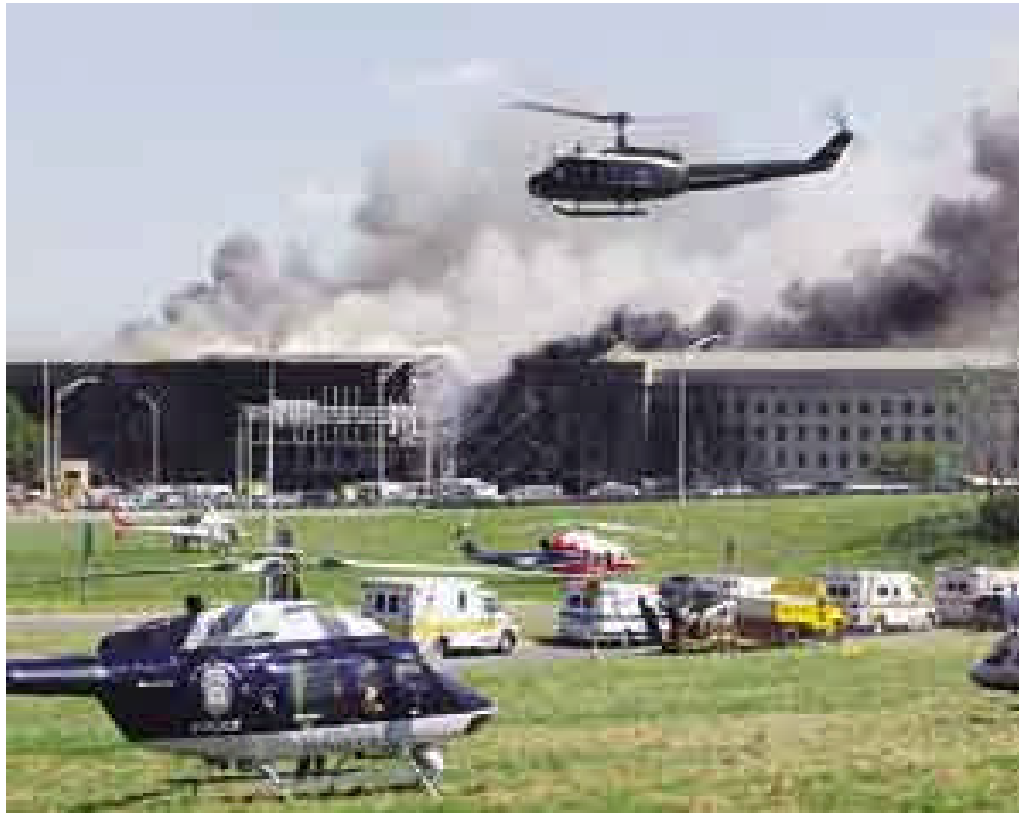
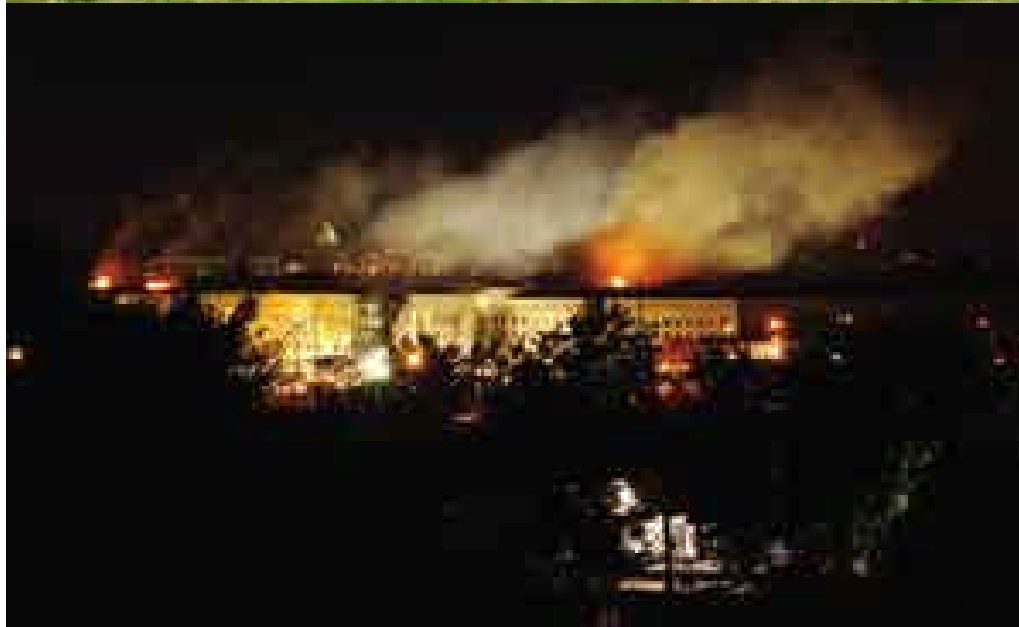
***“From a fire-damage standpoint, this was by far the worst, very intense, hot concentrated fire for a prolonged period of time. The heat of the fire drove out the water attached to the cement molecules. It literally disintegrated the paste and turned it to mush.”***

**RE: on September 12<sup>th</sup> 2001, APS was hired to evaluate the Pentagon’s concrete. Their task was two-fold:**

- Test the integrity of the Pentagon’s remaining structures, and;**
- Advise engineers what needed to be replaced**

**Pentagon concrete samples, *Potomac River* gravel mixed with sand, cement and water, were immediately sent to ASP's *St. Paul, MN* laboratory. In all, 170 pieces ranging in size from only a few inches square to more than a foot long were tested. Some samples arrived in such poor condition that super glue had to be used to piece them back together before they could be properly examined. Some samples had a reddish hue or tints of bright orange. These samples came from columns near the crash site. The red and orange colors come from tiny amounts of iron in the rock that were oxidized in extreme heat. When the airplane slammed into the Pentagon, the plane's jet fuel exploded and the resulting fire cracked the rock in the concrete mix.**

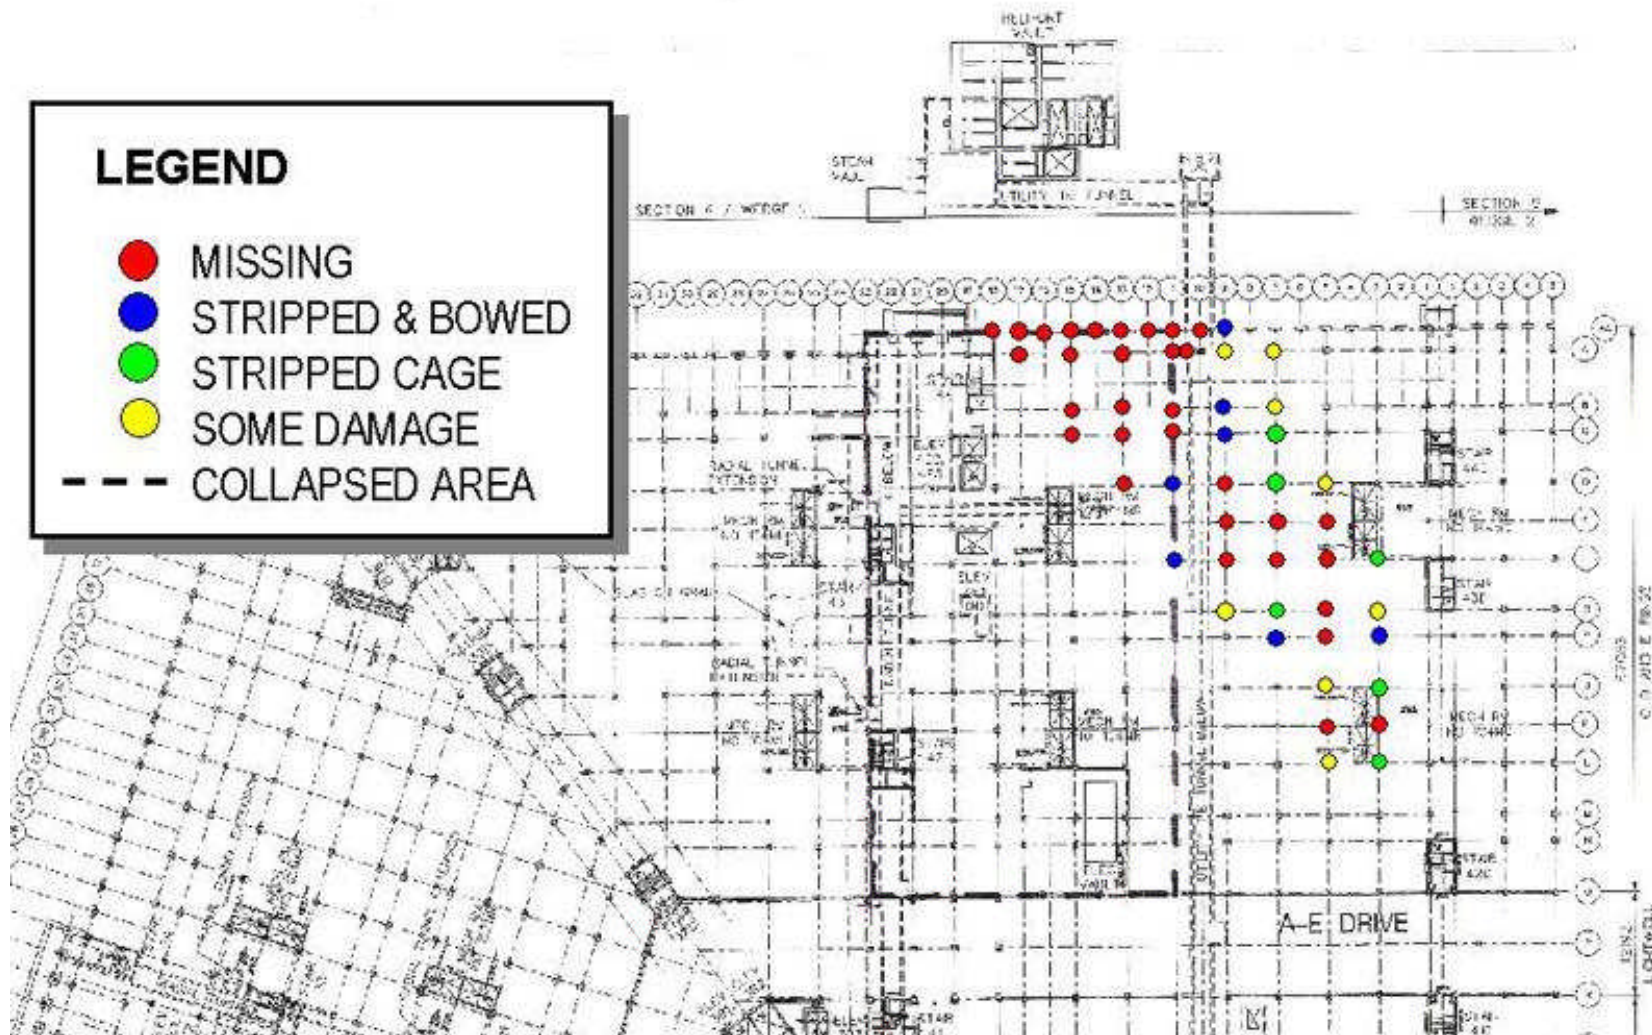
# STRUCTURAL INTEGRITY

***“...The primary structure of the Pentagon is 42,420 steel-reinforced concrete columns. Of these, only 32 were destroyed and 15 seriously damaged. As recovery efforts continue, the structure is being shored up with pressure-treated wood posts to protect against further collapses...”***

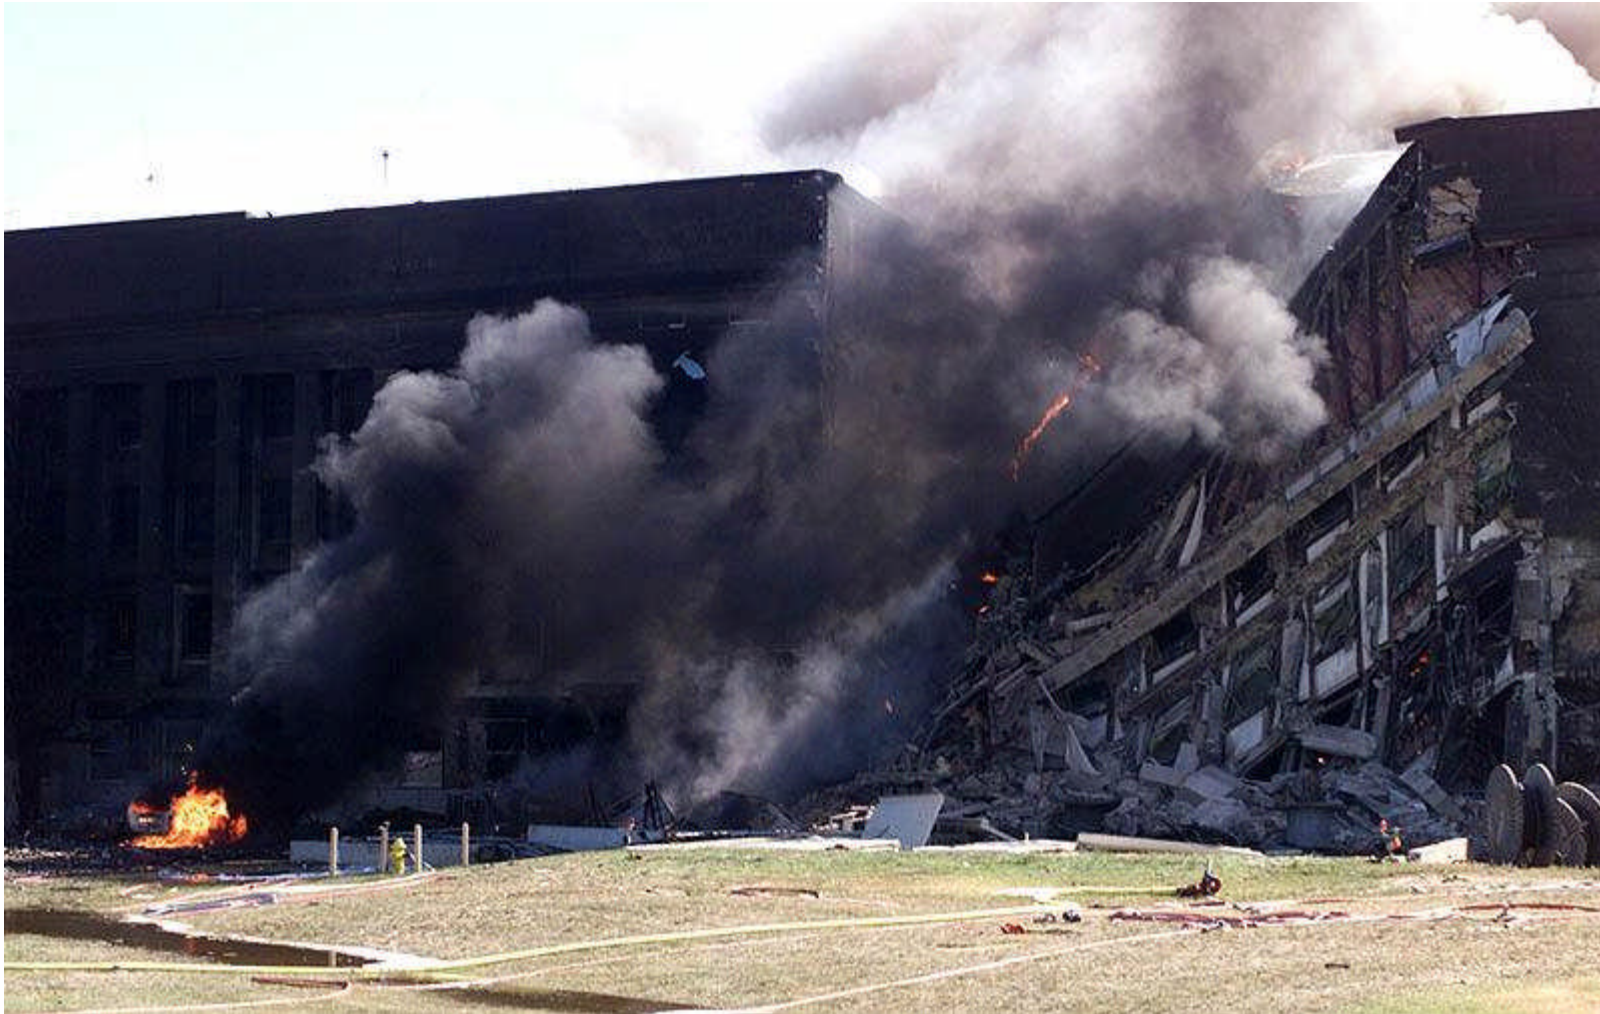
***“Looking at some of the concrete that’s been fire-damaged, we can see how the cracking proceeds through the aggregate. This tells us a lot about the temperatures the concrete reached. We decided to say to heck with it and not do a surgical type of repair, which is what we thought we would do initially. We decided to take out a large section and demolish the whole thing.”***

**RE: APS concluded that the concrete in the stricken area was irreparably damaged. Instead of working with the Pentagon’s remaining columns and beams, they determined that it would be best to remove it all and start over. As such, an area 300 by 150-feet by five stories tall was demolished.**

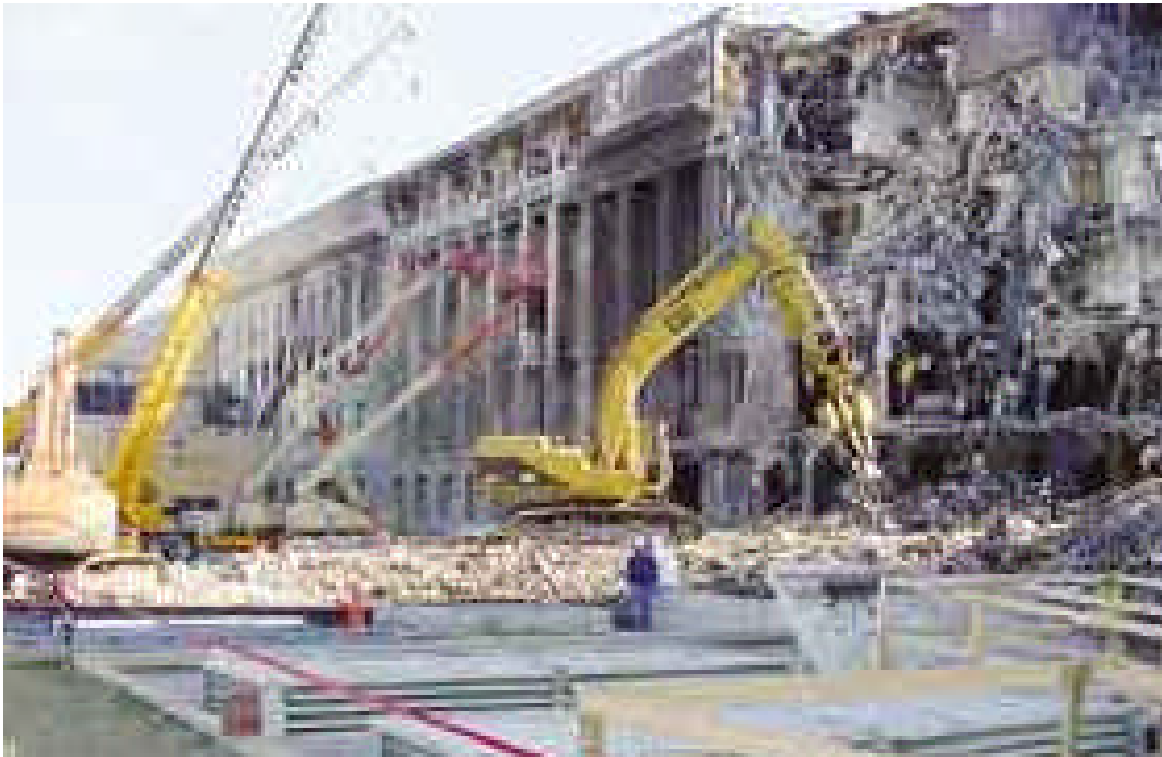
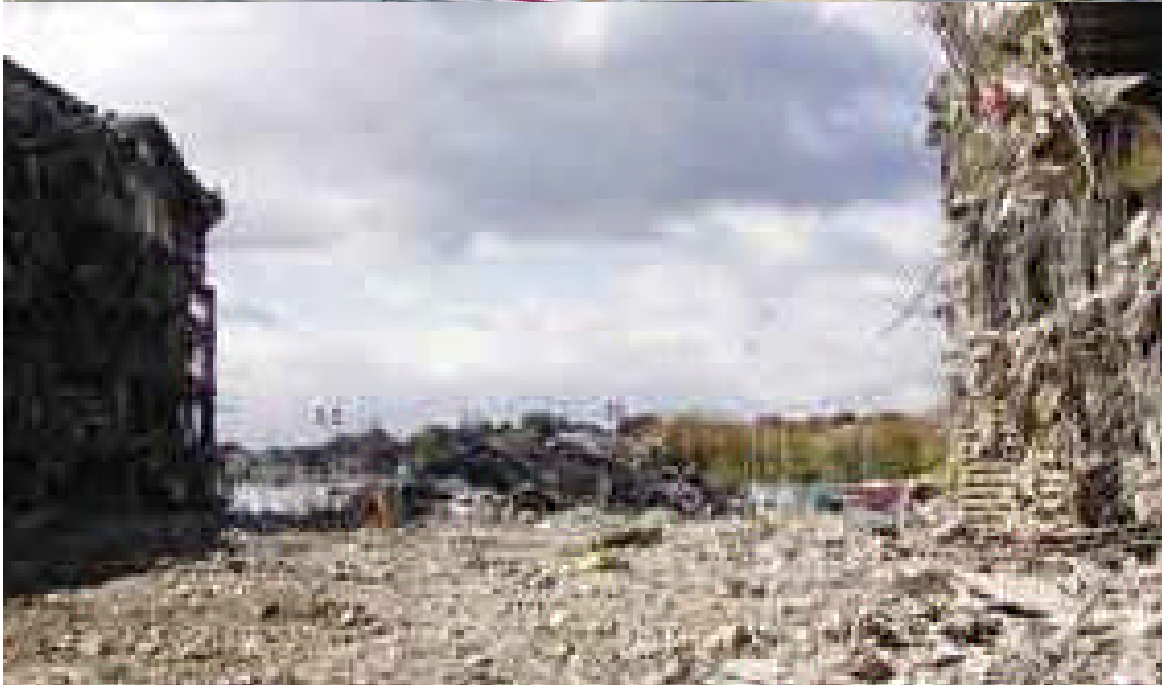
***“...The demolition took just one month, aided by round-the-clock work and landfills that stayed open all night. Workers celebrated the day they finished, Nov. 19, by placing a Christmas tree on the roof. There was reason to celebrate because they could now stop tearing down and start building up...”***

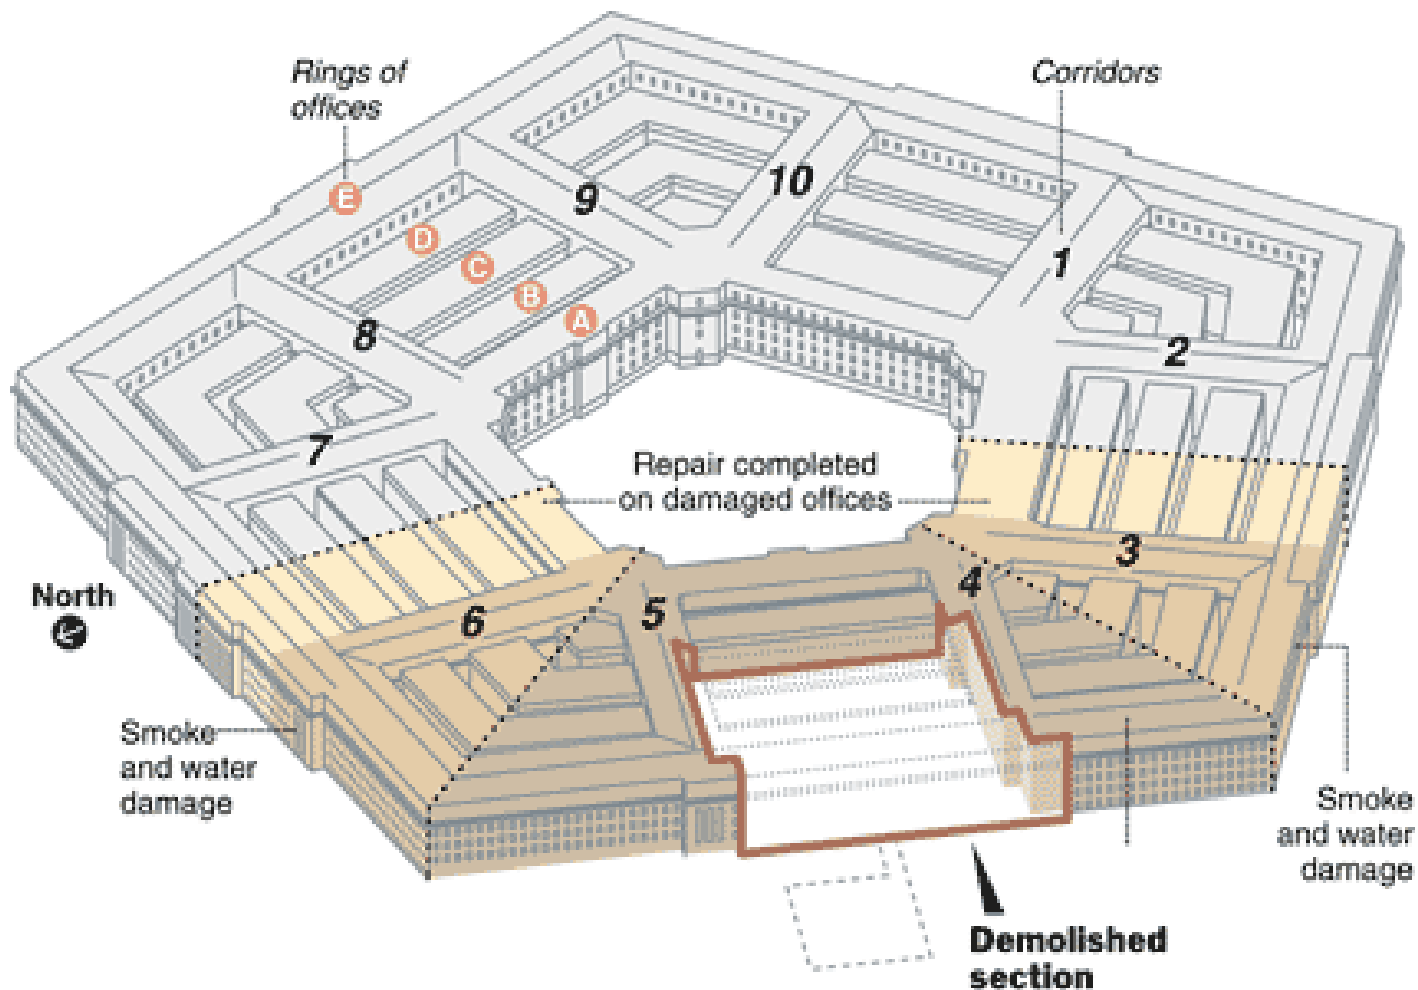
**Above:** caption: “Exterior: The rebuilt facade will be made from the same Indiana limestone as the original stone facing. Underneath the facade, however, reinforced concrete will replace the original brick walls. Office Space: Some of the offices damaged by smoke and water have been reoccupied, but much of the interior walls, furniture, electrical wiring<sup>59</sup> and phone lines had to be replaced.”

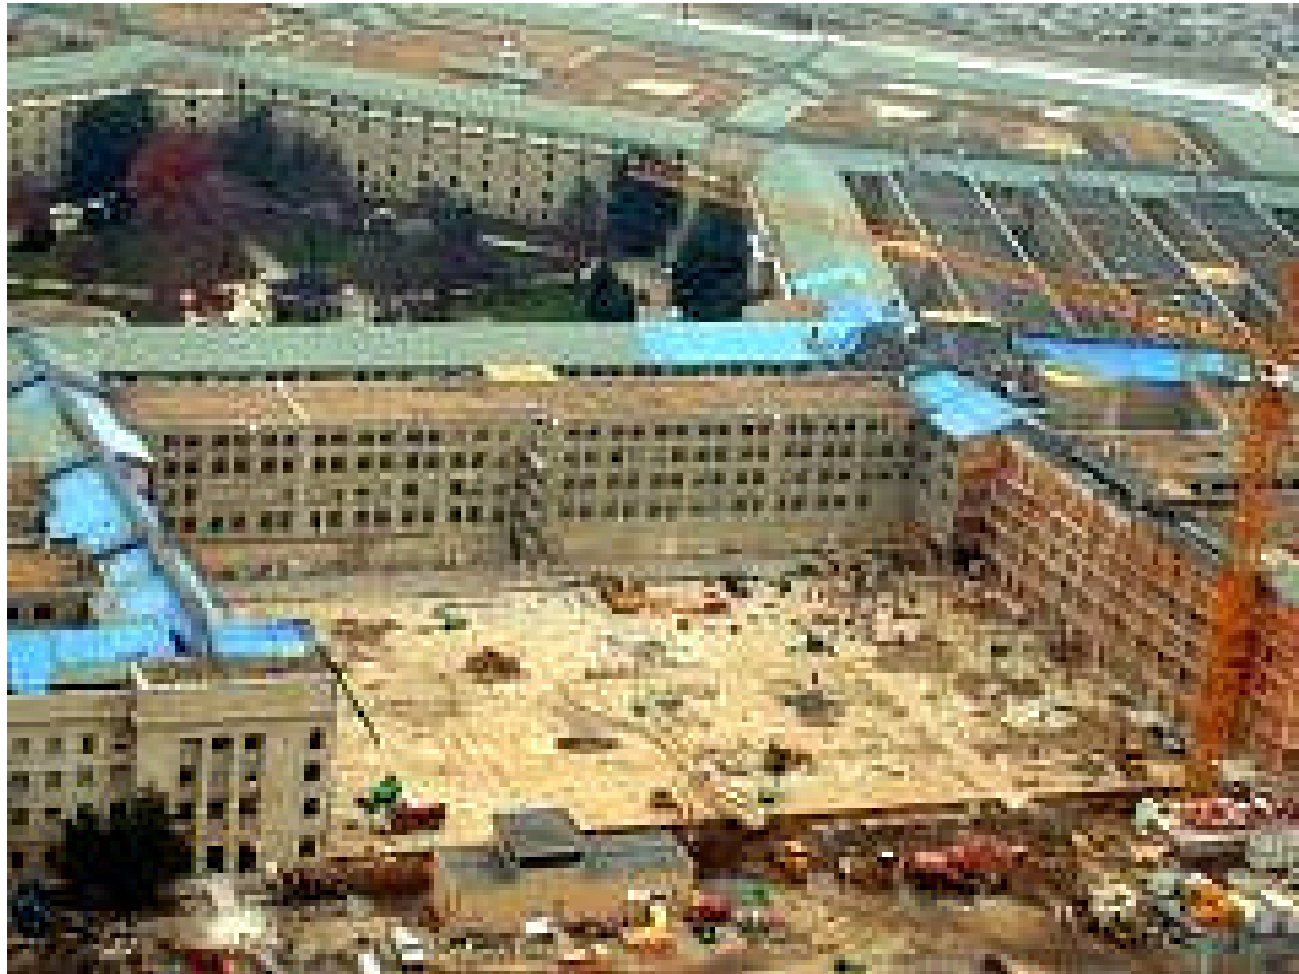
***“...The U.S. Army Corps of Engineers, Omaha District, Protective Design Center evaluated possible threats to determine a ‘most likely’ bomb blast scenario, calculating dynamic, time-varying forces for various blast sizes and locations on the building’s perimeter. From this analysis, the Renovation Office established blast resistance structural design criteria for the project. The next step in the process was to develop the design, incorporating the established criteria. The Renovation Program architect/engineer for Wedge One, Hayes, Seay, Mattern & Mattern, Inc. (HSMM), worked closely with the Protective Design Center in assessing the blast resistance of the existing walls and the proposed replacement fenestration. During the preliminary evaluation, the engineers studied the outermost (E) and innermost (A) ring walls. The resulting data helped formulate initial cost analysis data for reinforcing outer ring walls and provided a foundation for the final design. While HSMM considered various mitigation approaches, the options were few due to the Pentagon's existing exterior design, the window size/alignment and limestone facade, being considered architecturally significant and historical. Protective improvements, therefore, had to be made on the interior side. Other guidelines restricted new construction to a narrow area behind the exterior wall to avoid consuming significant amounts of interior, occupiable floor space...”***

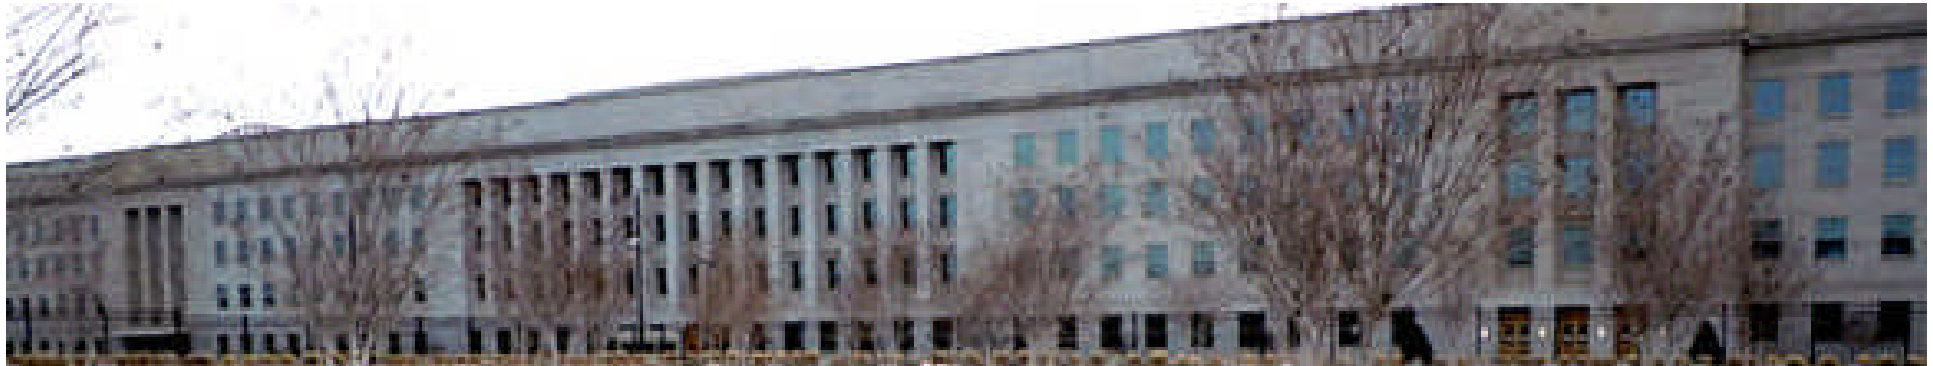
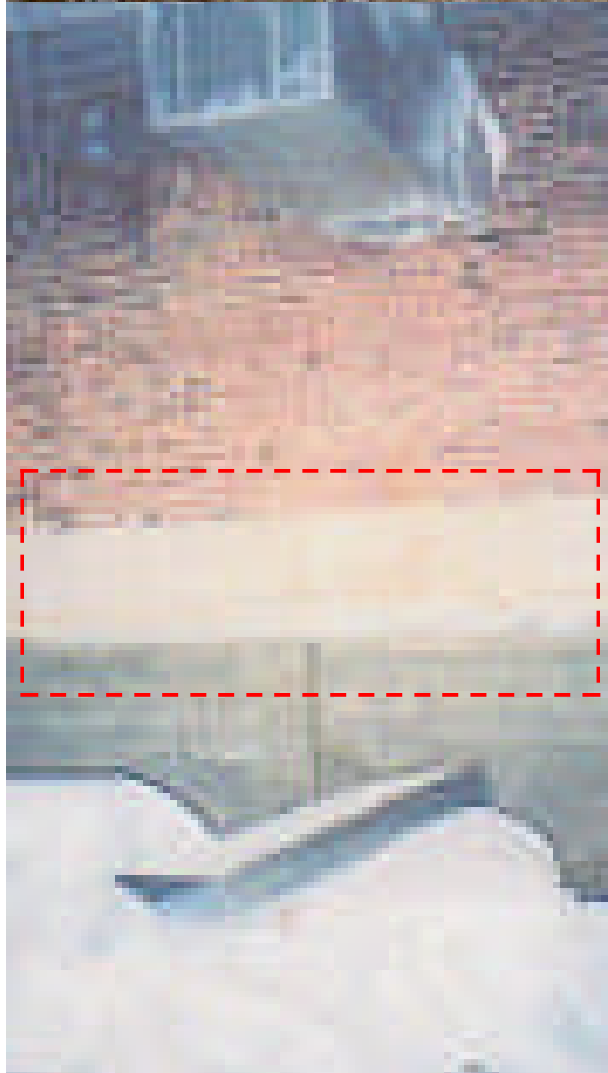
**Left:** typical bay with window

***“...Merely replacing existing windows with blast-resistant ones anchored to the existing brick infill would not be a workable solution. The newer windows would direct blast pressures to the window support connections at the infill. The tensile and shear loads would overwhelm the existing infill walls and allow the panes and frames to separate from the walls as potential missiles harmful to personnel working in the building. The idea of supporting the brick infill walls with a reinforced concrete wall ‘backing’ was rejected as a ‘typical’ approach because of the Pentagon’s extensive fenestration (although this design was accepted for ‘blank’ wall panels with no window openings)...”***

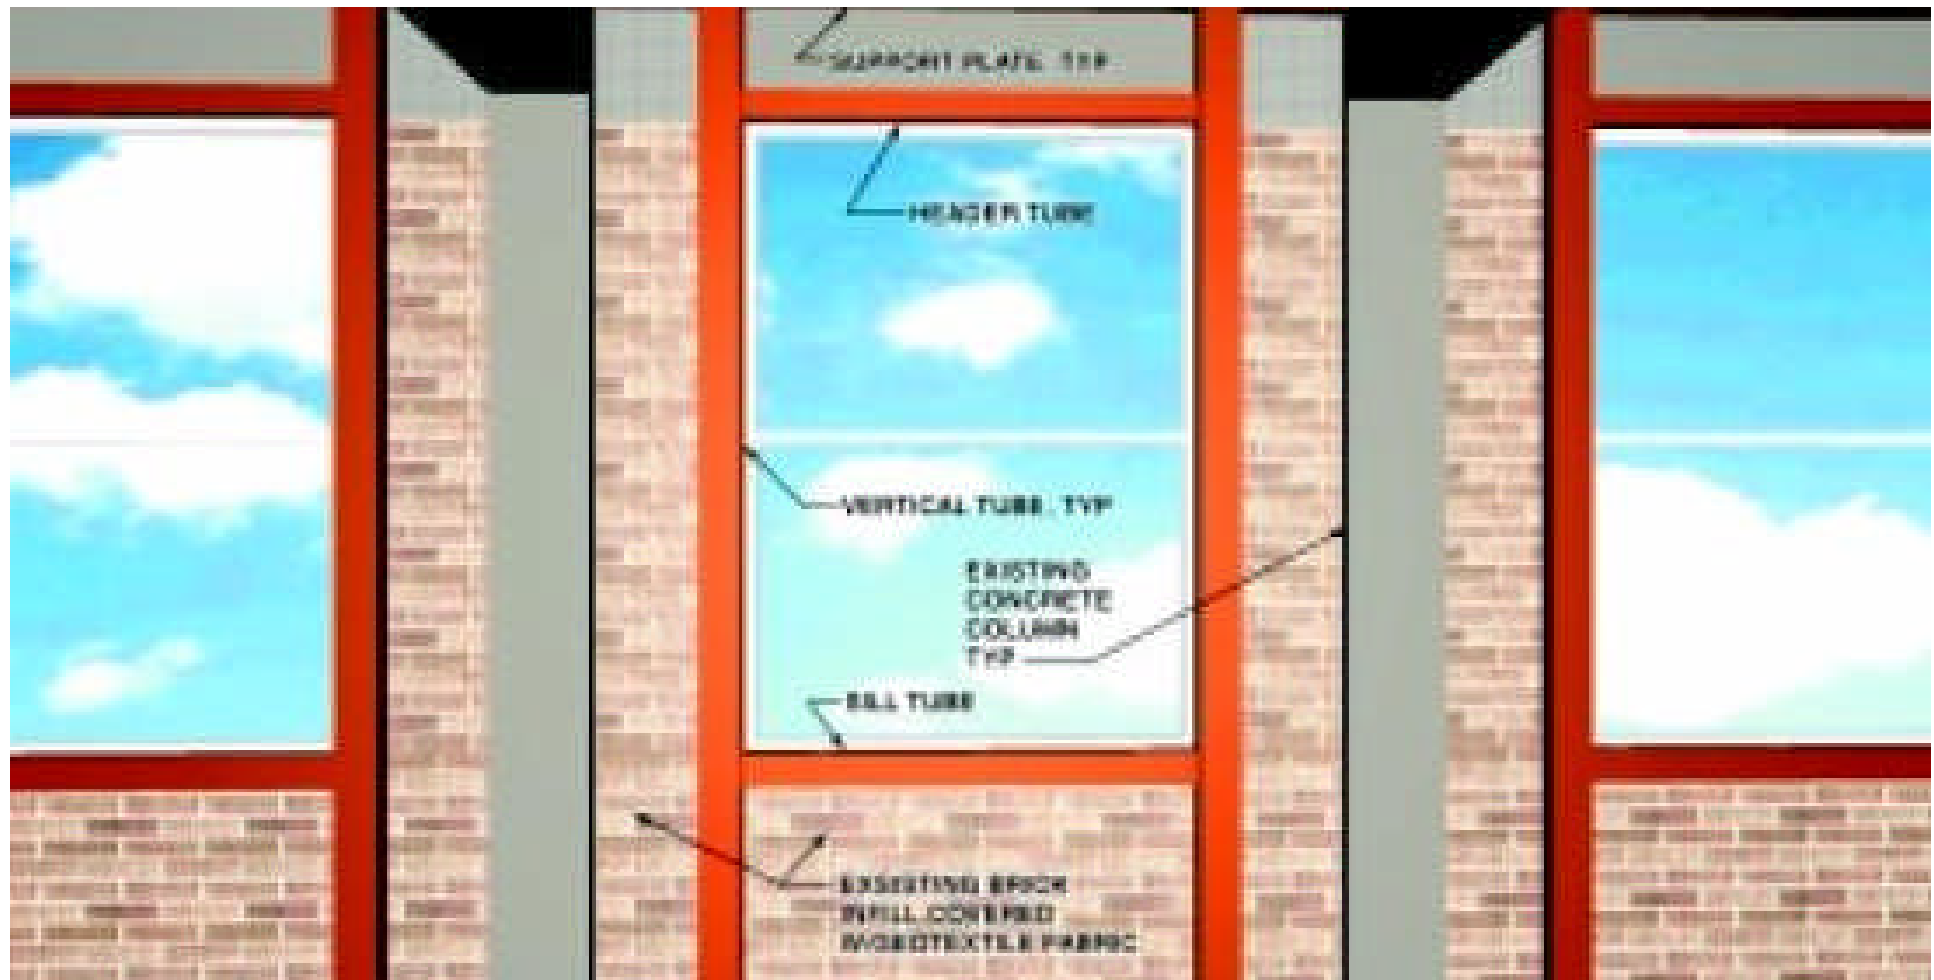
***“...This solution has a tubular frame for each windowed wall panel, consisting of two vertical tubes horizontally braced with tubes welded at each window’s head and sill. The frame becomes the structural support for the blast-resistant windows, with the vertical tubes giving new blast protection to the infill walls...”***

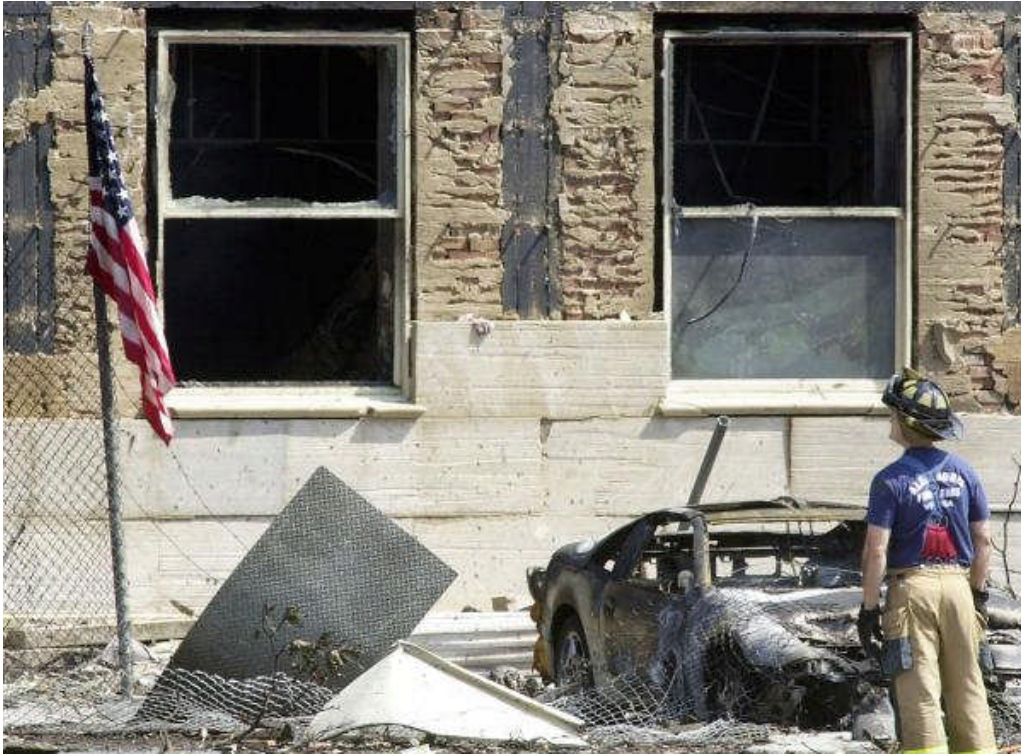
***“...The blast-resistant windows were nearly two inches thick. Some of them remain remarkably intact and in place adjacent to the point of impact. Some were popped out of their frames by the force of the exploding jet fuel, but they fell without breaking or splintering. Also on the exterior walls, between the steel columns, the renovation crew had placed Kevlar cloth, similar to the material used for bullet-proof vests. This had the effect of holding together building materials so they wouldn't become deadly projectiles in an explosion...”***

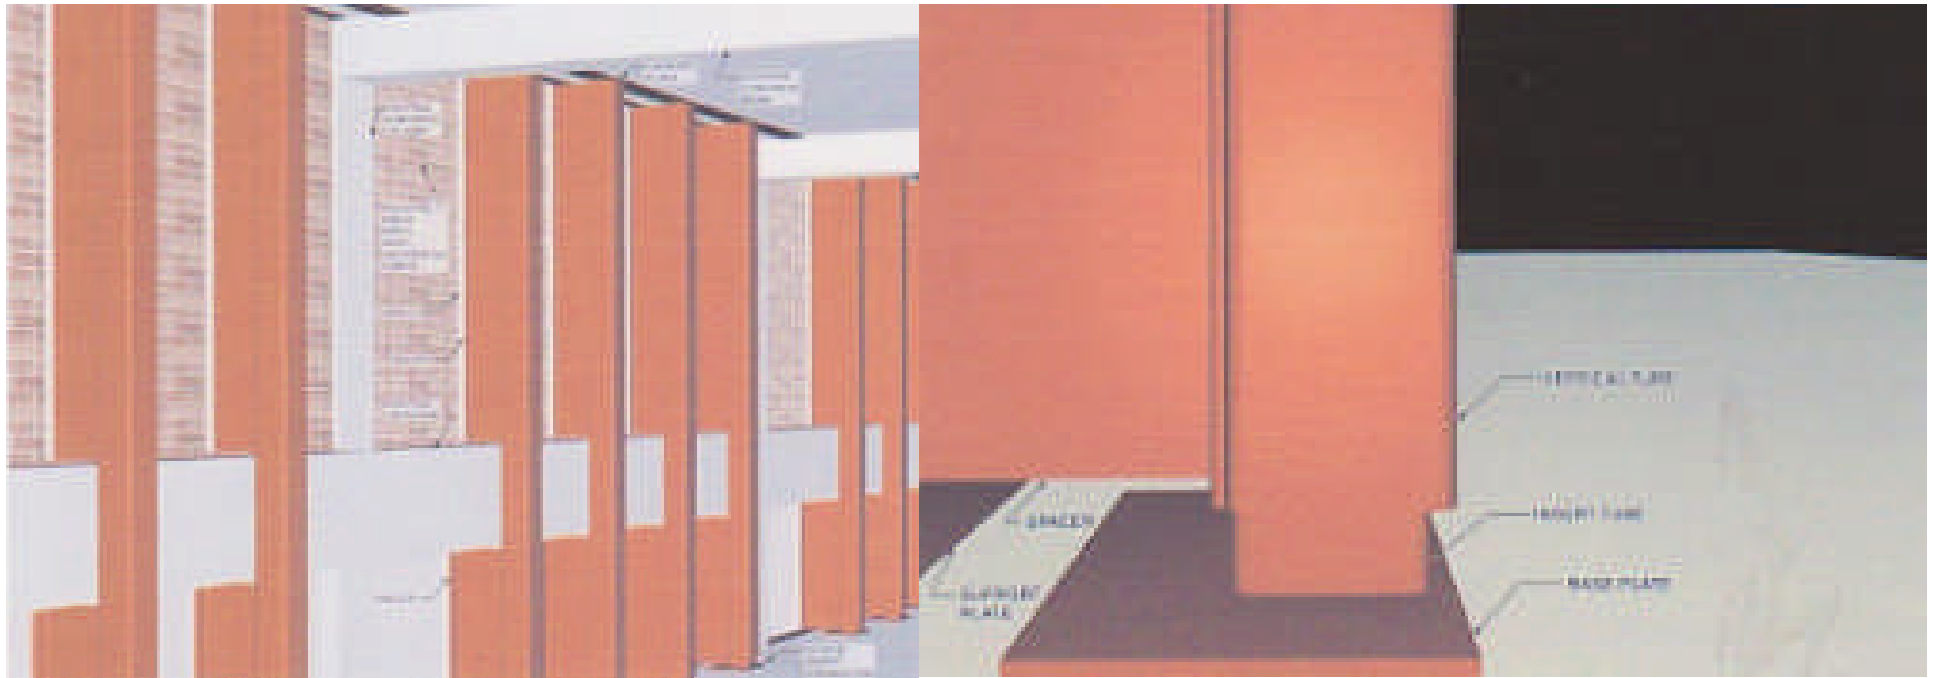
***“...However, the construction contractor, Morse Diesel International, Inc., suggested using instead a slip-insert assembly to reduce costs, one of the firm’s many practical suggestions for successfully installing these various structural supports. The sleeve design allows the tube to slip into the sleeve and bear against it to transfer shear forces to the slab. Because the tube itself is not physically anchored to the sleeve, the tube can slip upward to deflect blast loadings, thus diminishing the tensile forces and allowing the expansion anchors to maintain their integrity...”***

**Left:** caption: “Rendering of the vertical tube braces at fifth floor”

**Right:** caption: “Close up of the slip connection at fifth floor”

***“...The other ‘non-conforming’ area, the windowless (along the outer wall) fifth floor, also required a unique approach. The capstone mentioned earlier prevents alignment of the fifth floor’s vertical tubes with those from the floor below. To gain structural benefit for the vertical tubes, again the design turned to spacers to fill the in-space between the verticals and the masonry walls. A wide-flange beam spacer was used above the capstone and a somewhat smaller one above. Four of these new structural tubes with spacers were placed evenly between existing concrete columns to provide improved bracing for the wall section. Since the fifth floor ceiling is also the roof slab, a through-bolt connection would have to go through existing slate or copper roof material. This approach was unacceptable because it would alter the historically protected exterior. The design decision was to use expansion anchors. Though not acceptable for other areas, a design modification allowed their use on the fifth floor. To avoid the tensile strength problem and shear potential on the ceiling anchors, the design was altered to eliminate the tensile force. The first thought was to core-drill as on the first floor...”***

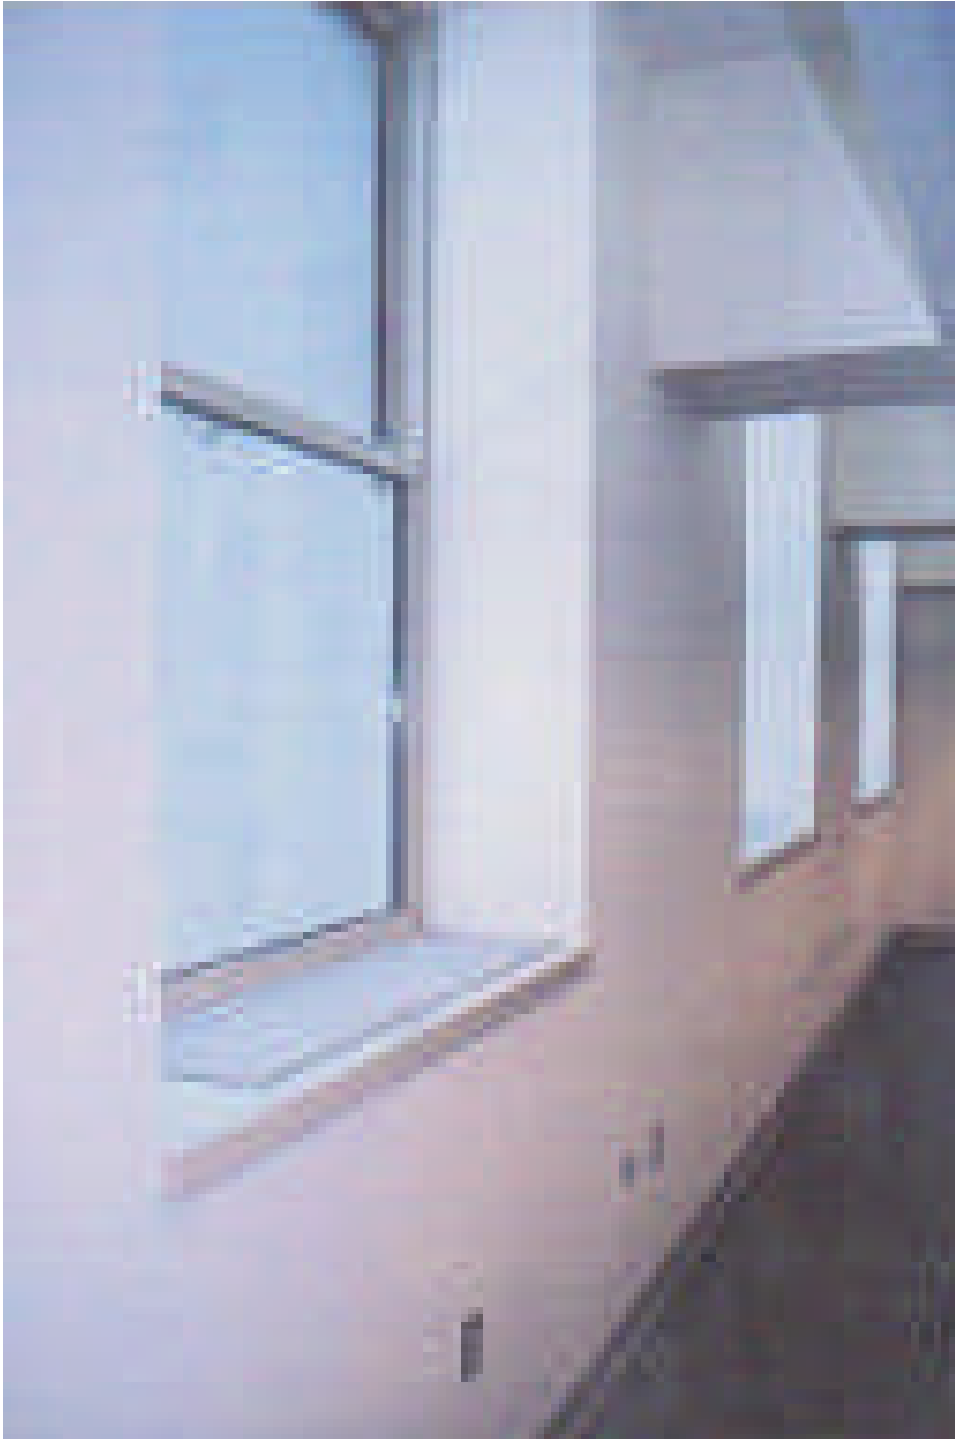
***“...Eventually, all of the nearly 8,000 windows in the Pentagon will be replaced with fixed double-pane glass mirroring the original architecture but offering improved thermal and ultra-violet filtering properties. However, the new exterior outermost E-Ring windows facing the perimeter roadways and the innermost A-Ring windows (at the courtyard center of the complex), being the most vulnerable, will be blast resistant. The new windows are an insulated, laminated, fully-tempered assembly that is designed to absorb and resist the blast loads without shattering into small projectiles or leaving the frame as a single unit. This design meets the client criteria for translucency and energy efficiency, as well as for safety in a blast event...”***

**Left:** caption: “Photo of the finished product”
