**PDHonline Course C682 (4 PDH)**

## ***Five-By-Five: The Making of the Pentagon***

*Instructor: J.M. Syken*

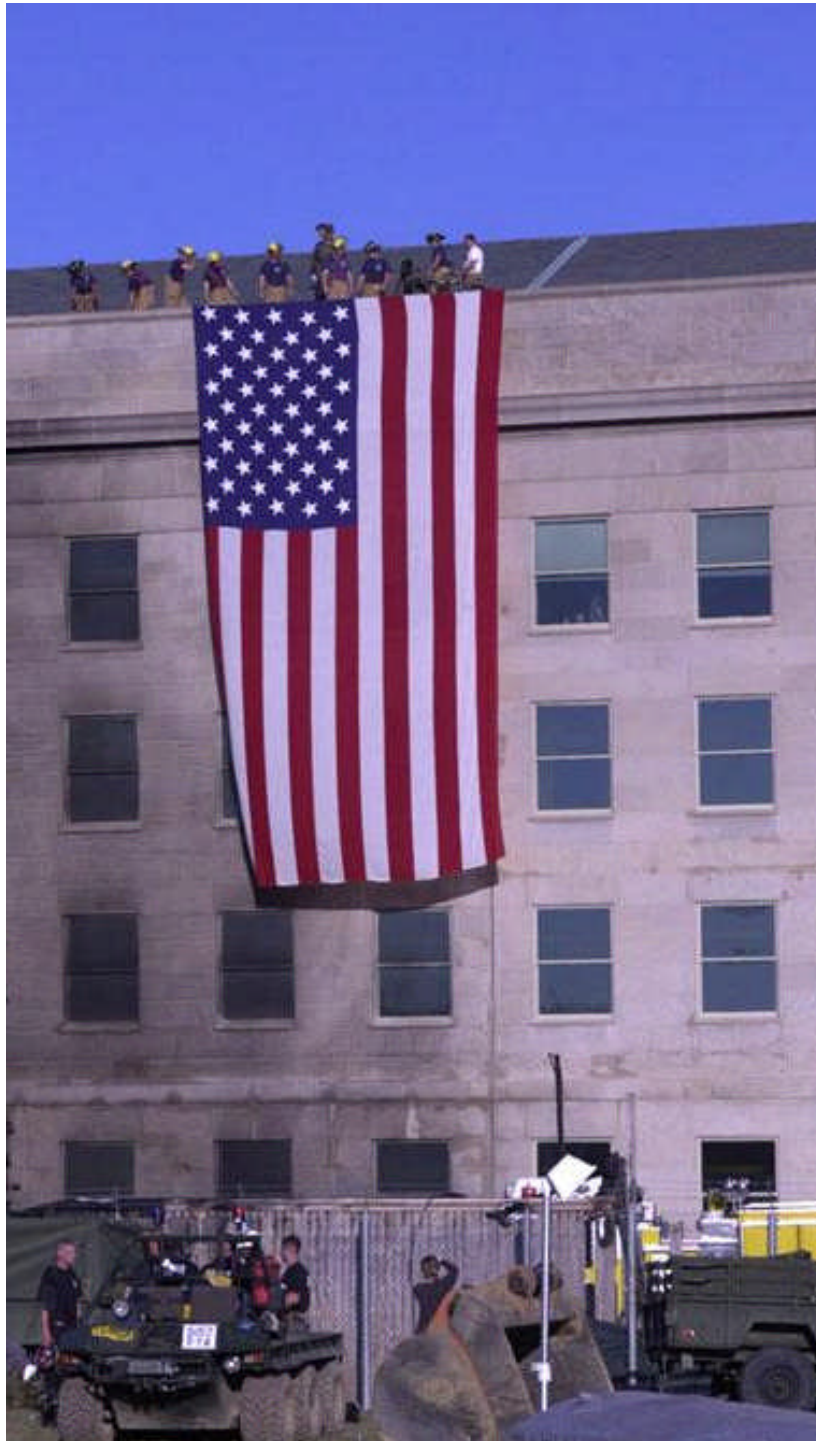
***“...Ironically, the fortress-like appearance provided by the exterior Indiana limestone is misleading. The limestone is not structural but a veneer supported by steel hangers. As the facade is repaired in the near future, matching replacement stone will come from the original quarry in deference to the building’s historic status...”***

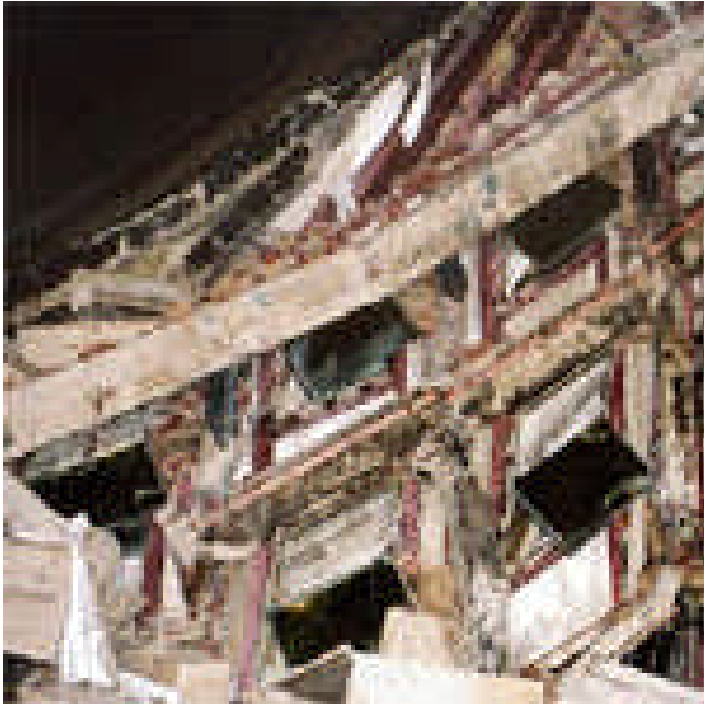
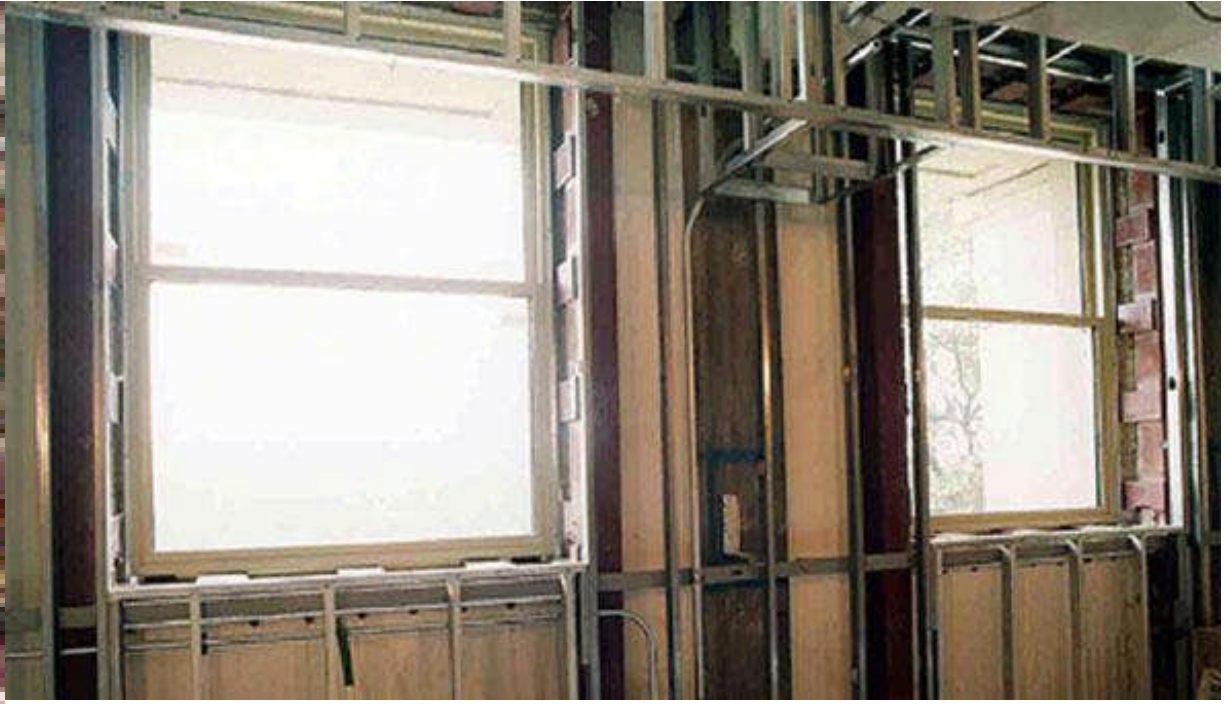
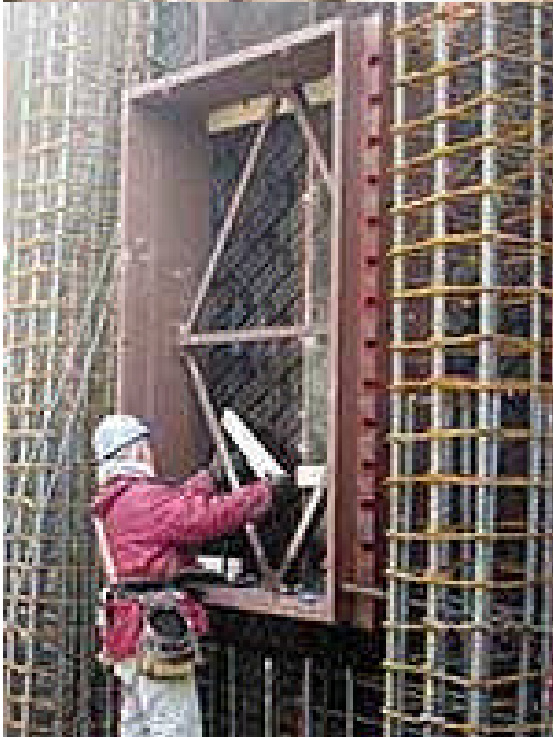
**Top Left:** caption: “When the Pentagon collapsed, the structure was held together by the ‘web’ of steel columns and beams, show in maroon, which are bolted together at the floors.”

**3 Blast-Resistant Windows:** Every exterior window and frame was replaced,, with new panes an inch and a half thick. Each window, with its frame, weighs 1,600 pounds

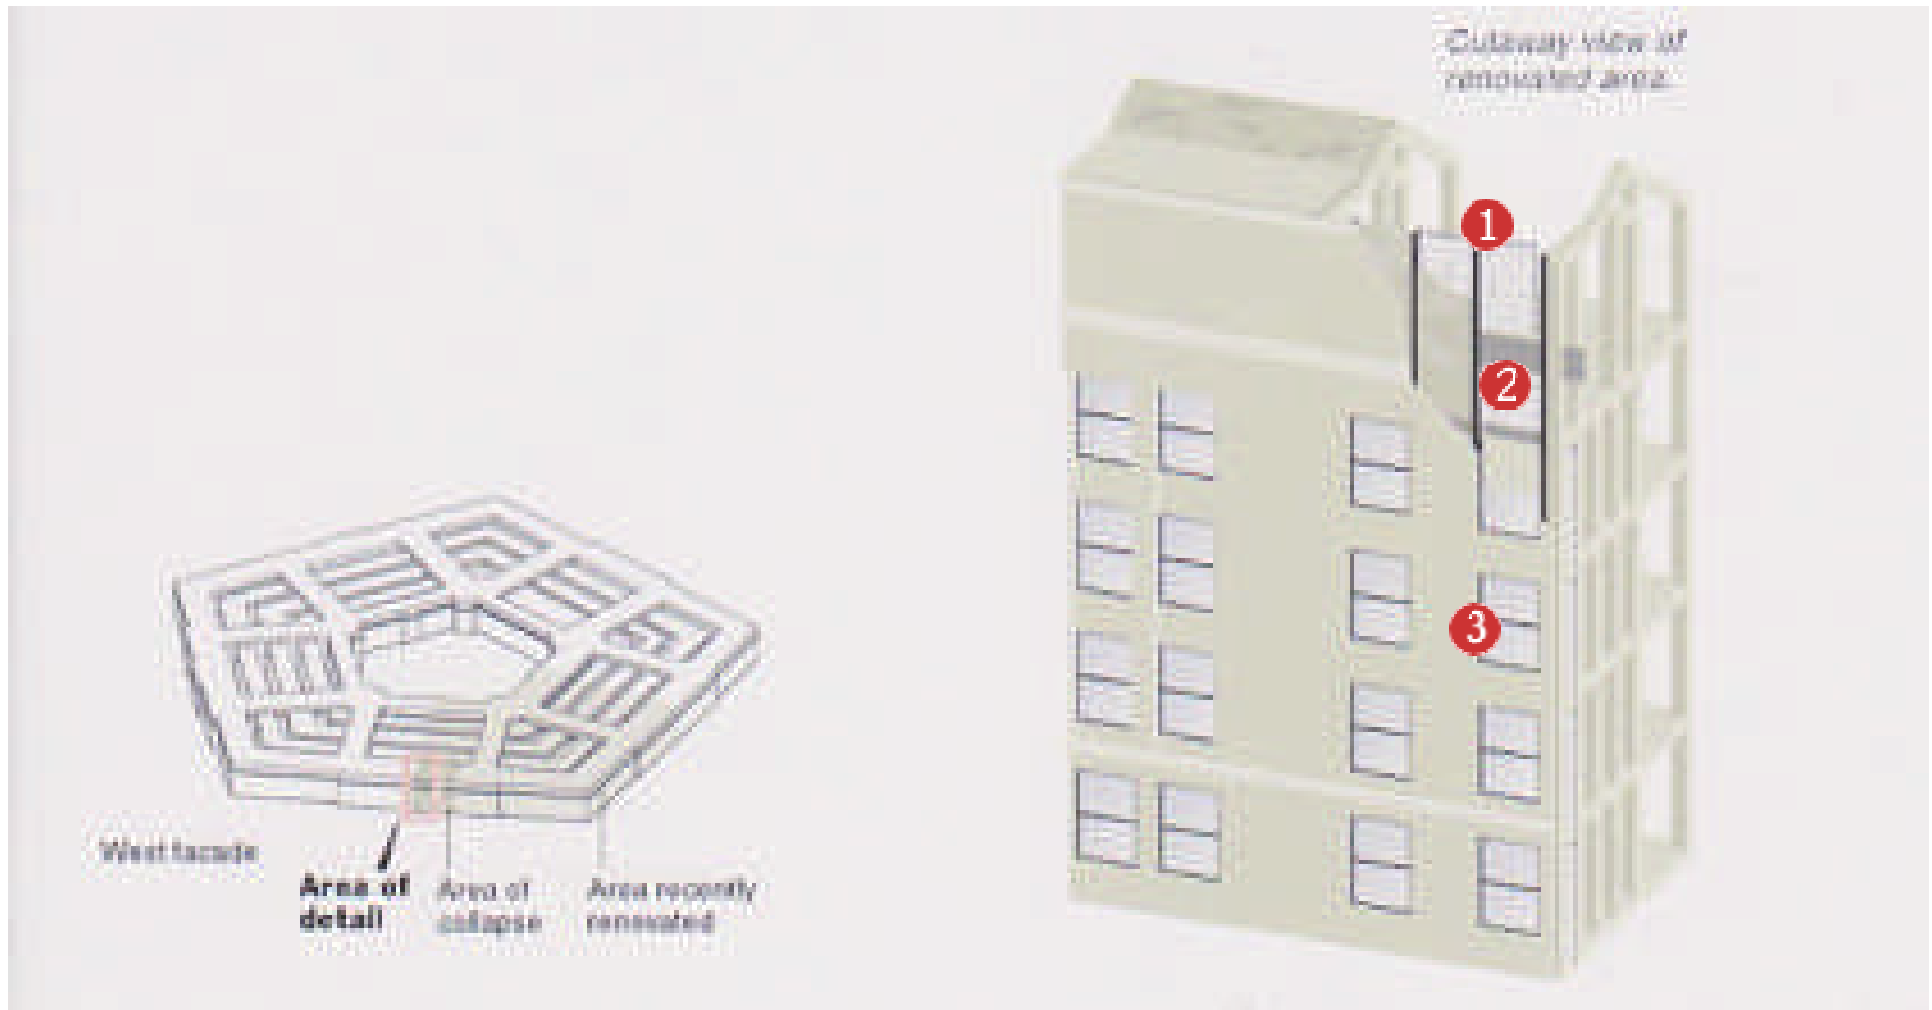
**1 Steel Beams:** New vertical steel beams were installed on each side of every exterior window

**2 Debris Guards:** A very strong mesh material, similar to Kevlar, was stretched between the stabilizing steel beams to contain debris in a blast

**Top Right:** caption: “Structural steel, running through all five floors, strengthened the walls around the blast-resistant windows. A Kevlar cloth stretched between the steel tubes prevented debris from becoming shrapnel during the explosion.”

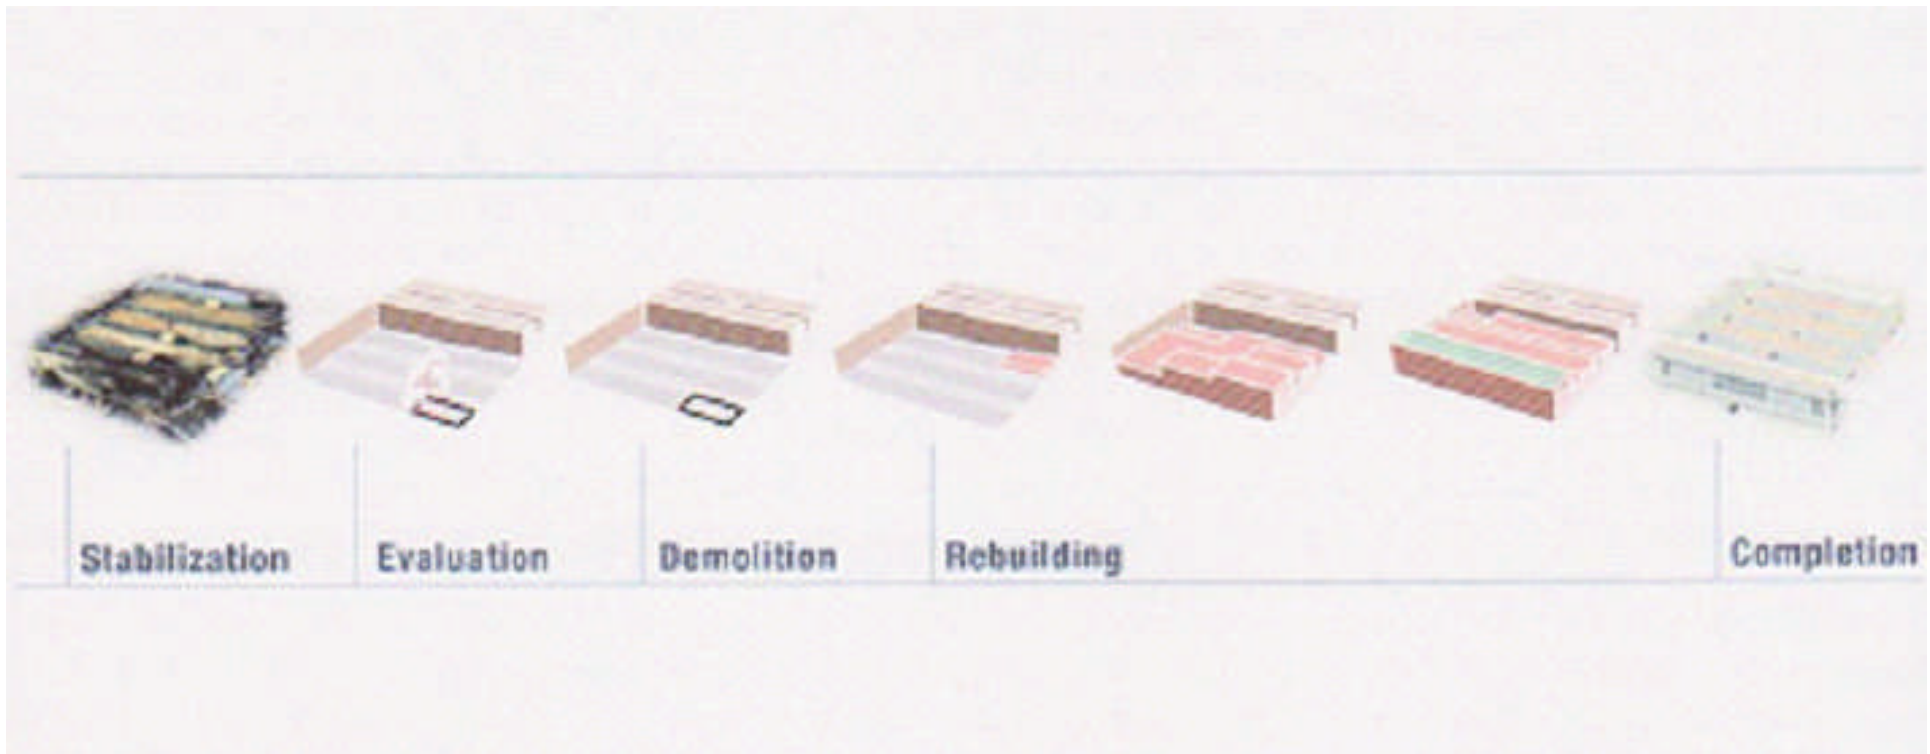
***Above: reconstruction phases***

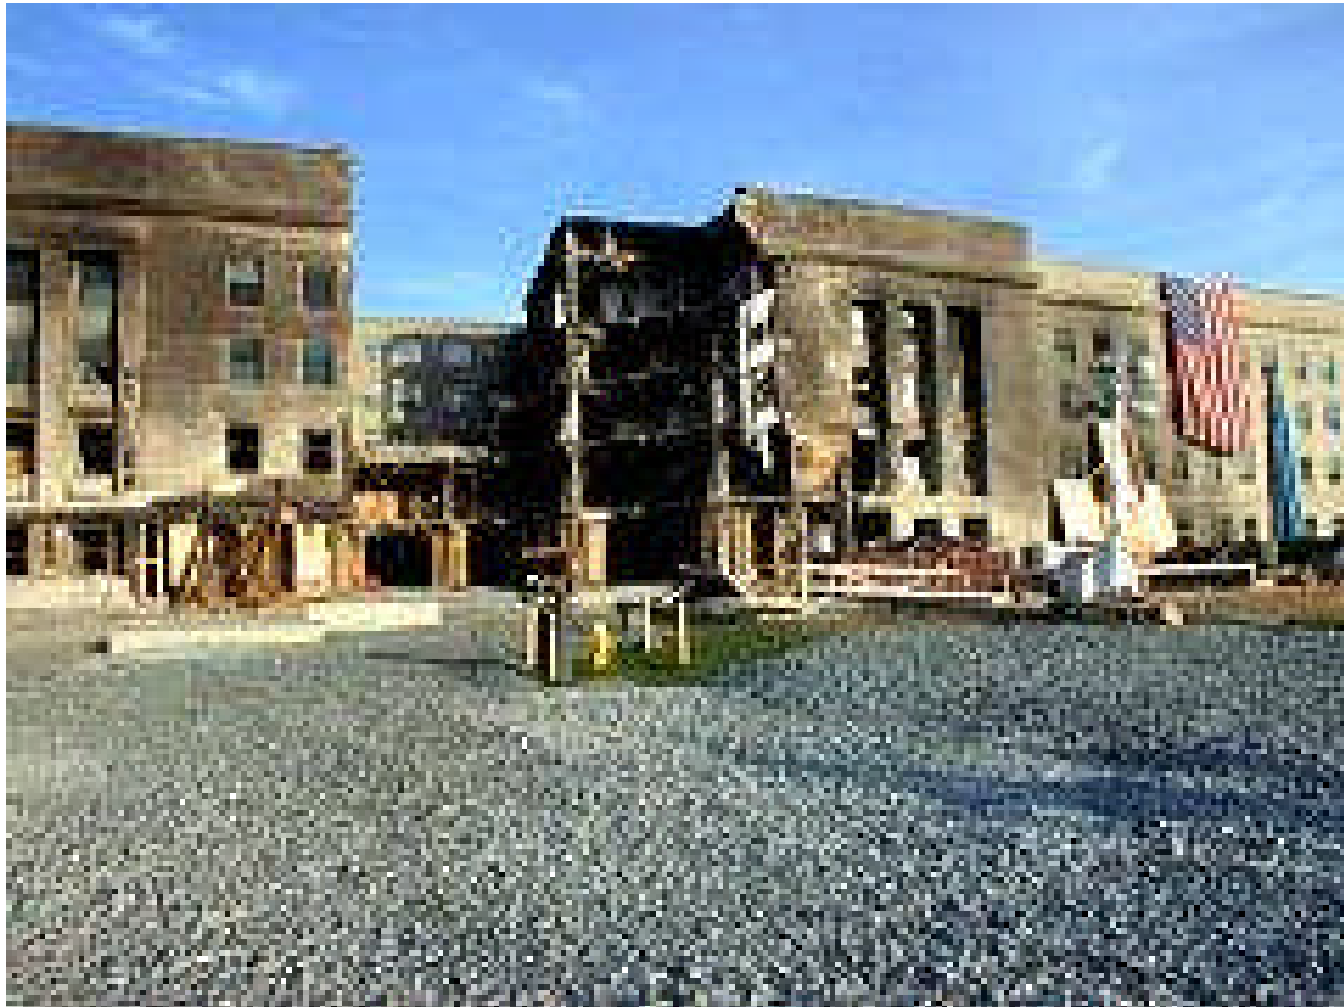
## STABILIZATION *Immediate Aftermath*

The plane and subsequent blast traveled at a 45-degree angle into the west face of the building. The outer three rings—E, D and C—between Corridors 4 and 5 were heavily damaged.

Massive fireballs—fed by fuel from the plane—destroyed many of the concrete support columns. Workers constructed makeshift columns from timber before they were able to fully assess the damage. About 10,000 tons of debris were removed in the first few weeks.

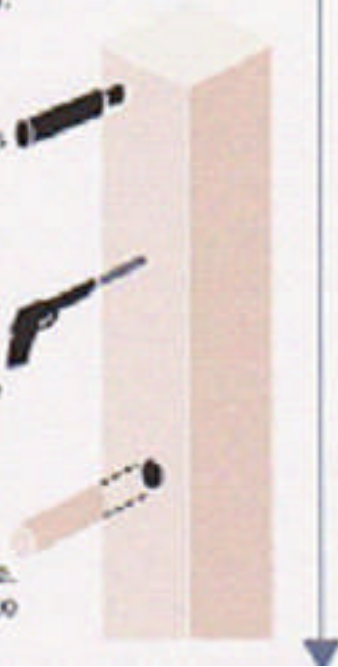
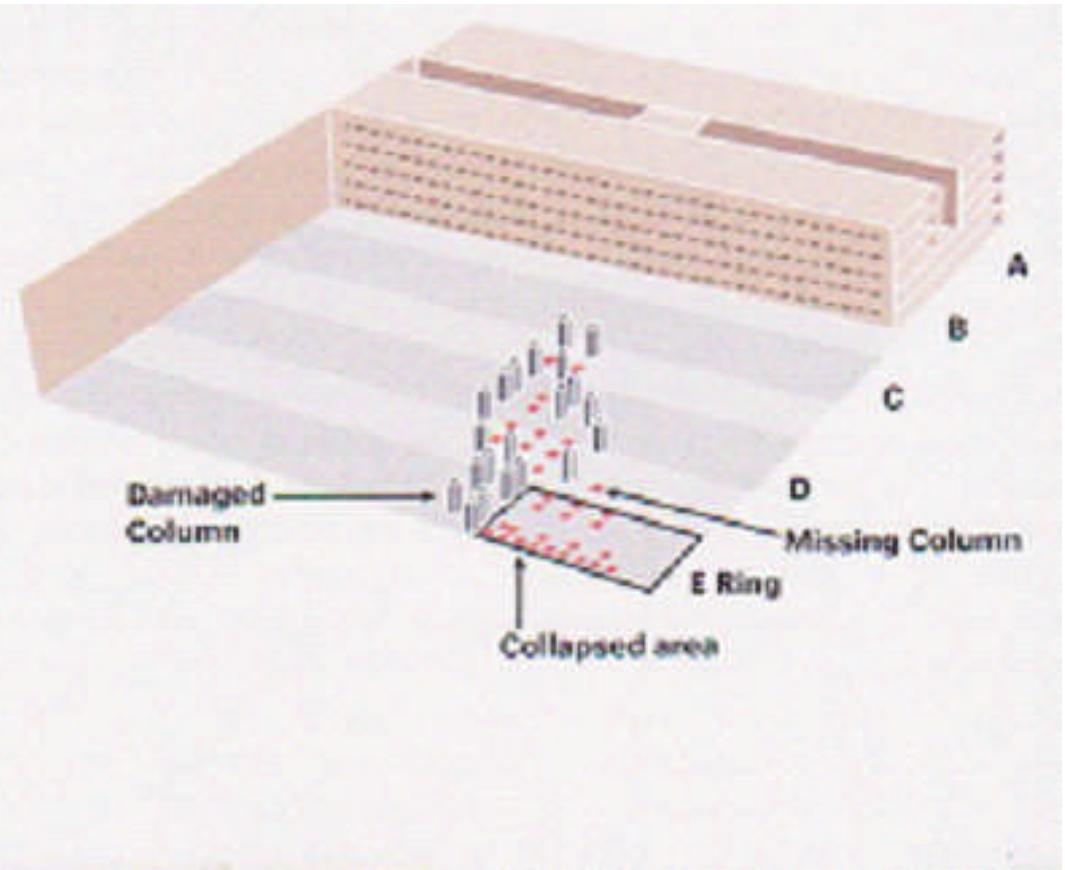
### Core sample

A core is drilled out and crushed in a vise-like machine. The amount of force needed to make it break is measured.

Once it was safe to enter the area of impact, structural engineers used a variety of methods to test the concrete to determine what remaining structures were compromised:

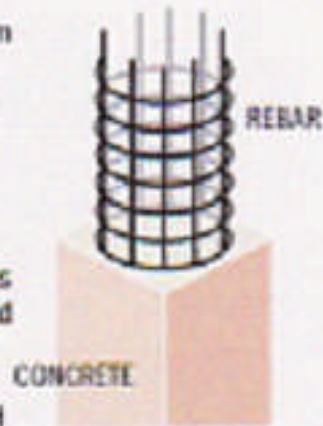
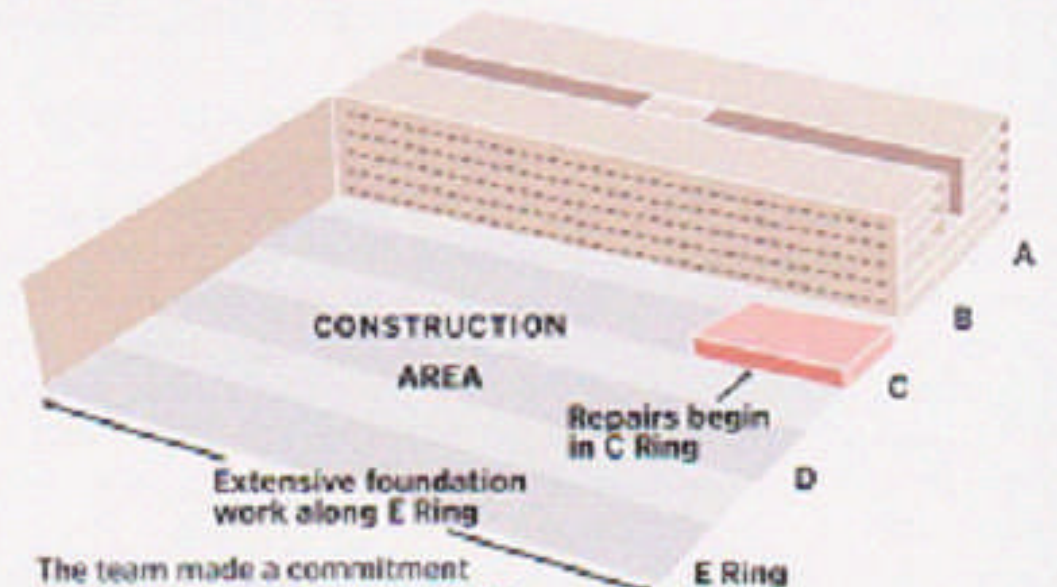
Following the original design of the building and maximizing the strength of the columns, each new column began with a steel cage of spiral rebar. The rebar was joined to 1.25-inch, high-strength stainless steel dowel rods and planted into the foundation. Formwork was secured around the rebar cages, and

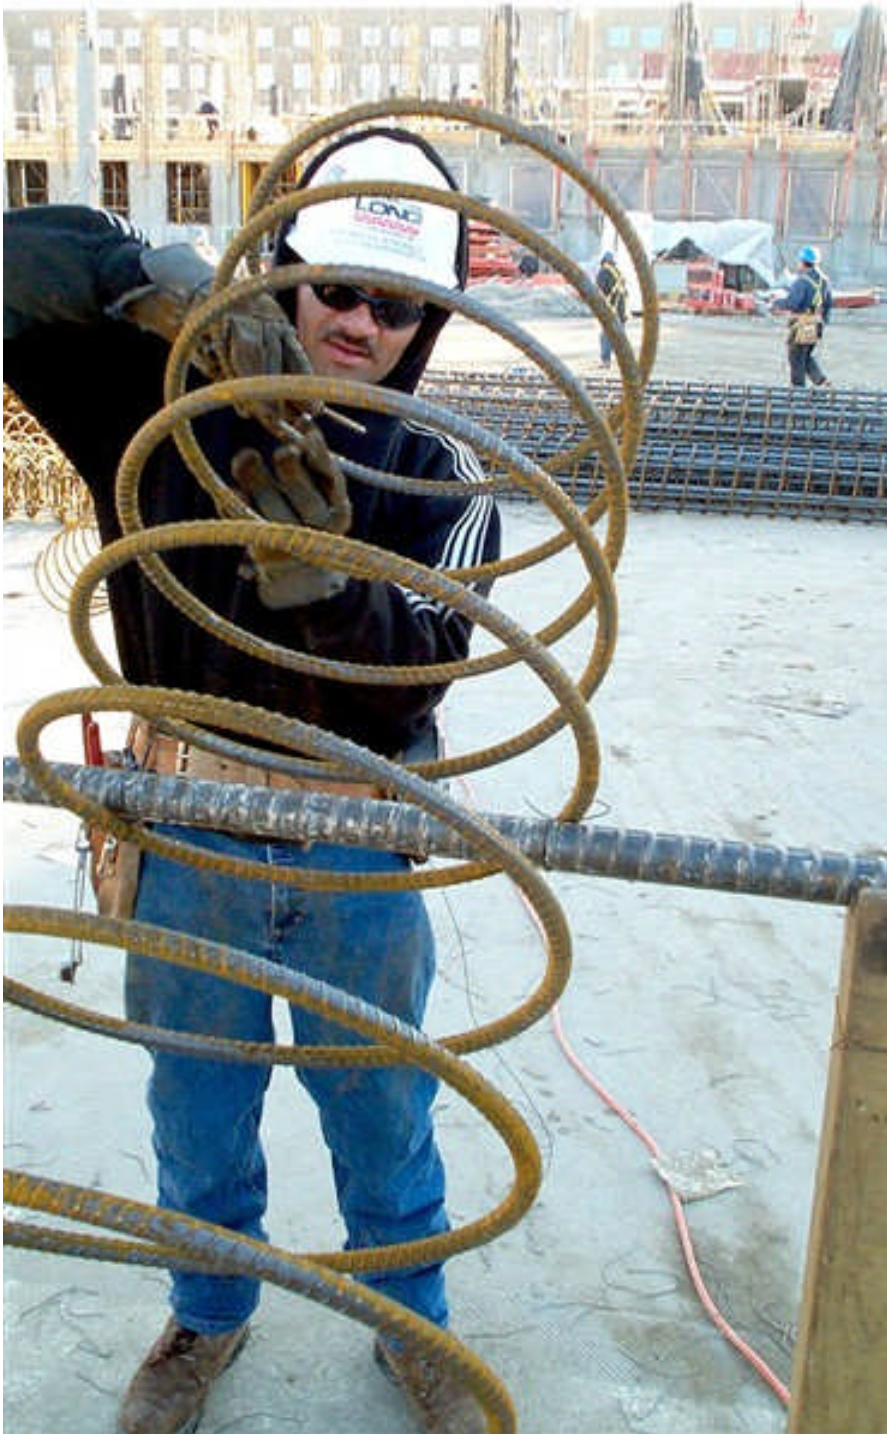
***Left: caption: “Workman prepares rebar to reinforce concrete columns”***

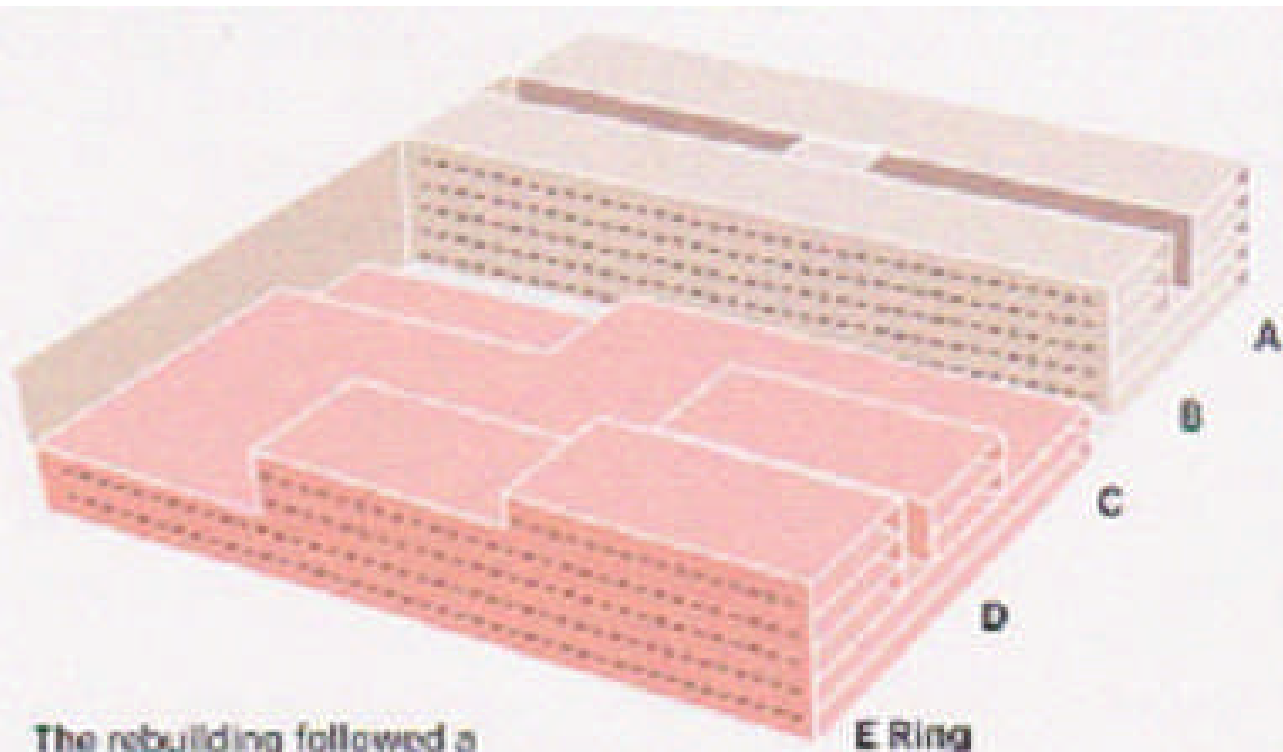
The rebuilding followed a "wedding cake" or stair-step structure. Sections of each floor were rebuilt in stages, with the goal of completing E Ring first.

On each floor, the columns are reconstructed first, followed by reinforced concrete walls, then floors, or "decks."

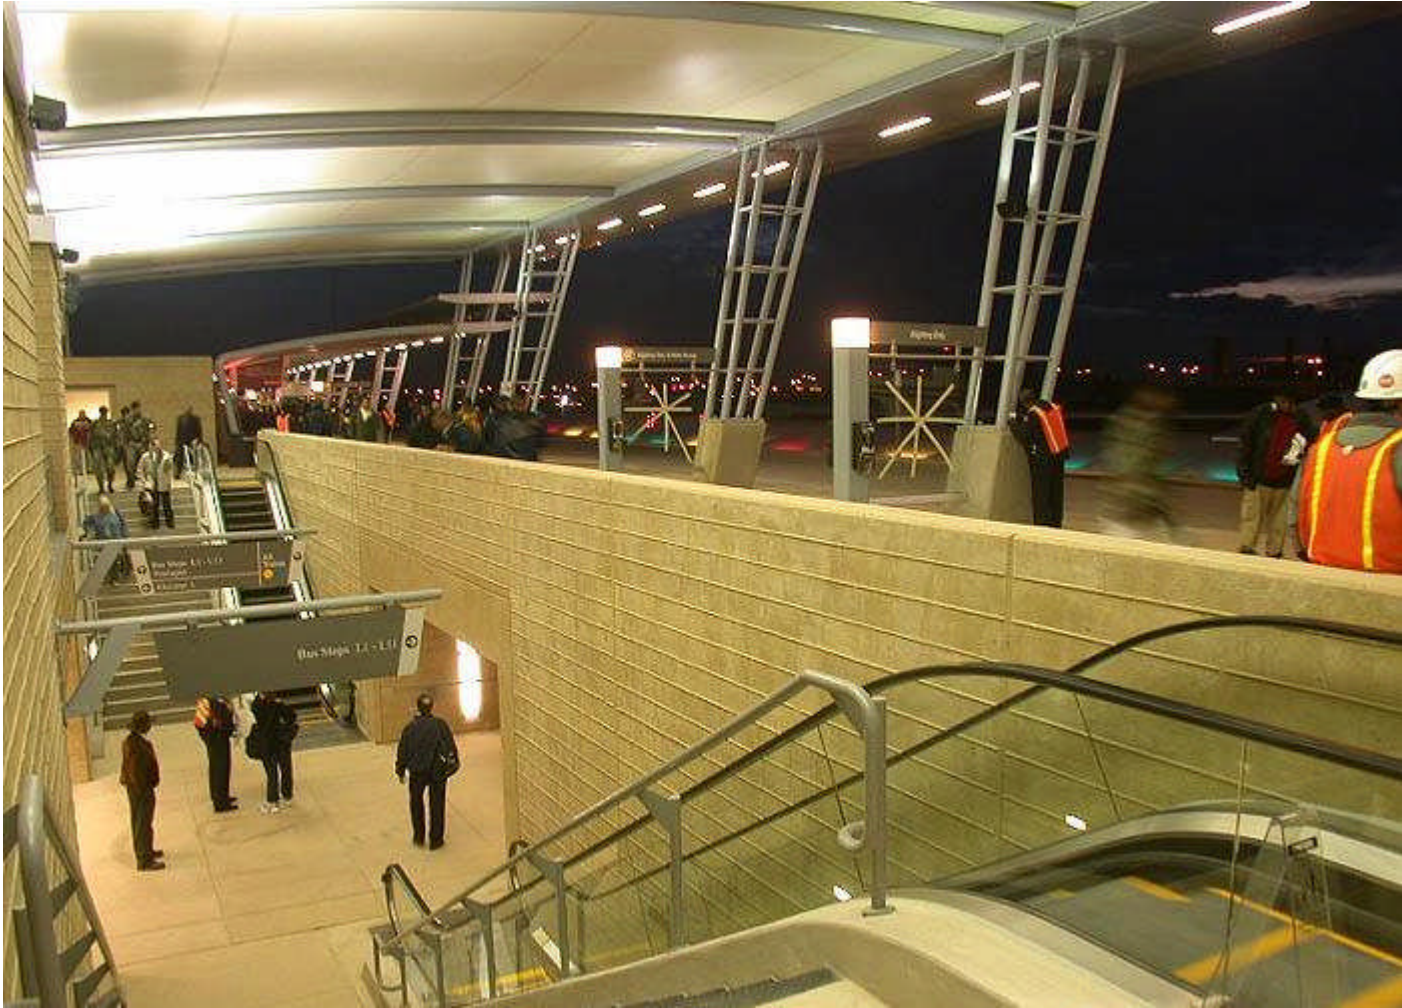
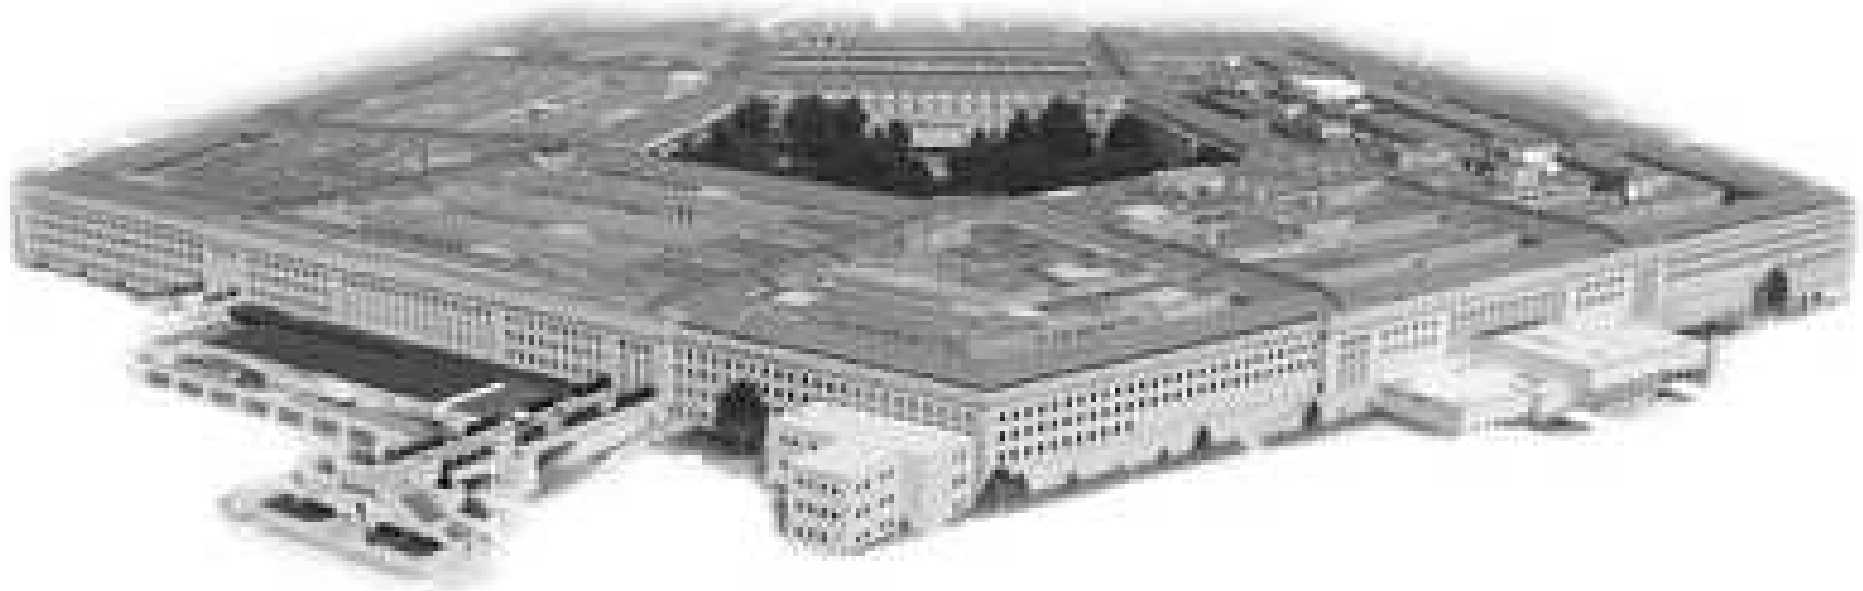
**The *Metro Entrance Facility* project was directed by Congress in the FY2000 *Department of Defense Appropriations Act* in response to security assessments that identified the need to improve the physical security of the Pentagon. These initiatives involved relocating the bus station and removing the existing direct entry into the Pentagon from the *Metrorail* station. The *Pentagon Metro Station* is the most highly trafficked Metro stop in *Northern Virginia* with over 34K riders daily. The project's goal was to improve the security of the Pentagon's Metro entrance by reorganizing Pentagon arrival, access and circulation areas to create a safe, secure environment. In order to improve the security of the Pentagon Metro entrance, the *Pentagon Renovation Program* removed the escalators and elevators connected to the Pentagon from the Metrorail platform and relocated all vehicle traffic away from the building.**

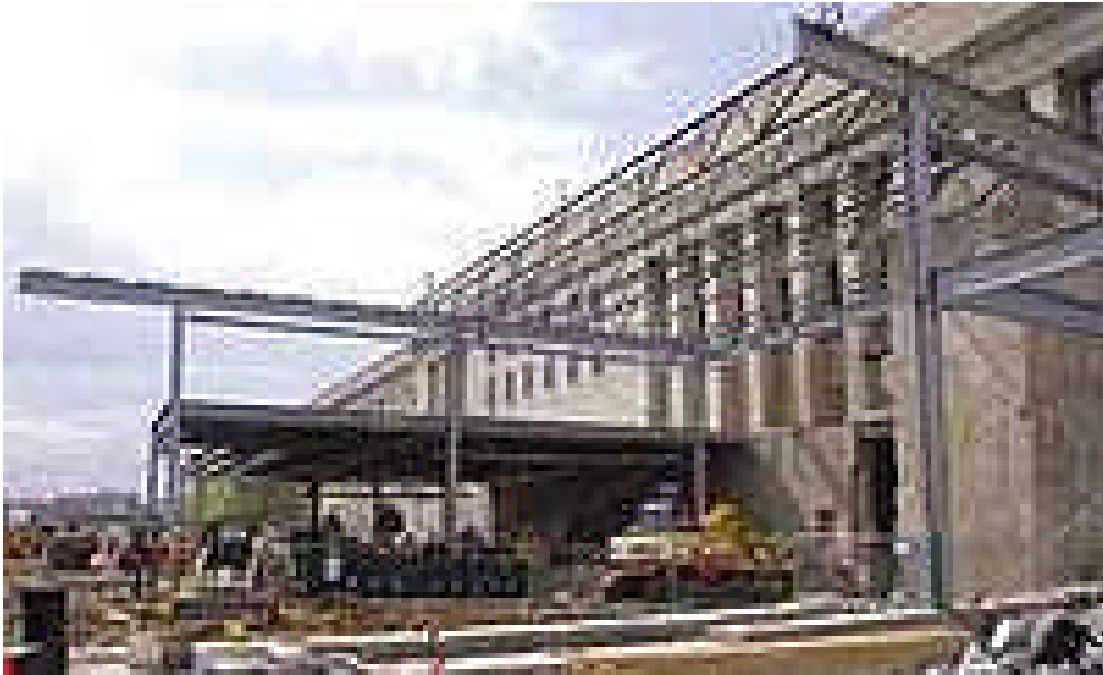
**The *South Terrace Project* included two pedestrian bridges over *Rotary Drive*, renovation of the loading dock and connection to the 2nd Floor of the Pentagon (at Corridors 2 and 3). The main purpose of the project was to provide separation of vehicular and pedestrian access while easing traffic congestion along the Drive. The first of two bridges was completed in December 1999. The second bridge (and connecting bus stop wall) was completed in February 2001. To organize Pentagon arrival, a more controllable ingress/egress procedure was established for employees, visitors and public transportation users. Inside the Pentagon, all pedestrian traffic is elevated to the second floor. Design and construction of the new bus facility began in Spring 2001 and was operational in November 2001. The *Physical Fitness and Readiness Facility* (PFRF) replaced the existing 55-year old *Pentagon Athletic Facility* with a larger, modern facility. The 130K-square-foot PFRF is located at Basement Level underneath and adjacent to the Pentagon's *Mall Terrace*.**

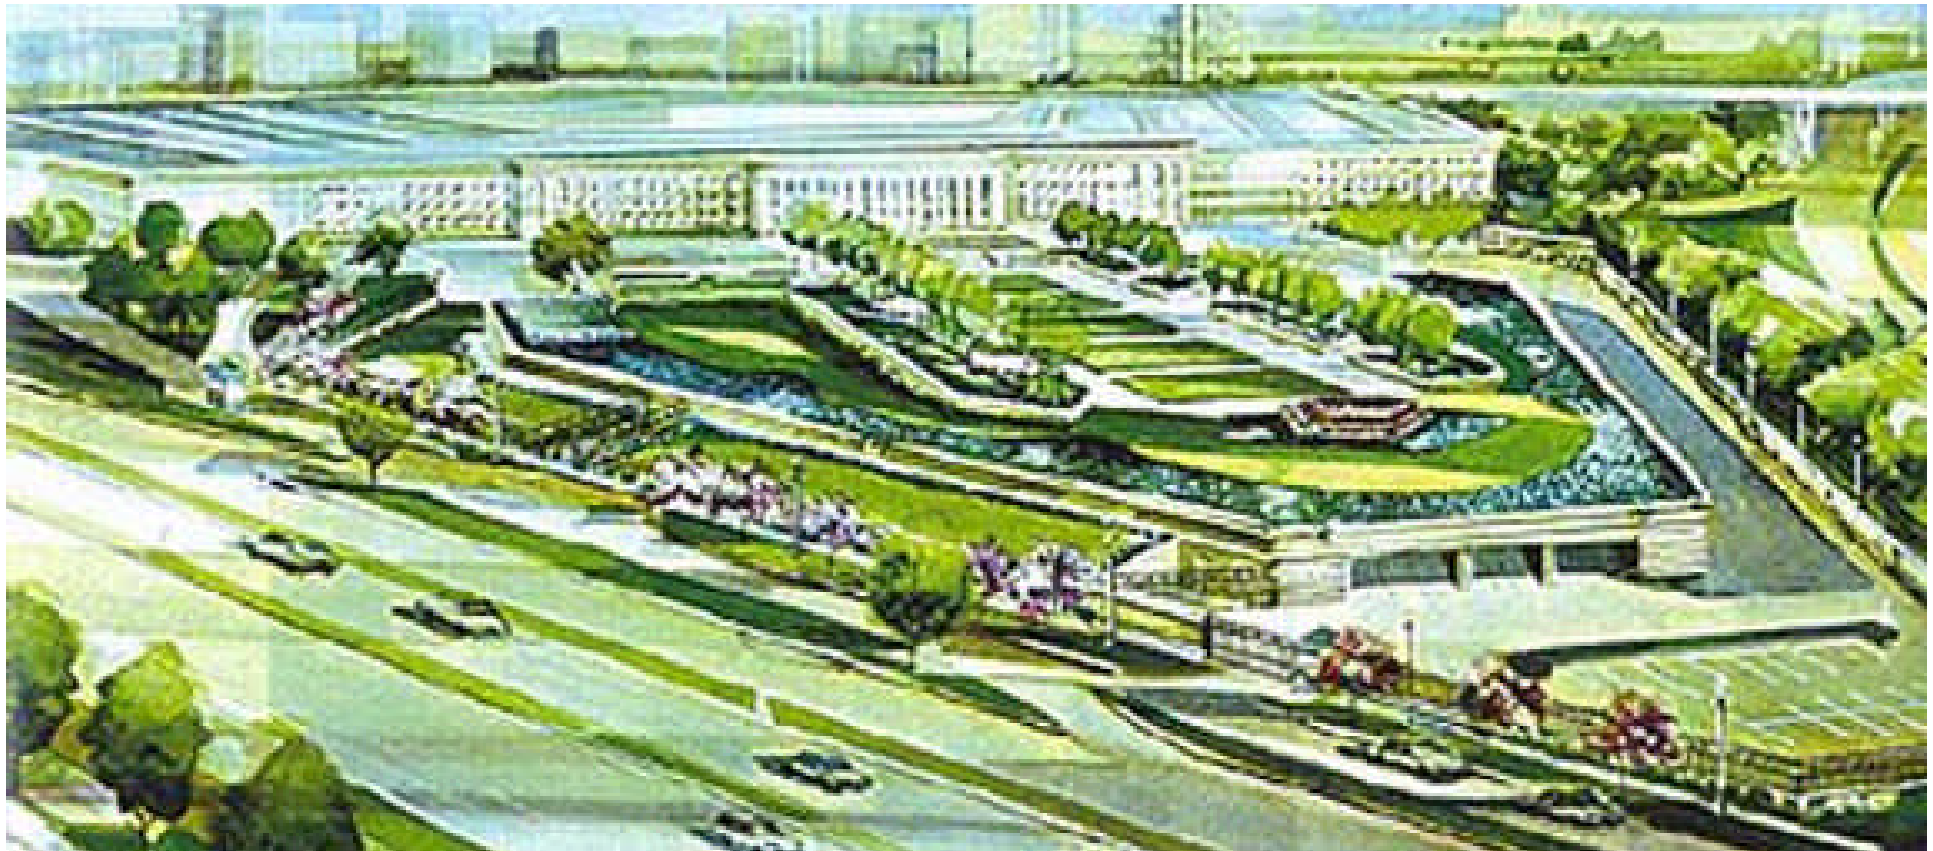
# RDF

The Pentagon's *Remote Delivery Facility* (a.k.a. "RDF" – conceptual rendering above) is a 250K-square foot shipping and receiving facility adjoining the Pentagon completed in March 2002. The RDF significantly improved the physical security of the Pentagon by providing a secure, consolidated location for receiving and screening thousands of items shipped to the building each day. Before construction of the RDF could begin, the *Mall Extension* parking lot was demolished. By storing the excavated soil at sites around the Pentagon Reservation (for later use instead of disposing of it off-site), the program saved over \$1 million (demolition was completed in June 1999). The landscaping of the roof of the facility created a park-like atmosphere, enhancing the view for the tenants who work on the E-ring of the *Mall Terrace* and created an alternate location for some of the ceremonial activities that take place on the *River Terrace*. 225

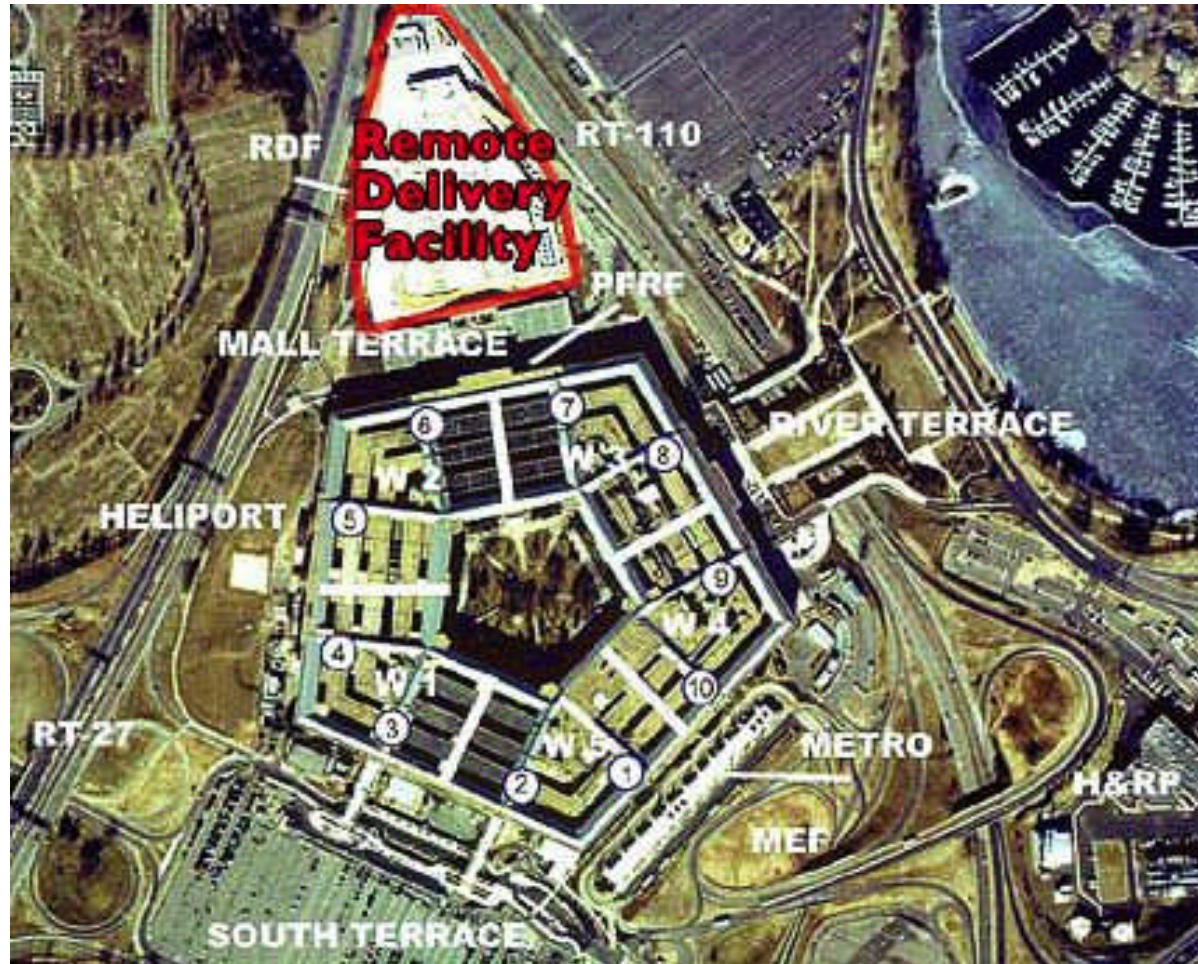
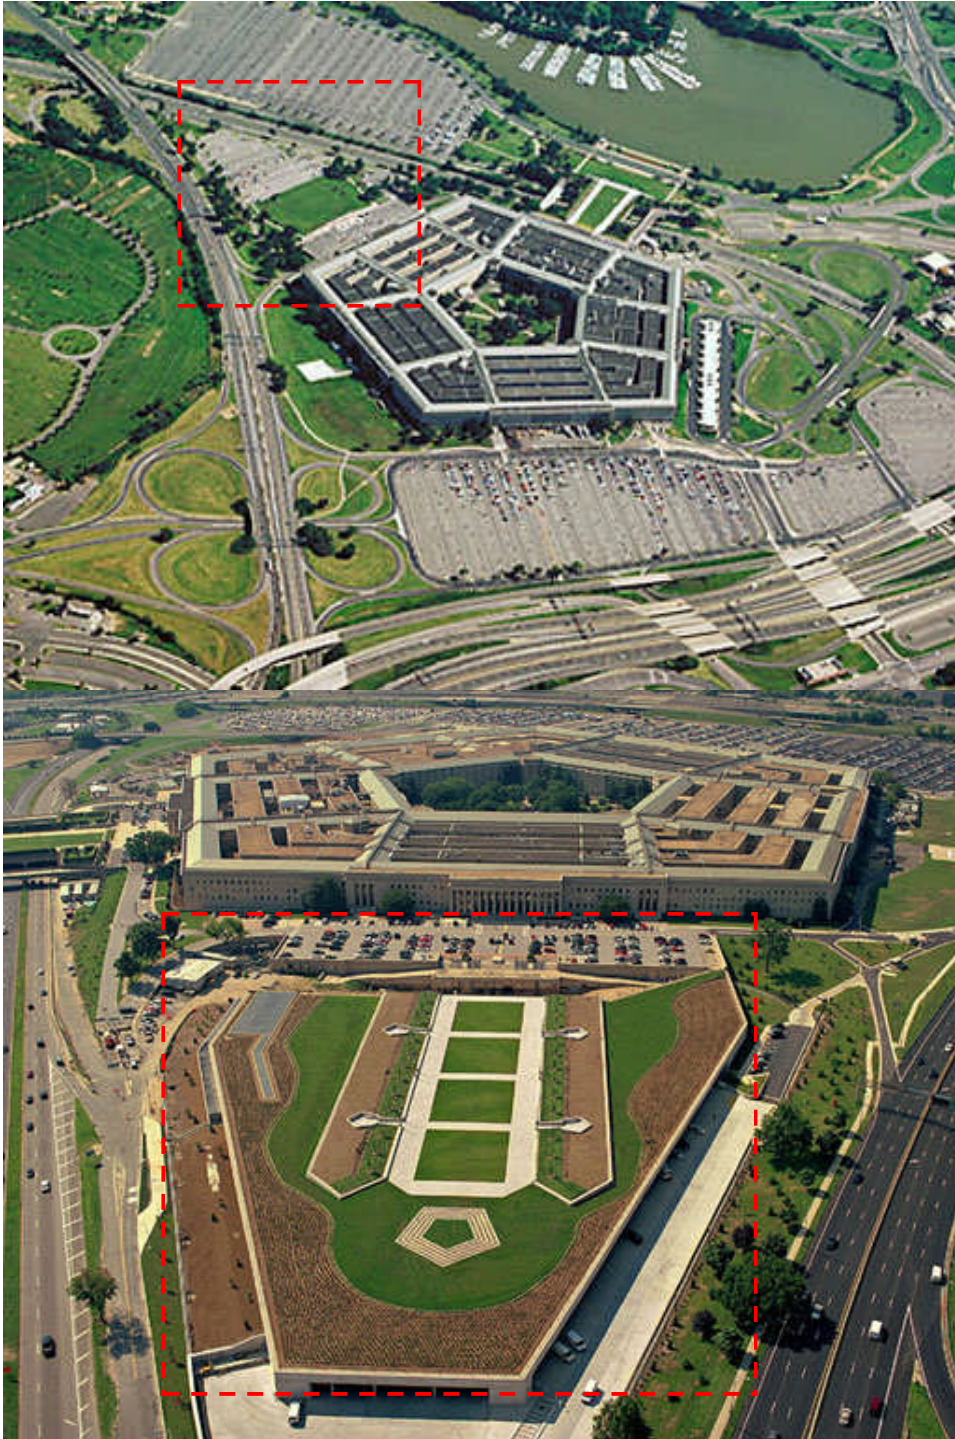
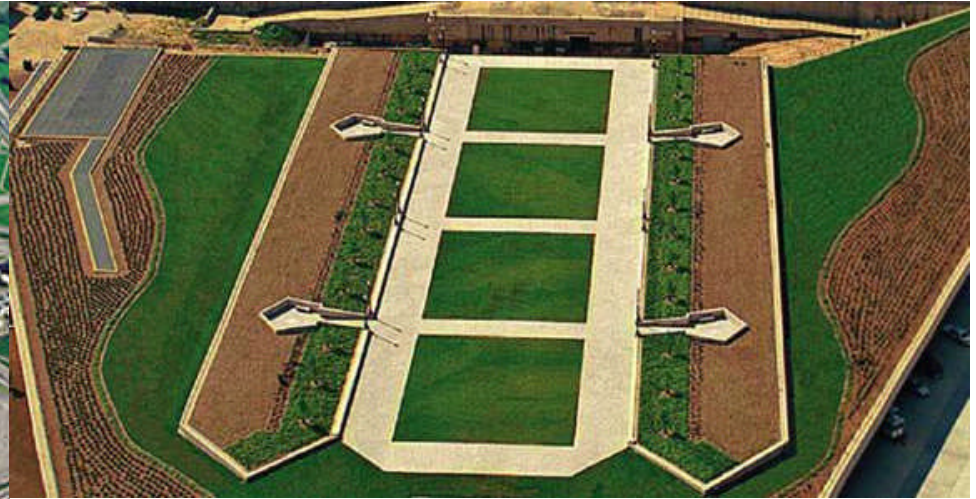
**Top Left:** location of the RDF (highlighted) prior to construction

**Above & Lower Left:** Aerial view of the RDF facility. The four grass squares in the middle of the photograph are *Grasspave2* heliports. Helicopters land on the concrete pad/s and park in one (of four) small pentagon shapes (flanking the four landing pads). *Grasspave2* was selected as a “green” alternative for helicopter landing pads having a high compressive strength (5,721psi). The Pentagon RDF is also a *LEED Certified Project* and it has the largest green roof east of the *Mississippi River*.
